### Hydraulics Field Report

Y12463

Goodnough Creek SR 16 MP 16.59 (WDFW 105 K051618a)

3/26/2021

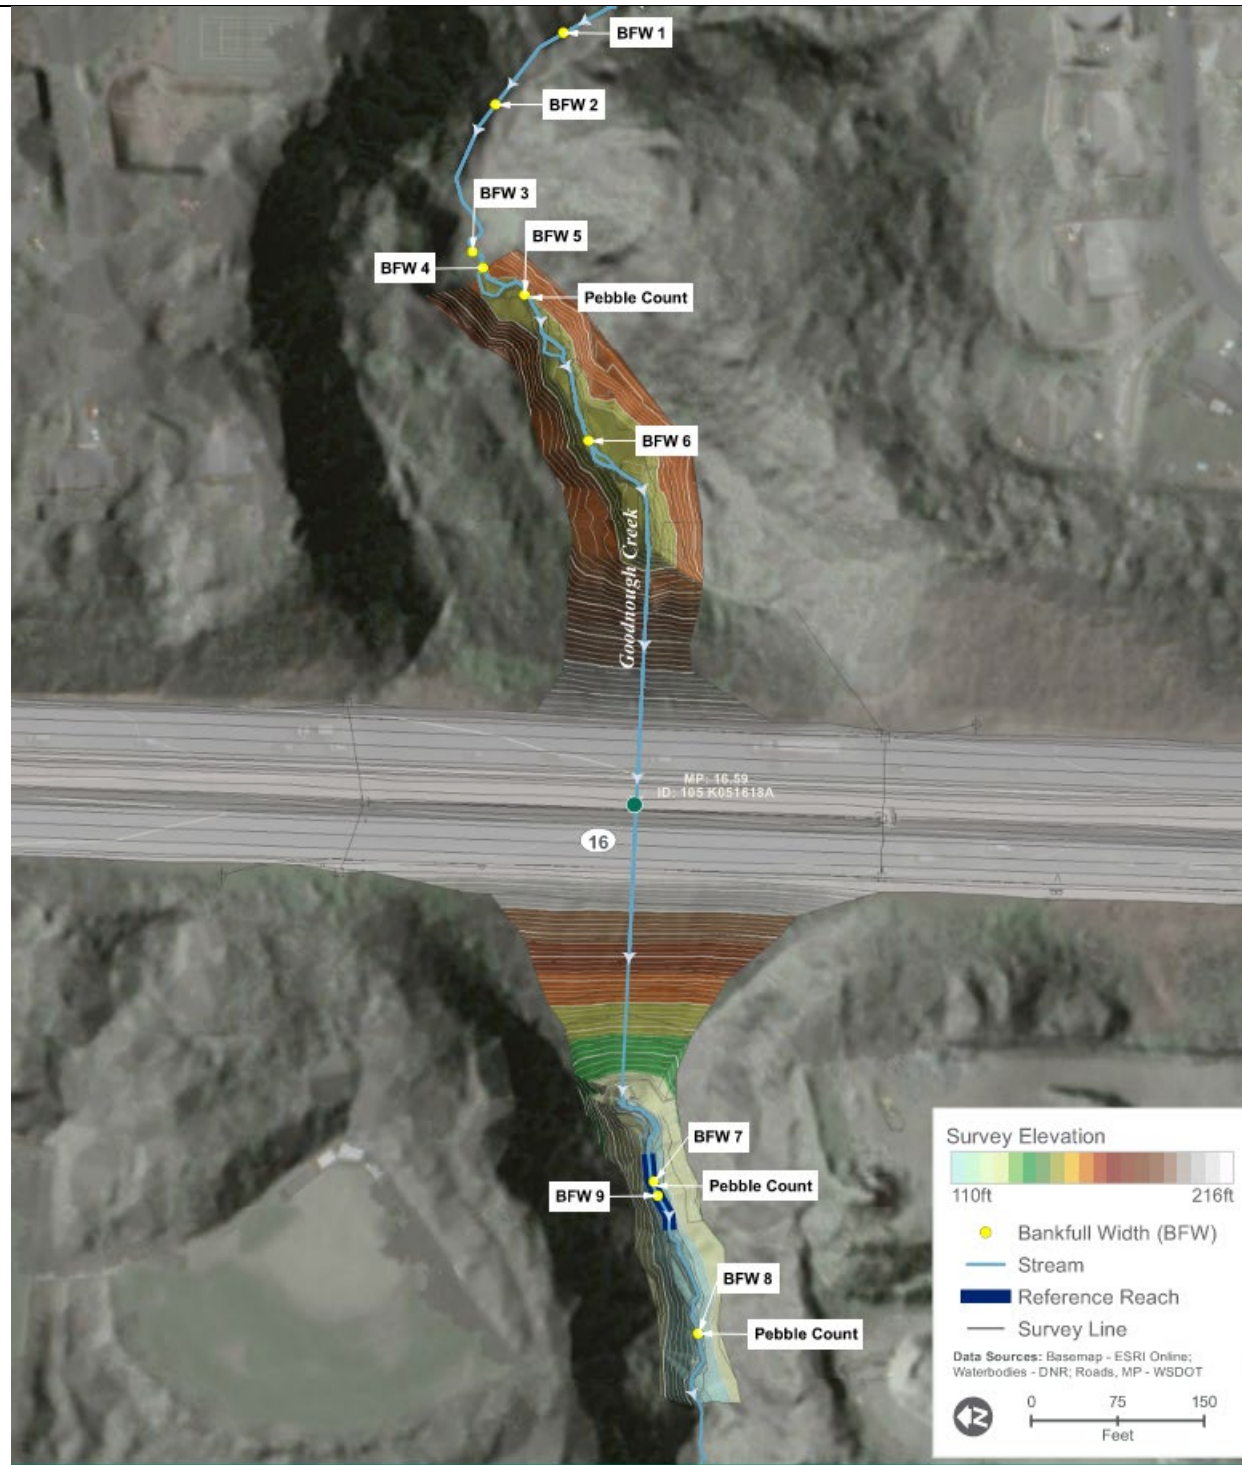
Figure 1: Reference reach, bankfull width, and pebble count locations

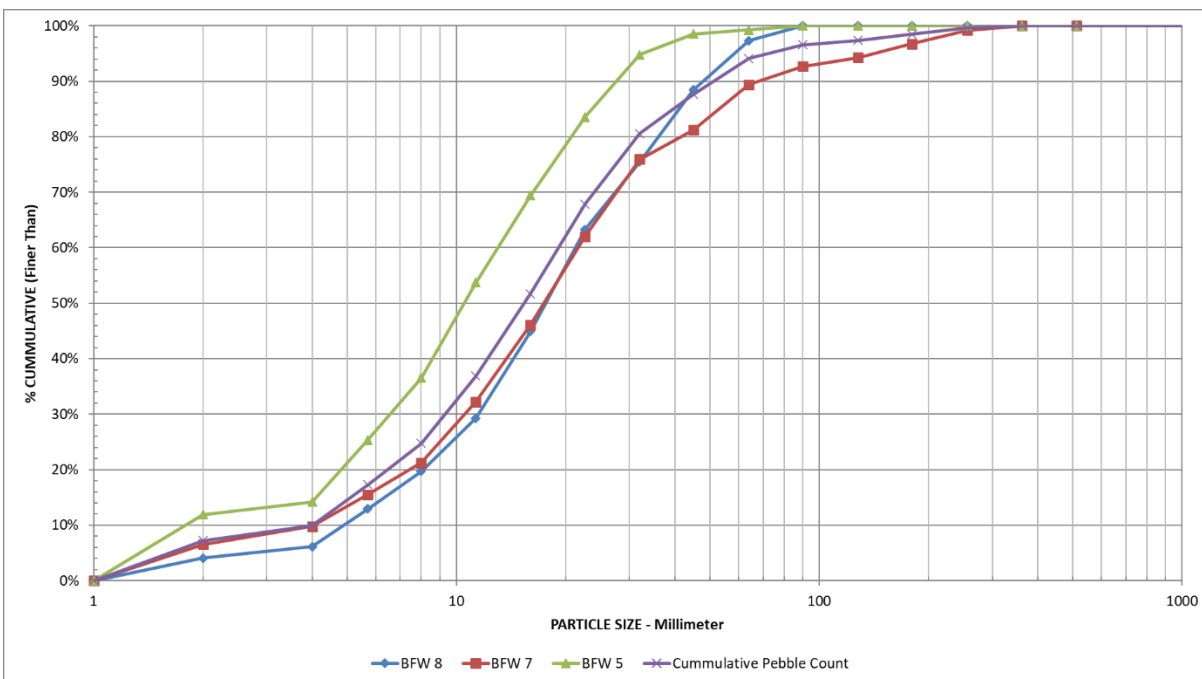
*Figure 2: Sediment size distribution*

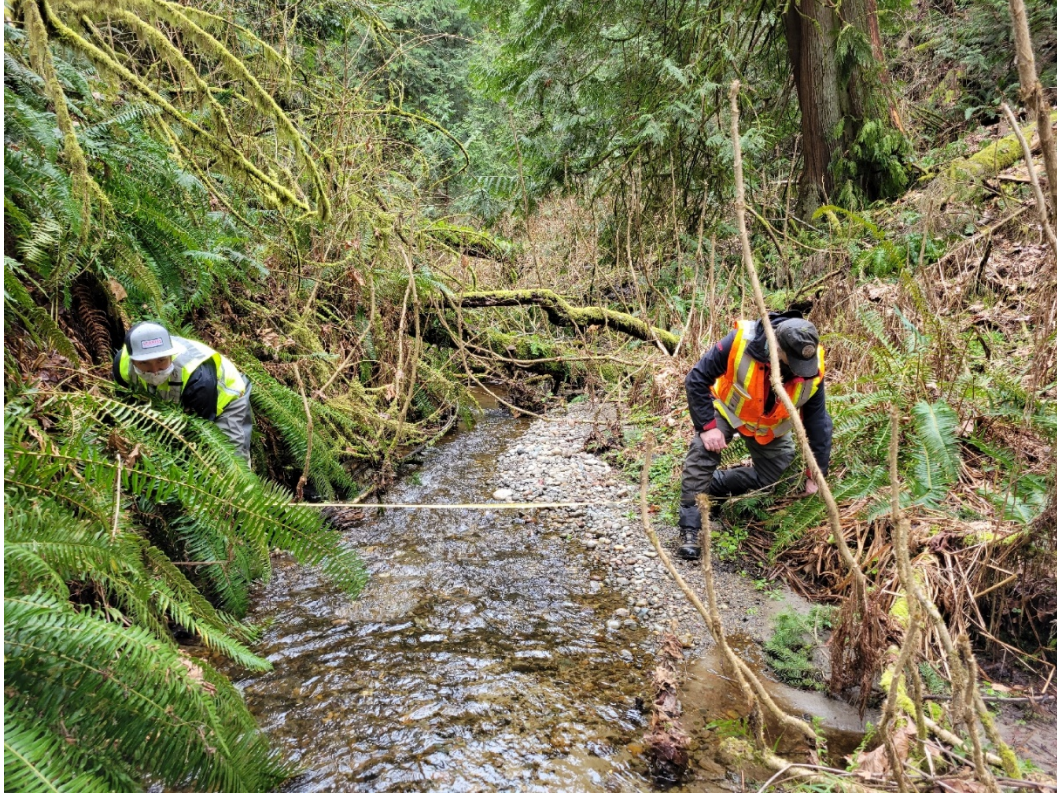
*Figure 3: BFW 1 approximately 250 feet upstream of survey extents*

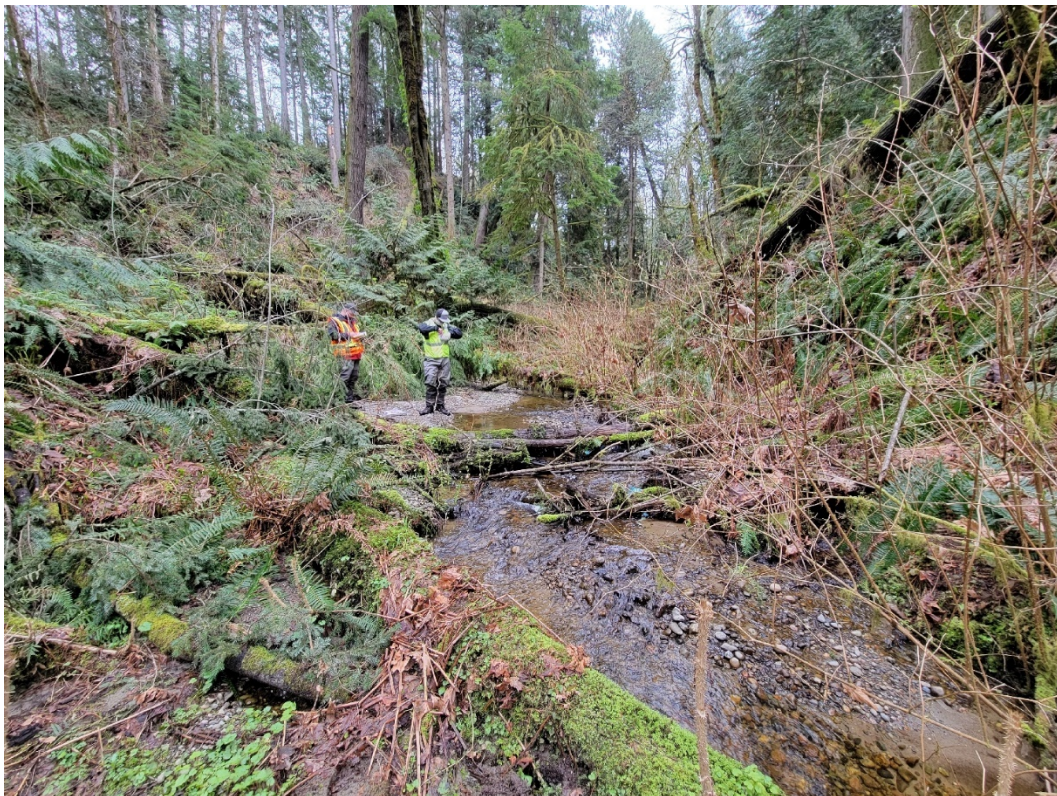
*Figure 4: Upstream channel ravine*

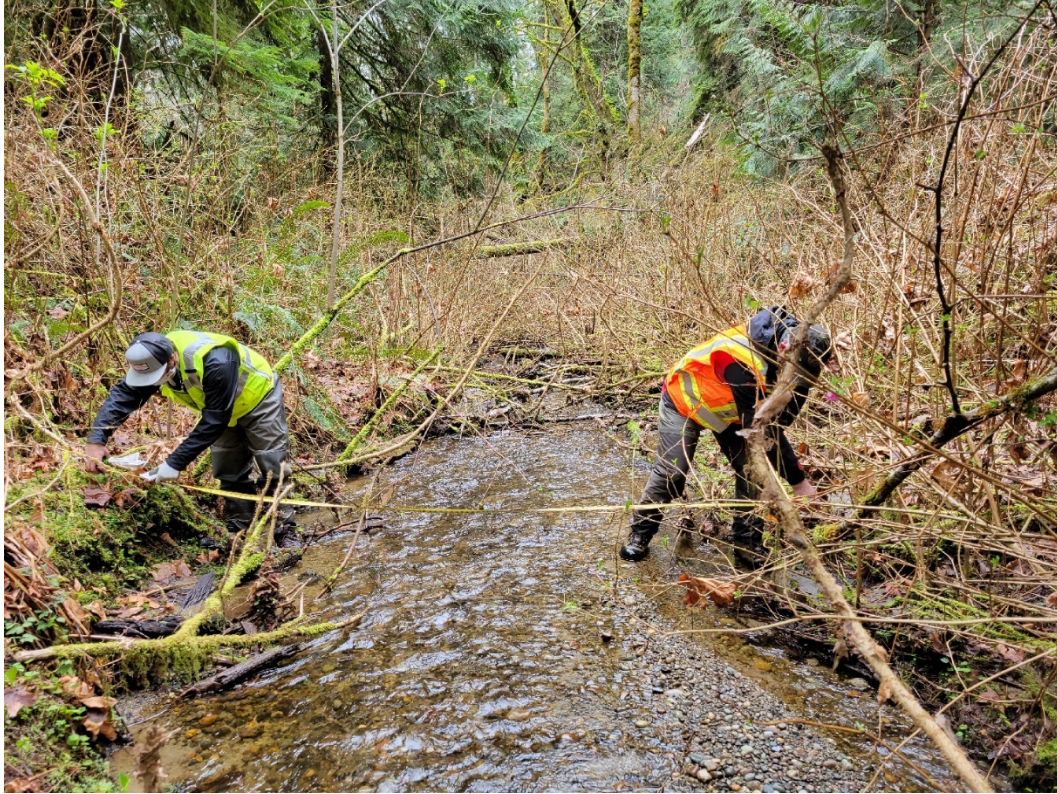
*Figure 5: BFW 2 approximately 100 feet upstream of survey extents*

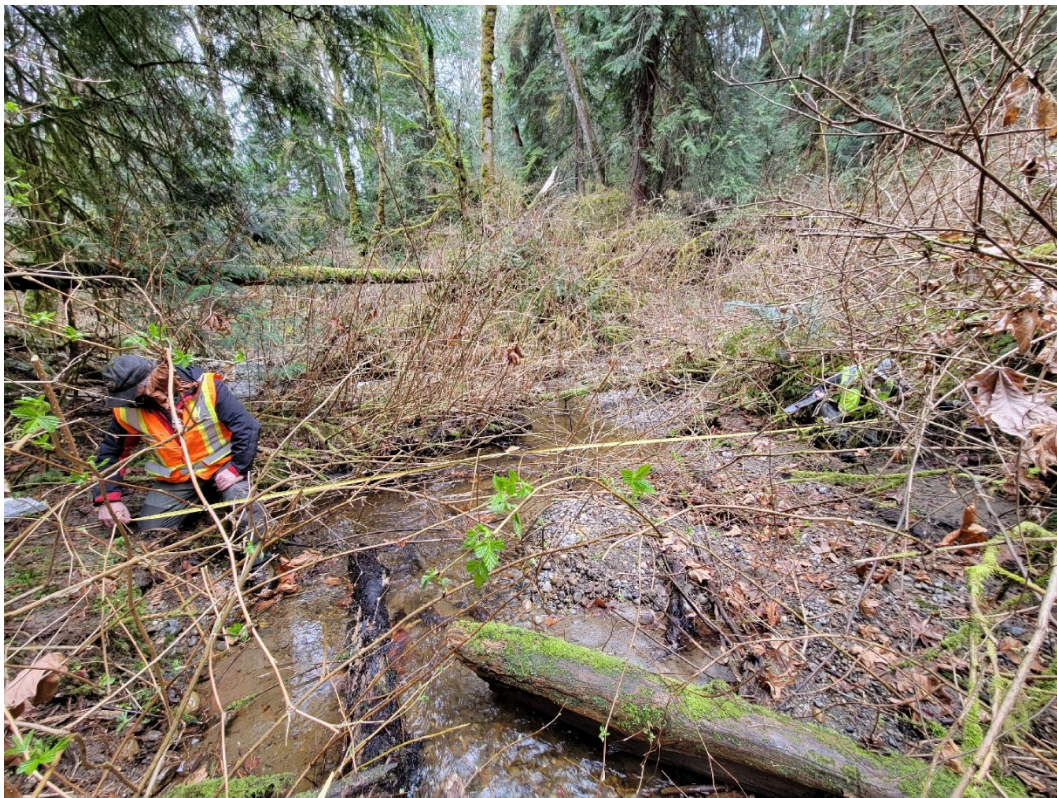
ravine width for approximately 100 feet. The ravine side slopes are steep, and the channel is confined. Three bankfull measurements were taken throughout the reach ranging from 19.5 to 25 feet that reached across the whole ravine. See Figure 6 for BFW 3, Figure 8 for BFW 4 and Figure 9 for BFW 5. The channel briefly becomes braided with a mid-channel gravel bar for a short length with a pool under large wood material (Figure 7). The banks are covered in brush and the streambed is a mix of small to medium gravel (Figure 8). Erosion is visible where the channel has incised against the bank toe (Figure 9). A log jam is located approximately 200 feet upstream of the culvert inlet that creates another short segment of braided channel (Figure 12). The sediment around the log jam consists of fines and gravel. Downstream of the log jam (approximately 160 feet upstream of the culvert inlet) the ravine walls widen and there is an approximately 25-foot-wide floodplain on the left bank (Figure 13).

*Figure 6: BFW 3 measurement*

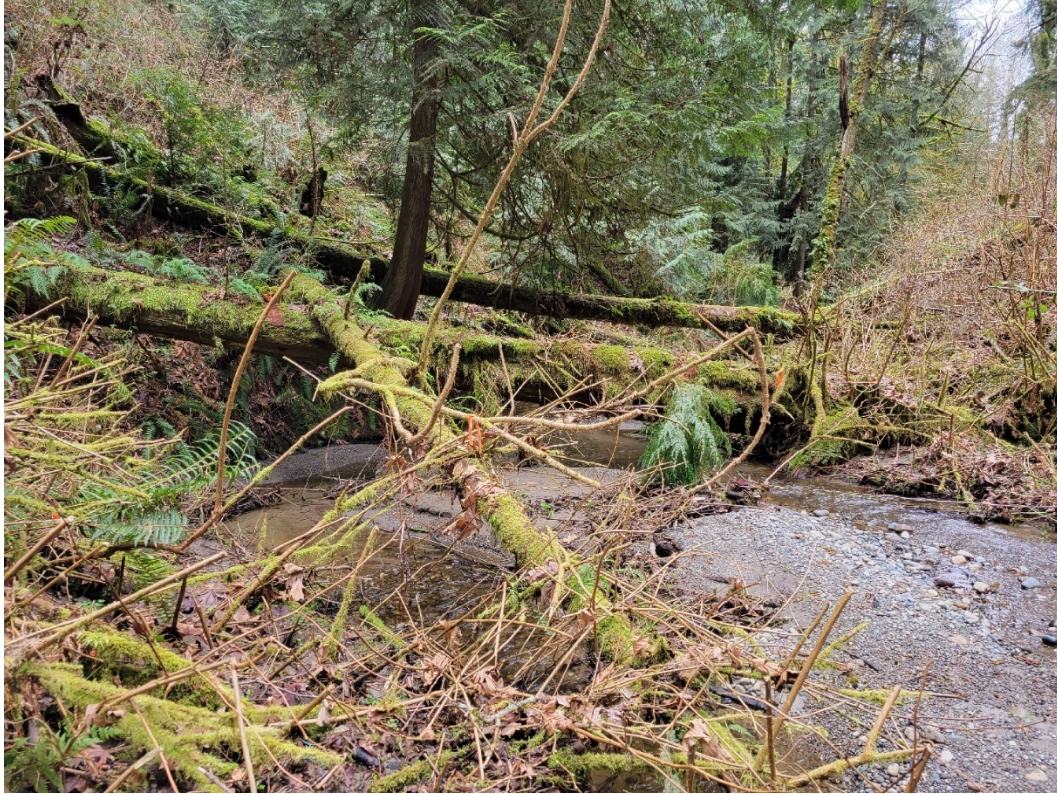
*Figure 7: Braided channel near upstream survey extents*

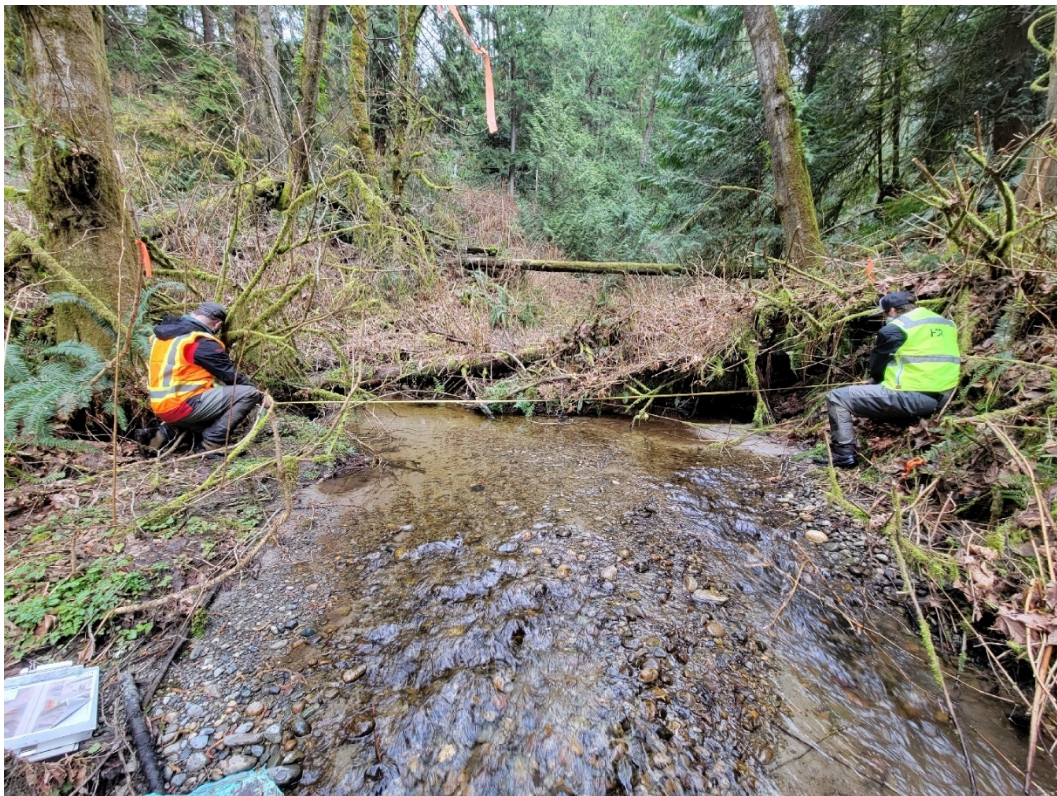
*Figure 8: BFW 4 measurement*

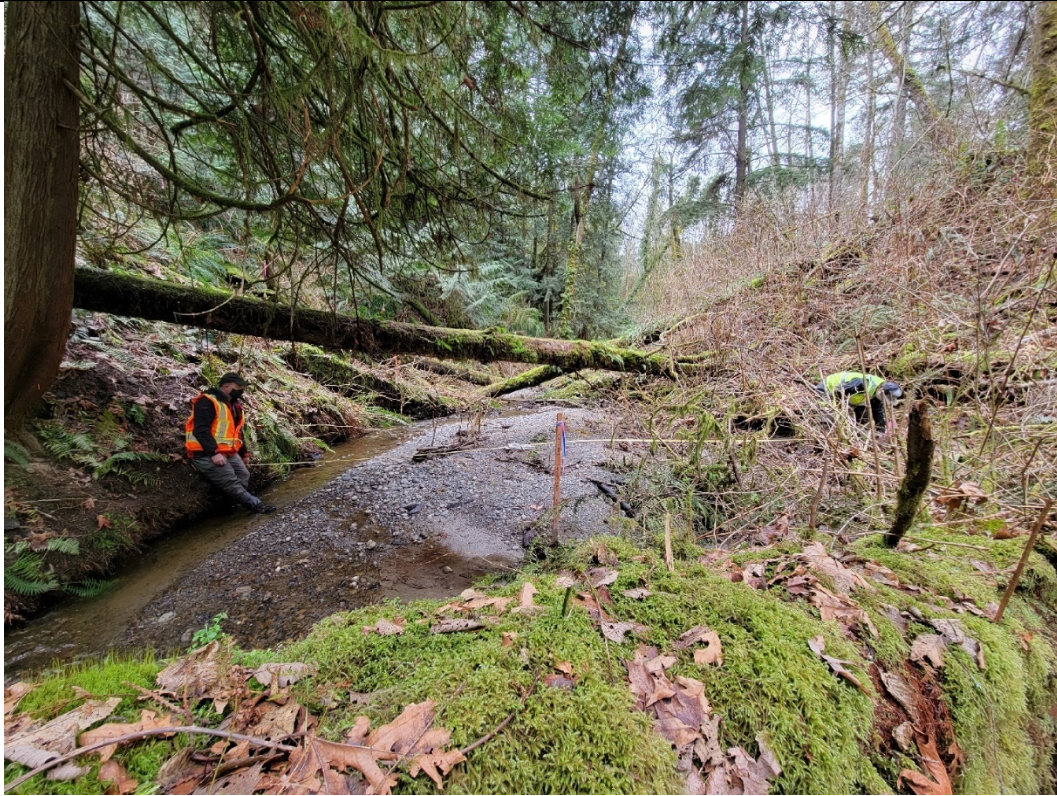
*Figure 9: BFW 5 full ravine toe width measurement*

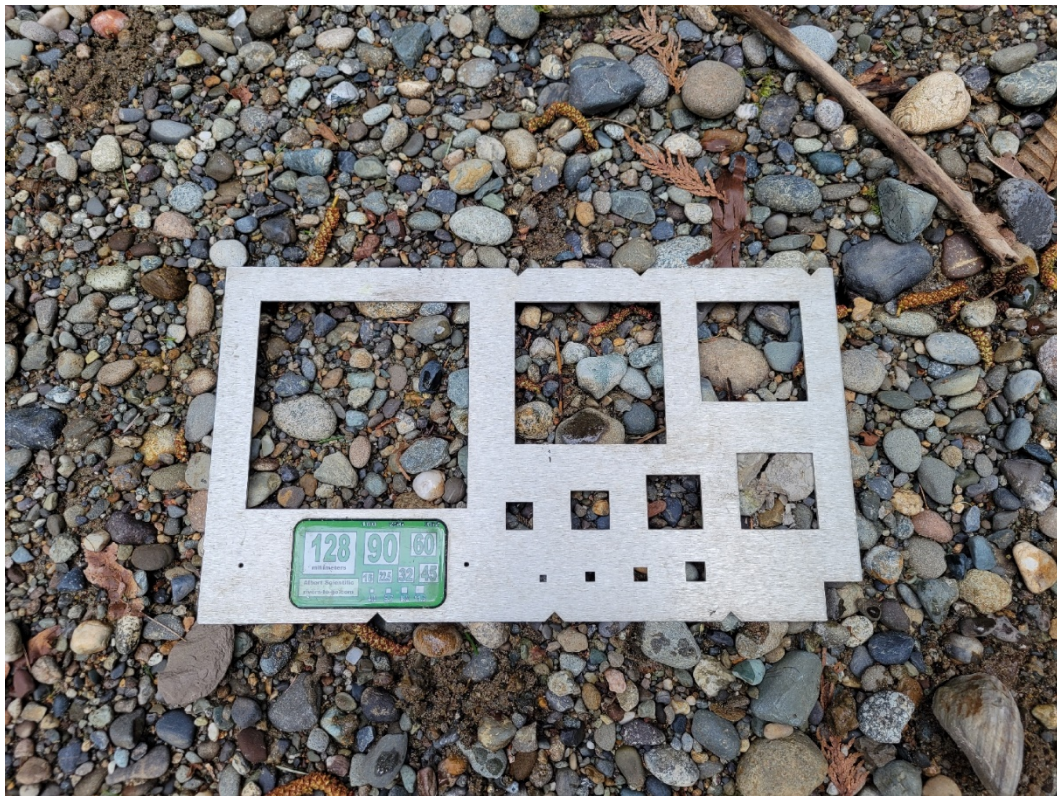
*Figure 10: Streambed material at BFW 5*

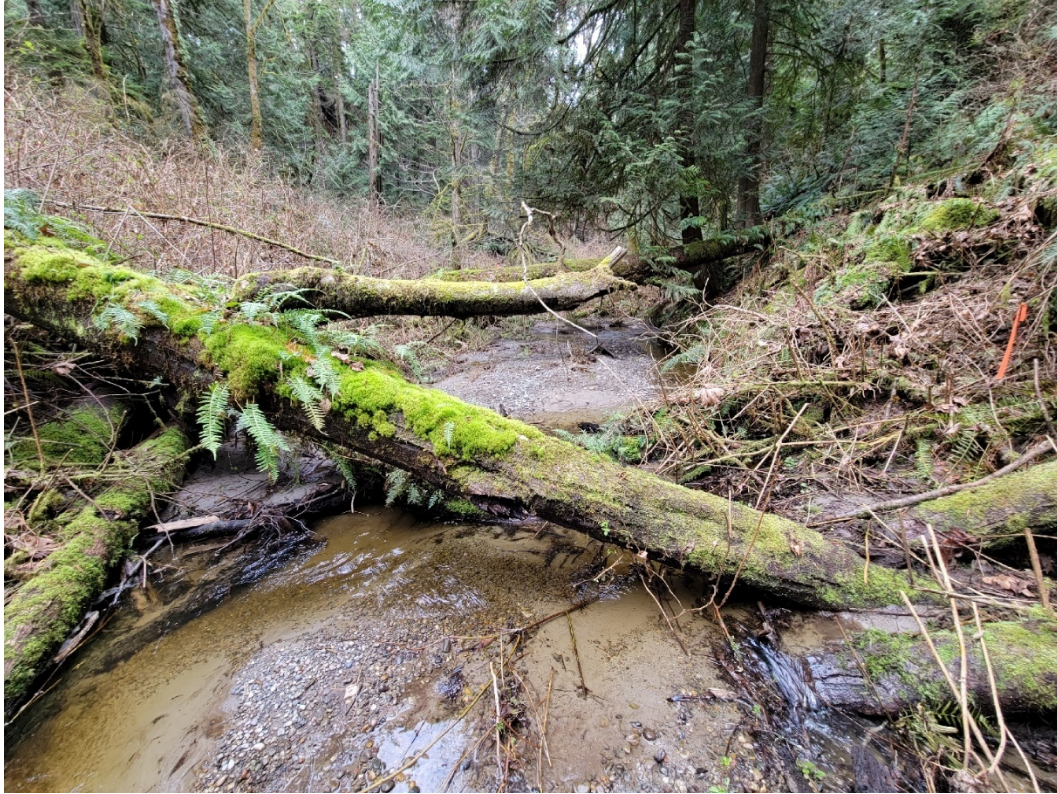
*Figure 11: Channel spanning LWM*

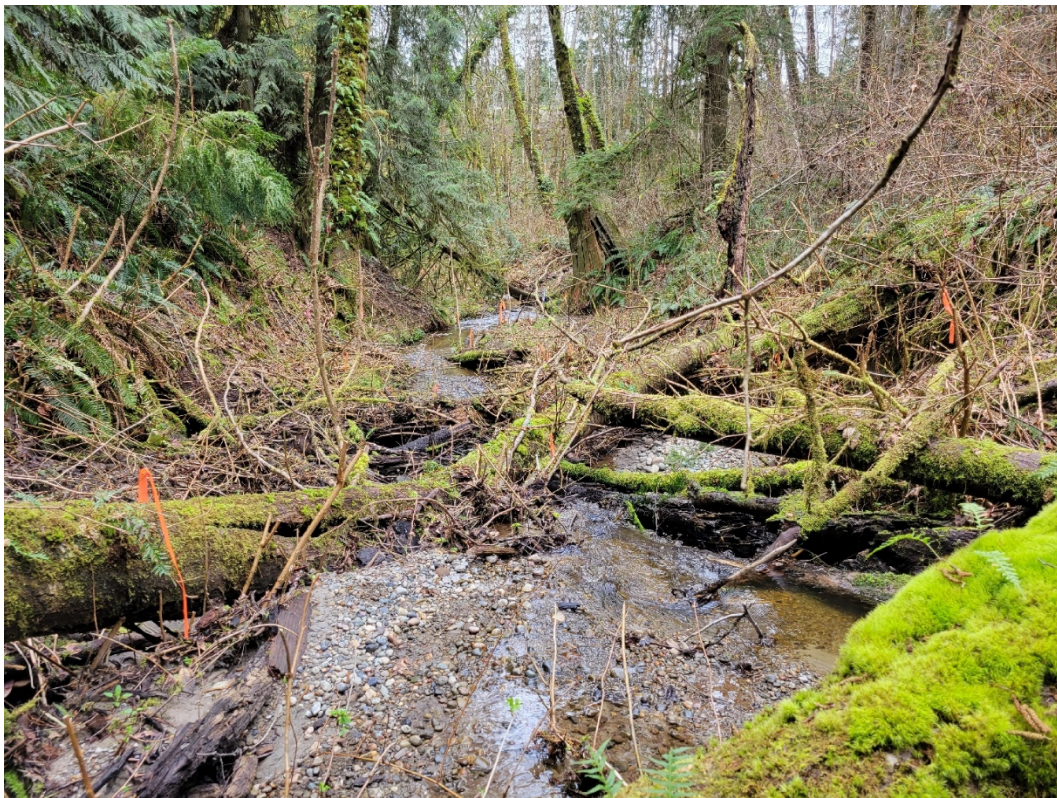
*Figure 12: LWM accumulation*

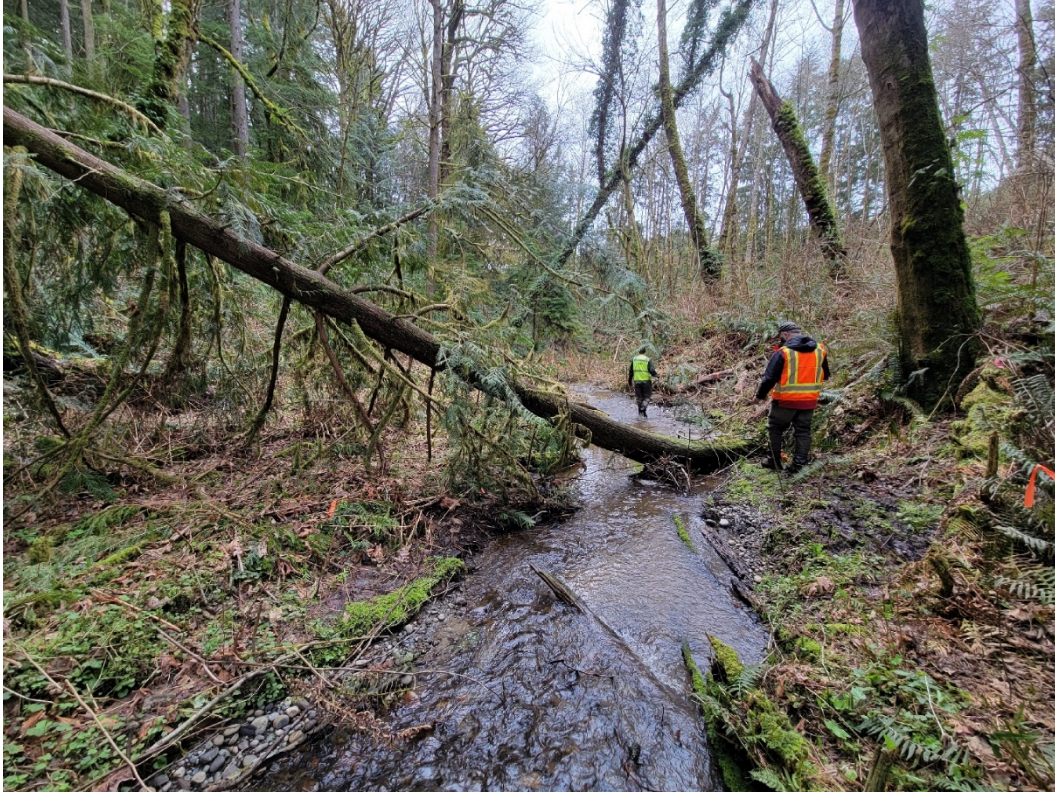
*Figure 13: Ravine widens*

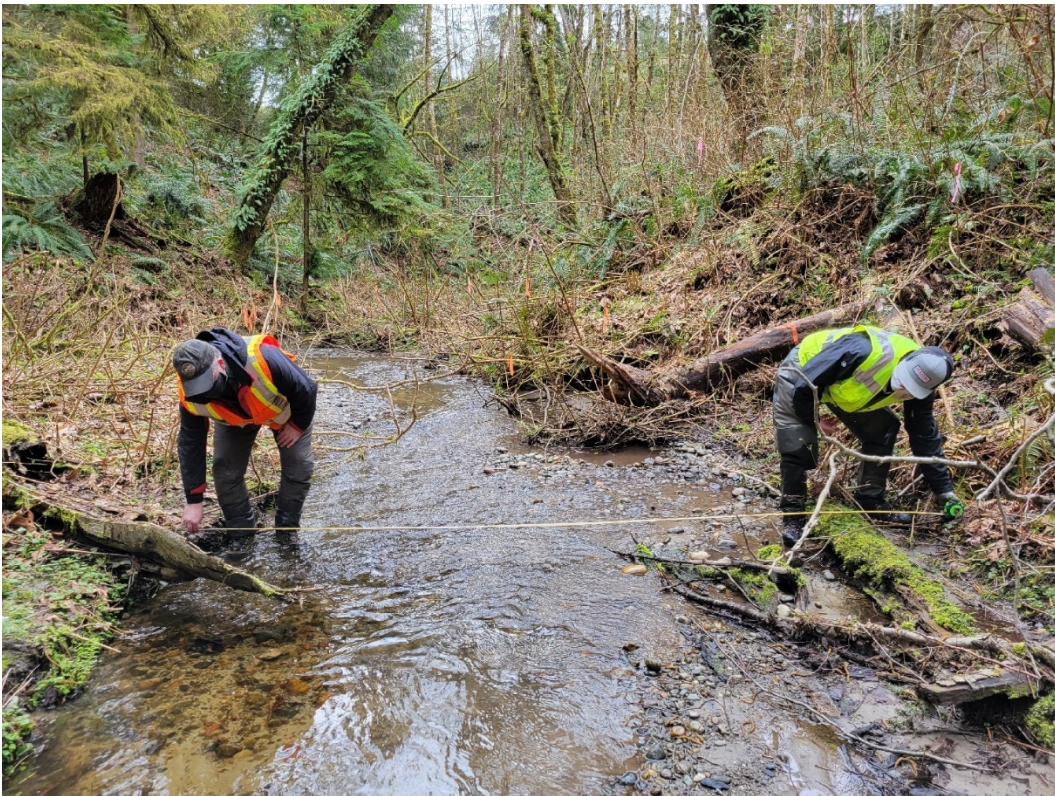
*Figure 14: BFW 6*

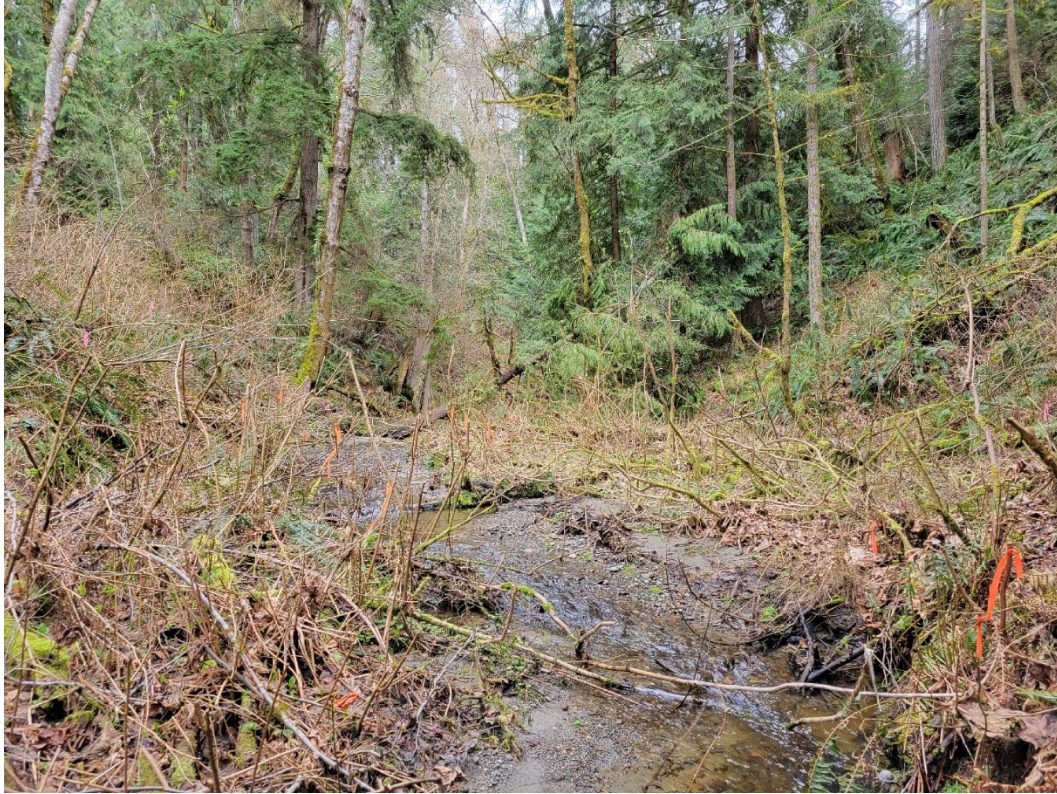
The channel remains relatively uniform from this location up to the entrance of the culvert. The floodplains are covered in small brush and fallen wood (Figure 15). The stream sediment is primarily fines with some gravel mixed in. There are cobbles and small branches in front of the culvert inlet (Figure 16). The culvert has steel wingwalls mitered to the embankment slopes and is a 4-foot CMP pipe that is straight without any drops between the entrance and exit. The entrance to the culvert is clear without sediment present.

*Figure 15: Upstream channel near culvert entrance*

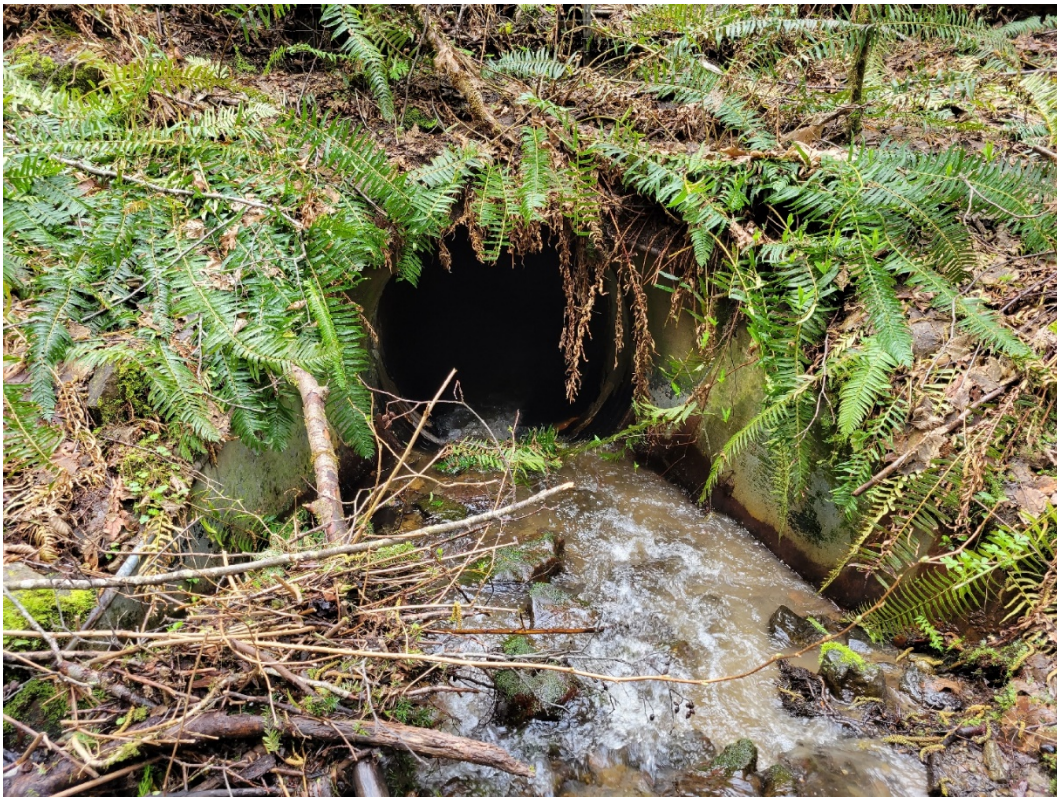
*Figure 16: Culvert entrance*

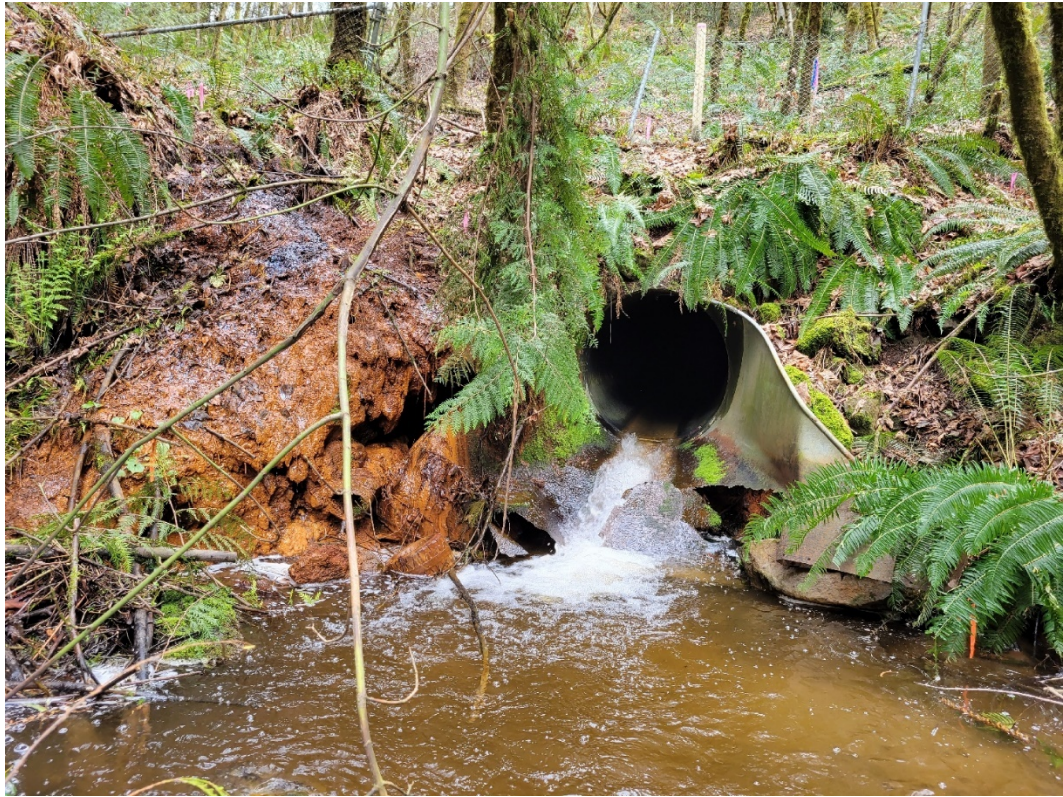
The culvert exit has scoured the bottom channel and rusted around what was once the steel wingwalls (Figure 17). Ground water was observed seeping through the hill side and a small pipe is visible with little flow coming out of it. The scour pool is approximately 3 feet deep created from high velocity at the culvert outlet. Immediately downstream of the culvert outlet the channel bends left and then immediately right, there is a small water surface drop from a buildup of small branches and cobbles (Figure 18). Like the upstream reach, the creek is at the bottom of a ravine with a small floodplain confined by the steep ravine walls. The channel continues to meander between ravine toes. Meandering is driven by LWM and to a much lesser extent a few boulders observed within the reach. Immediately downstream of the small drop (Figure 19) the channel substrate is mix of moderate to large gravel with a few observed locations of exposed compacted clay banks shown in Figure 20 and Figure 21.

*Figure 17: Culvert exit*

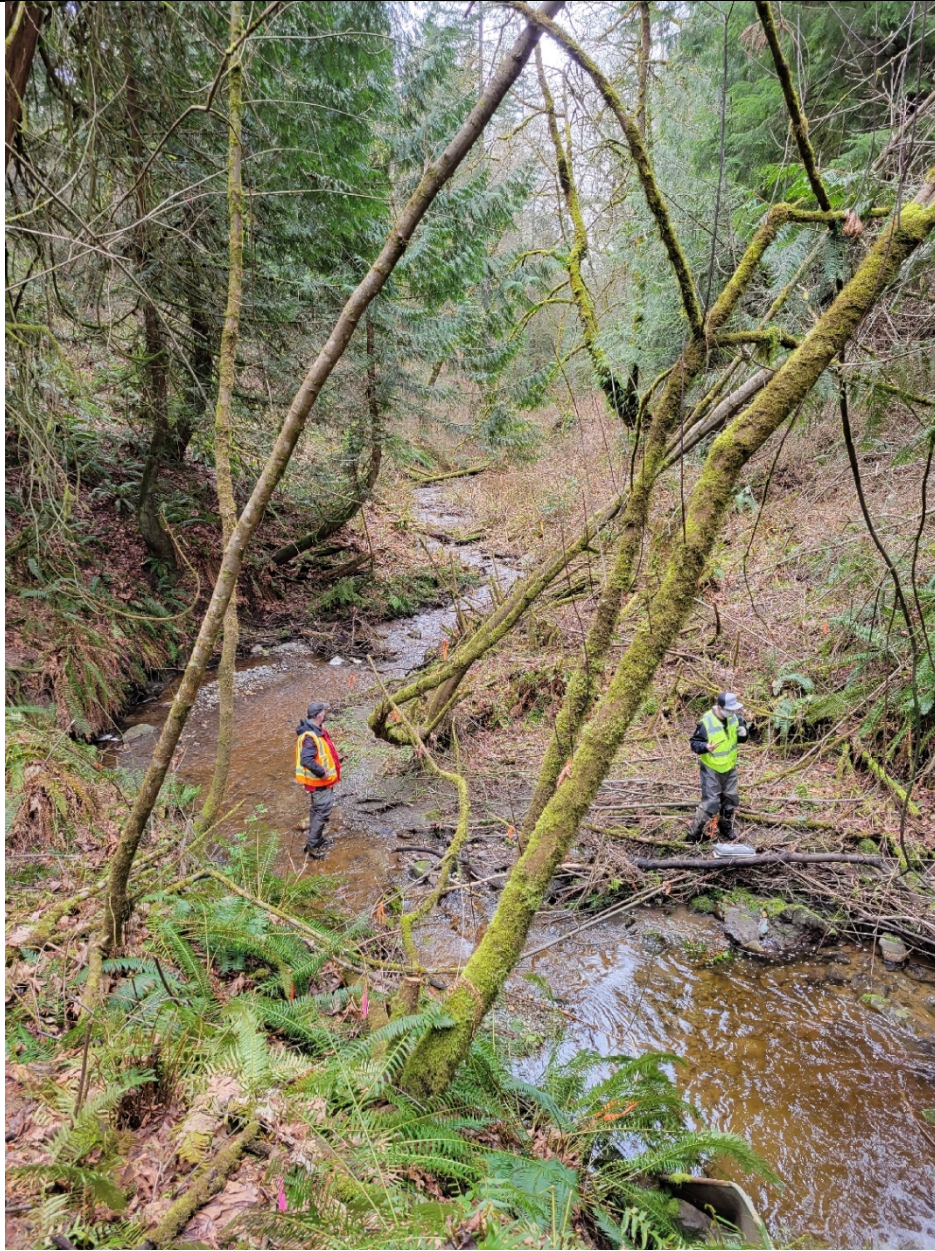
*Figure 18: Downstream channel after culvert exit*

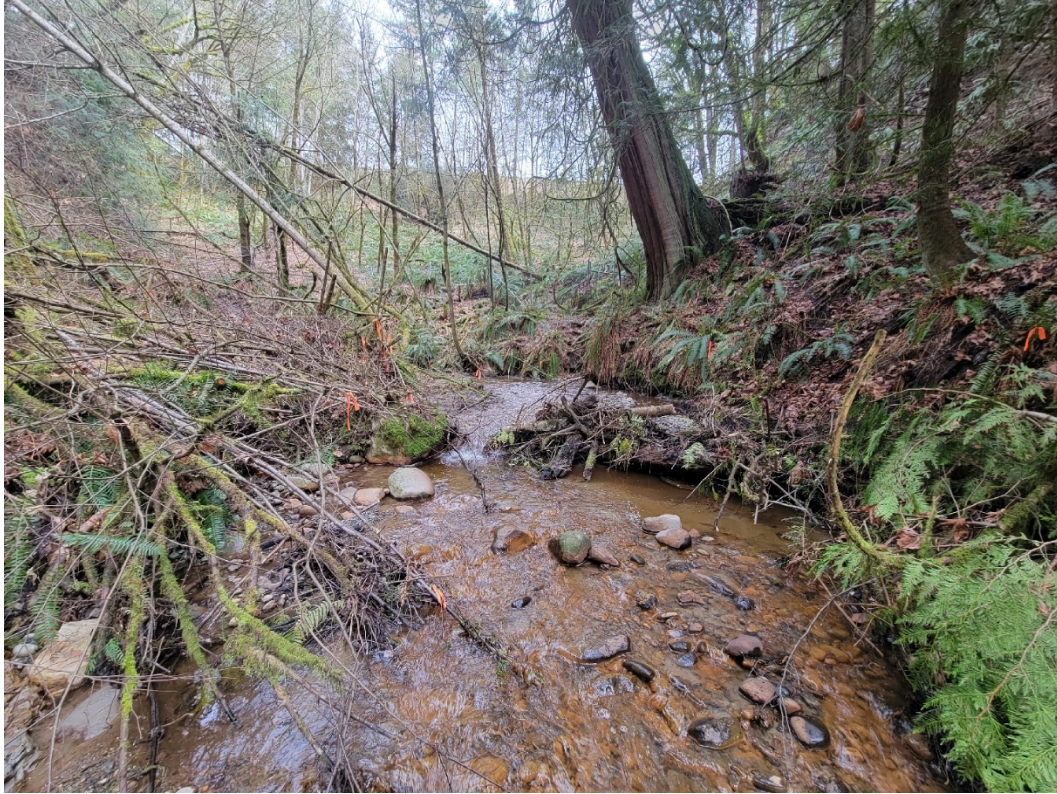
*Figure 19: Channel widens after water surface drop*

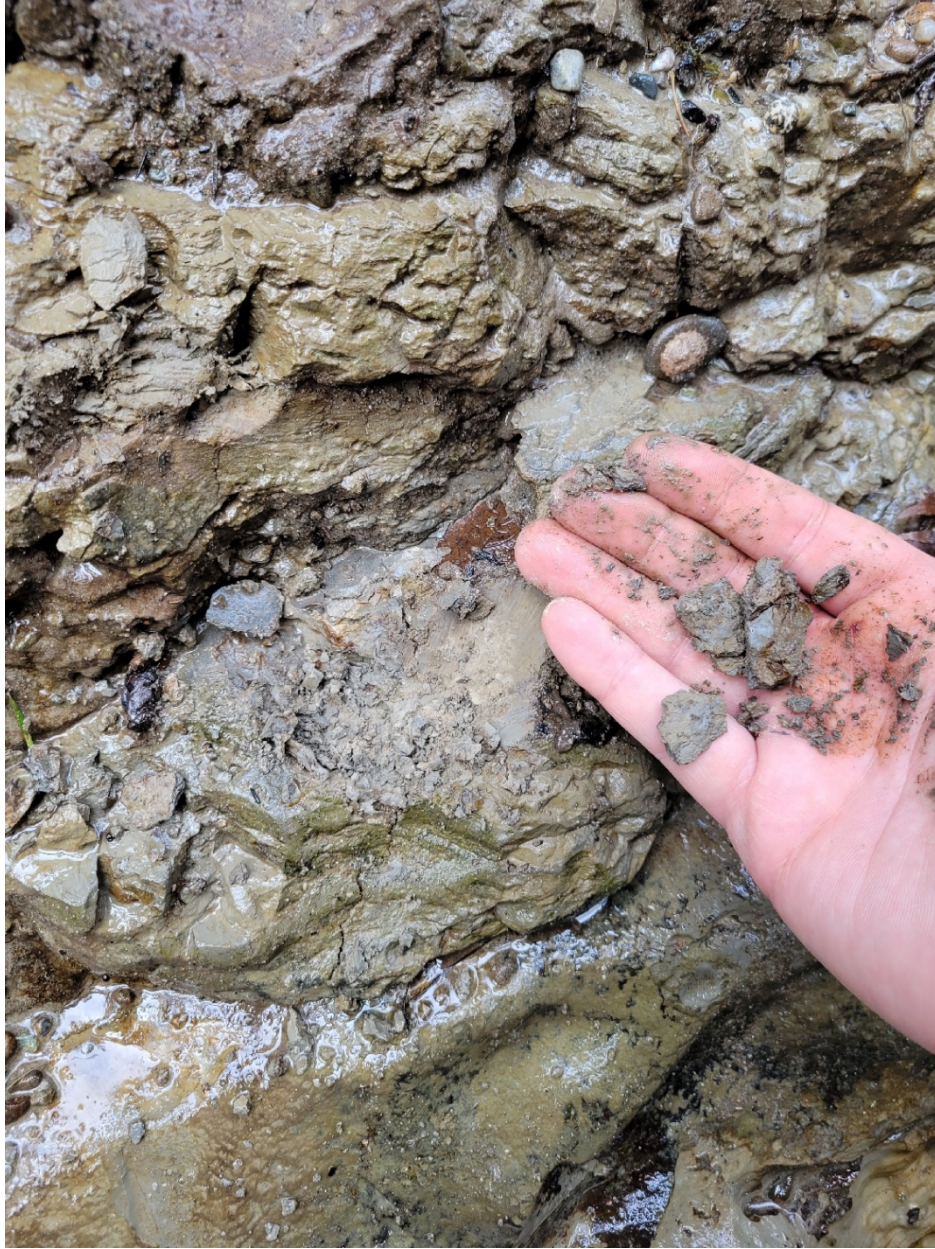
*Figure 20: Typical exposed compacted clay bank*

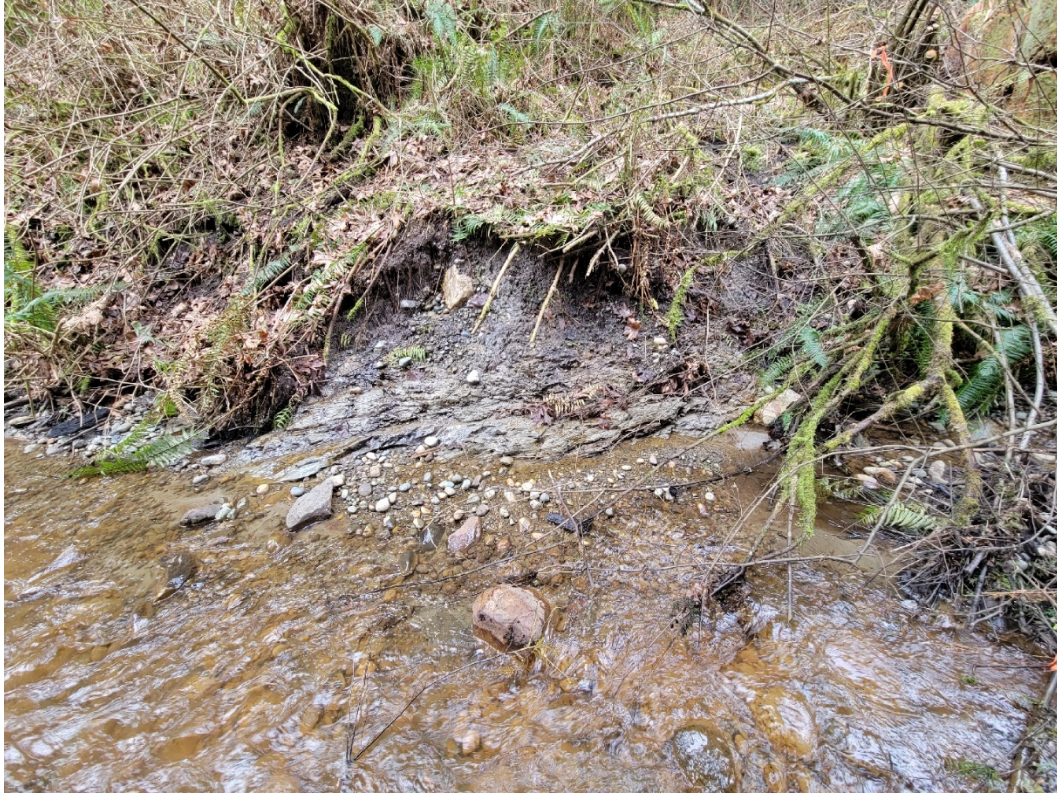
*Figure 21: Exposed compacted clay bank*

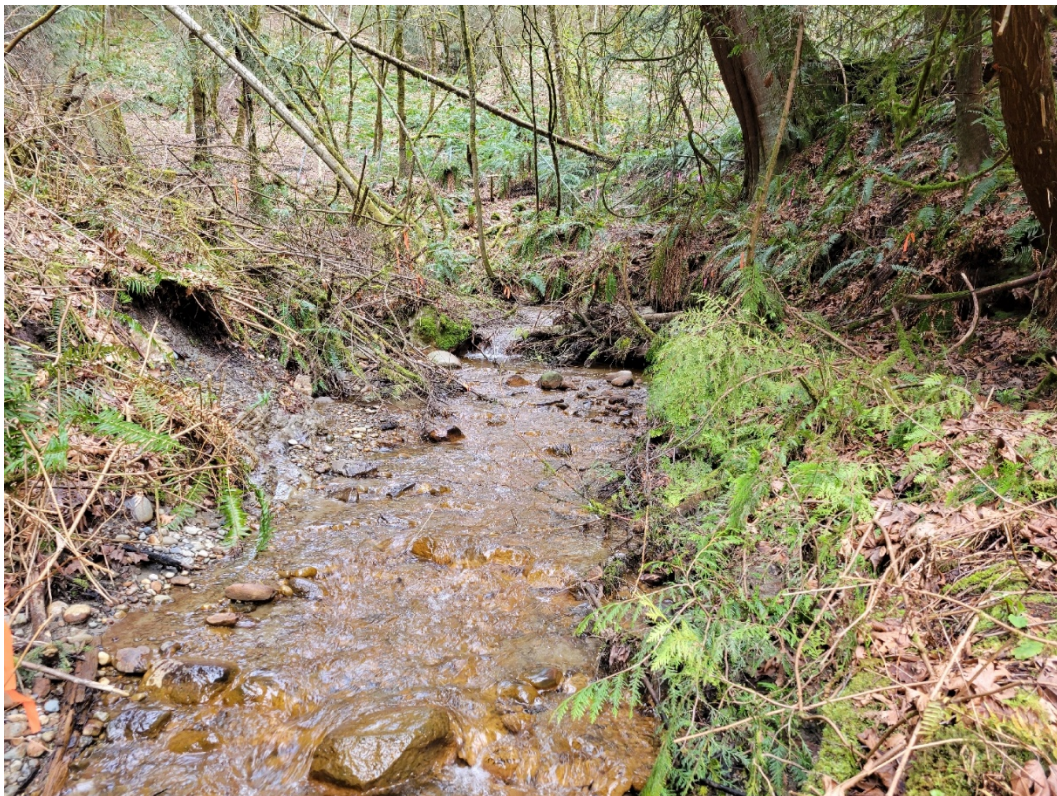
Further downstream of the water surface drop the stream gradient increases and the channel narrows compared to the upstream reach (Figure 22). This location was selected as the reference reach due to the gradient being more closely representative of the prevailing slope of the channel from the survey longitudinal profile. Step pool morphology was observed within the reference reach. The slopes downstream of the culvert and through the reference reach are higher than upstream, approximately 4.0 percent. The stream has low sinuosity through the reference reach. The BFW measurement (BFW 7) within the reference reach was 14.5 feet. Within the reference reach few areas had small floodplains and primarily the top of banks transitioned into the confined ravine walls. The material within the reference reach was larger than the pebble count conducted upstream and consisted primarily of coarse gravel with a few small cobbles (Figure 23).

*Figure 22: Reference reach*

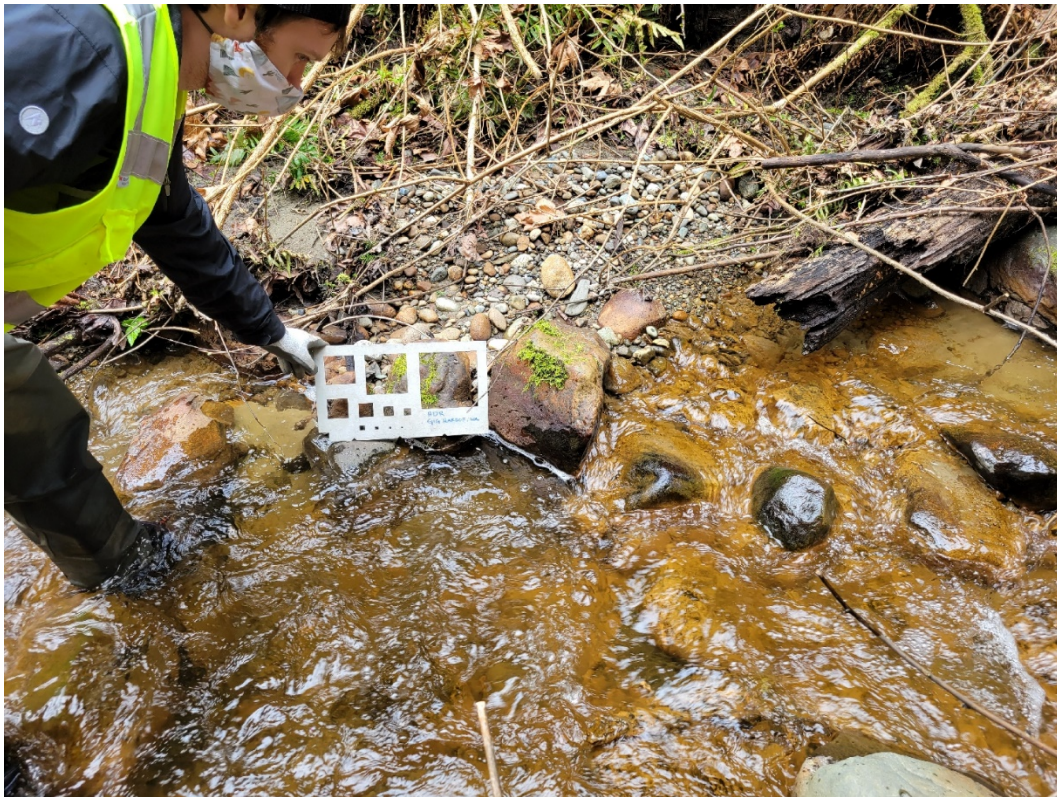
*Figure 23: Substrate material in reference reach*

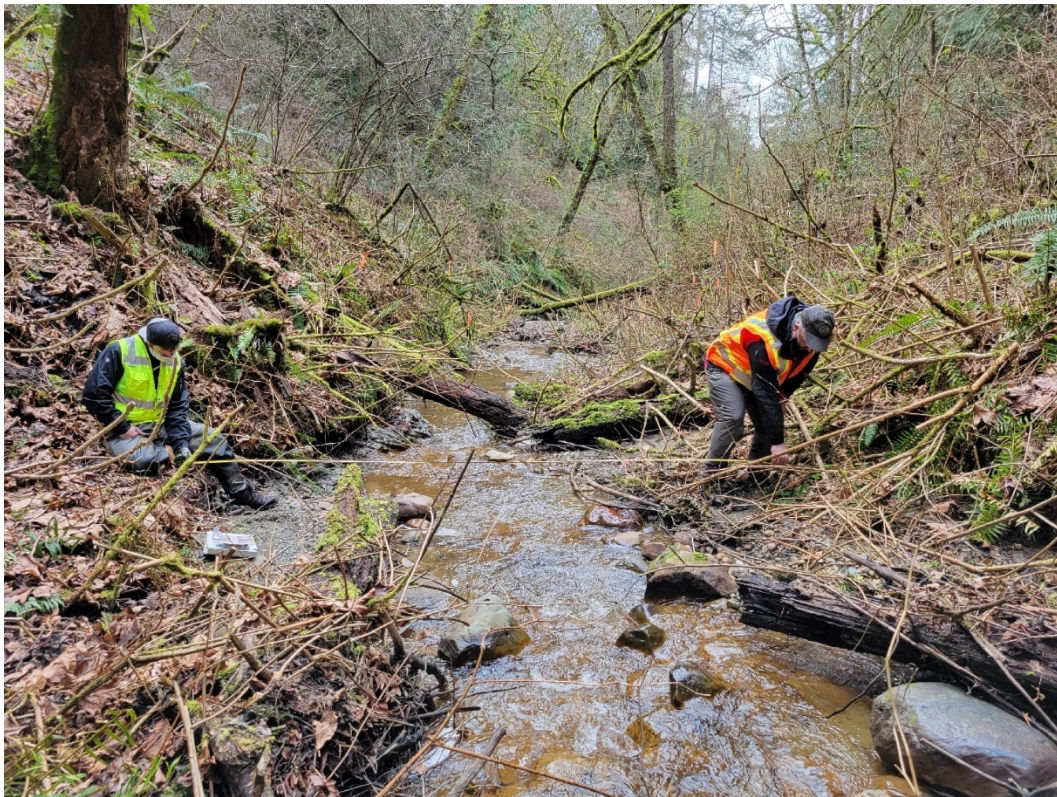
*Figure 24: Reference reach and BFW 7 measurement*
