### Hydraulics Field Report

Y12463

Goodnough Creek SR 16 MP 16.59 (WDFW 105 K051618a)

3/26/2021

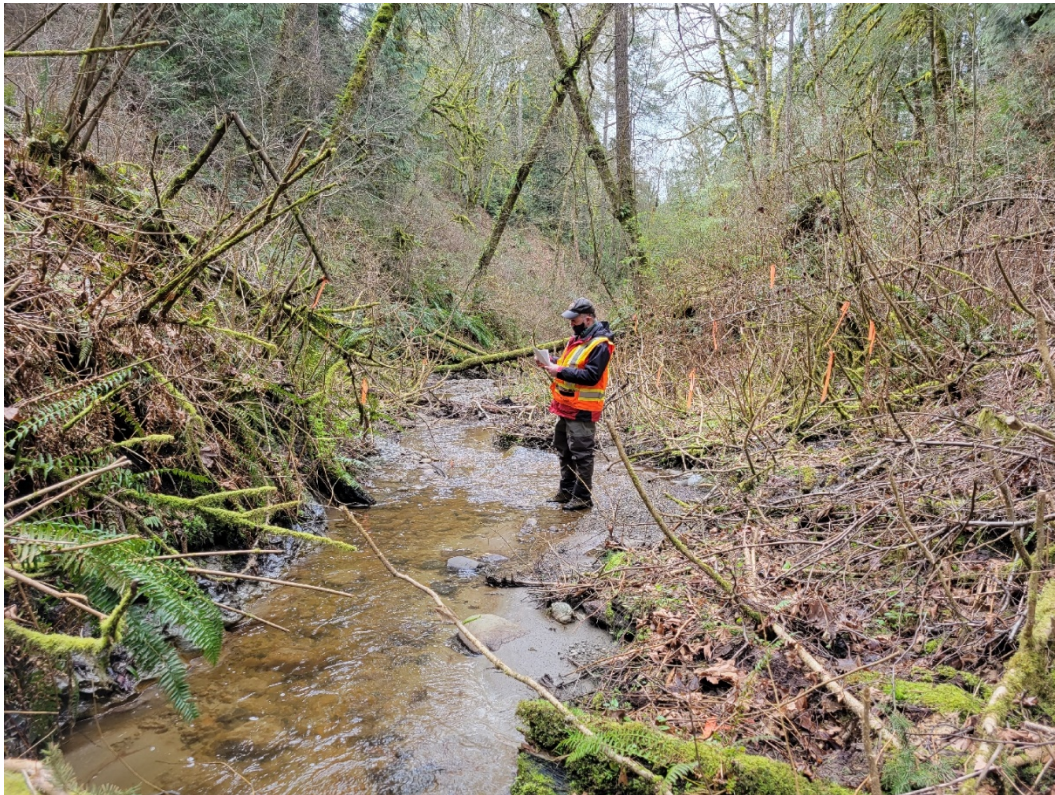
Continuing downstream from the reference reach the channel remains uniform with a small floodplain on the right bank. Exposed compact clay is visible along the left bank toe (Figure 25). The bankfull depth is roughly 1.5 feet and the floodplains contain small shrubs and downed wood. A few 2-man boulders were observed throughout this reach (Figure 26). Further downstream from

*Figure 25: Looking downstream, left bank exposed compact clay at toe*

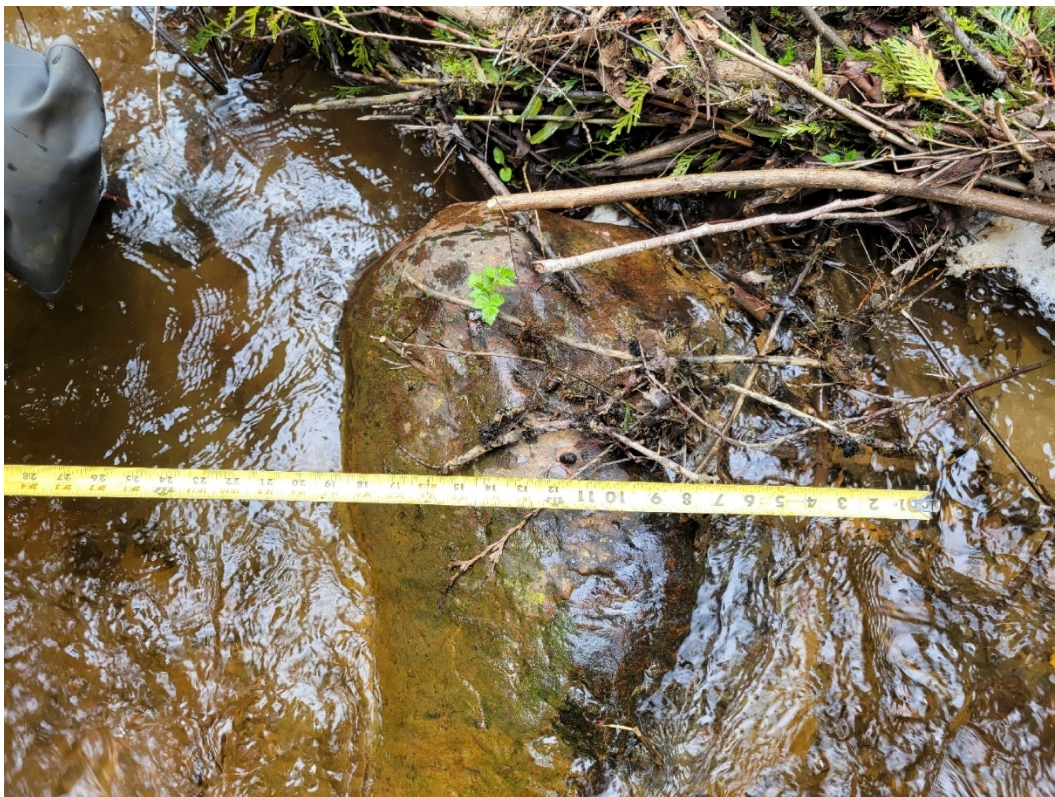
*Figure 26: 24-inch boulder in stream*

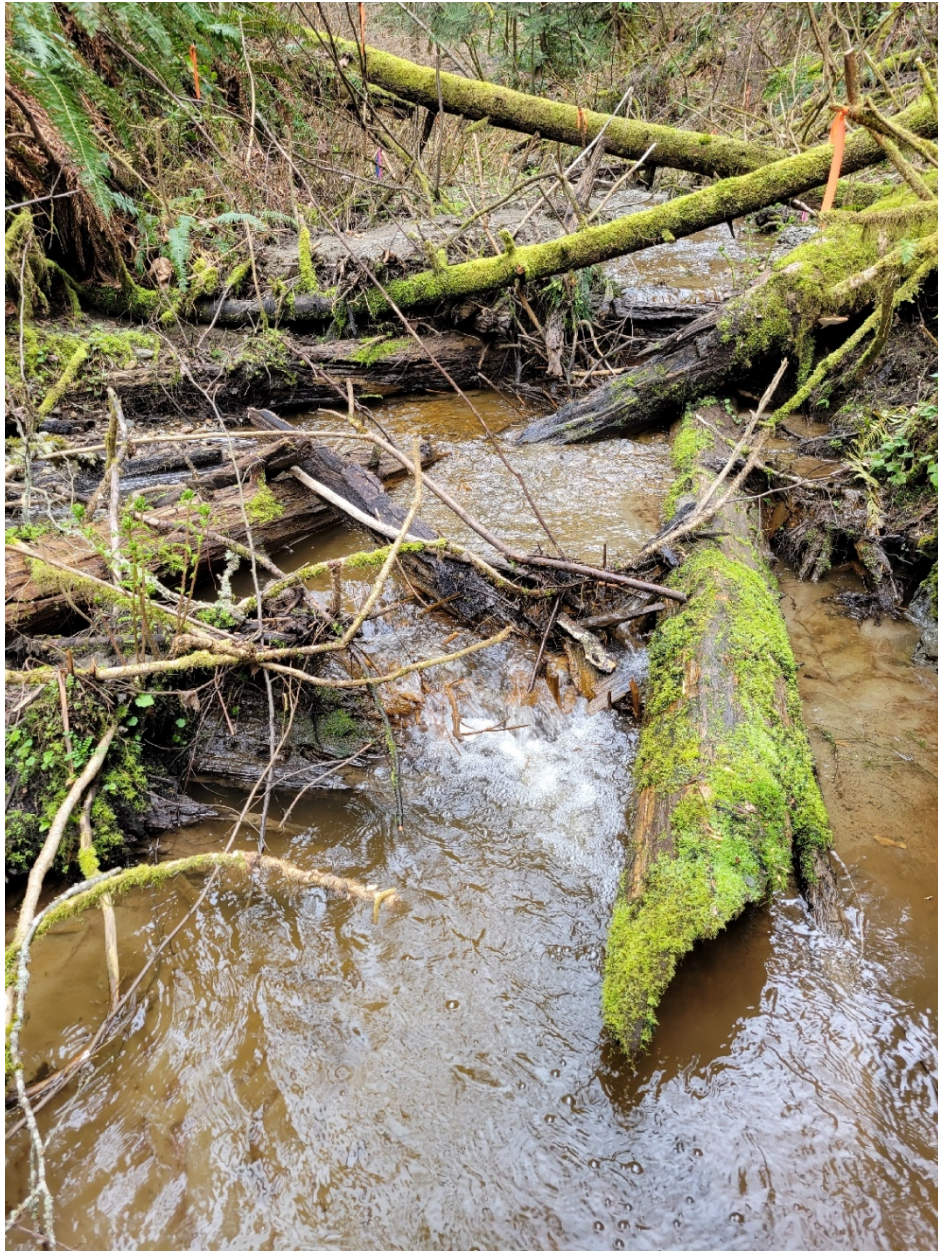
approximately 200 to 280 feet downstream of the culvert outlet, a series of log jams from downed trees with small boulders that have created small water surface drops is shown in Figure 27, Figure 28, and Figure 29. The last BFW measurement (BFW 8) was taken downstream before the end of the survey downstream of the series of water surface drops created by LWM and was 14.0 feet (Figure 30). At the downstream survey limits large wood material spans the width of the channel and another observation of compacted clay along the right bank. After the end of the survey the stream is densely covered by devil's club and small trees (Figure 33). A third pebble count was conducted near BFW 8.

*Figure 27: LWM accumulation*

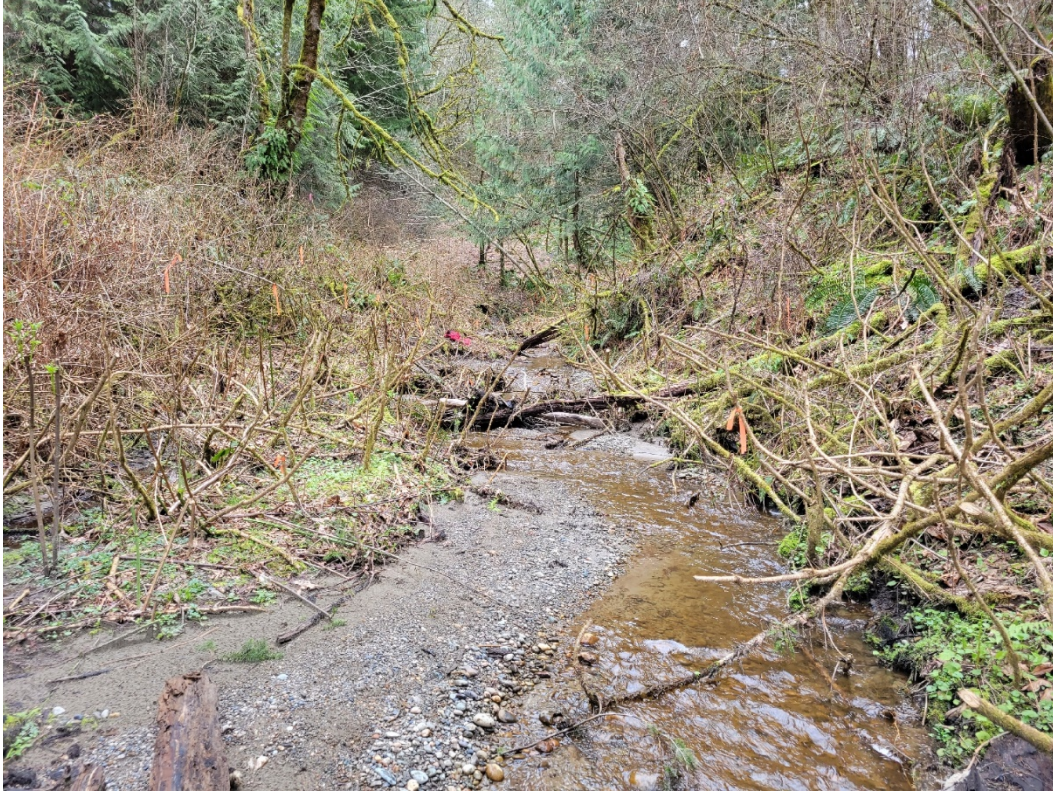
*Figure 28: Water surface drop from small logs*

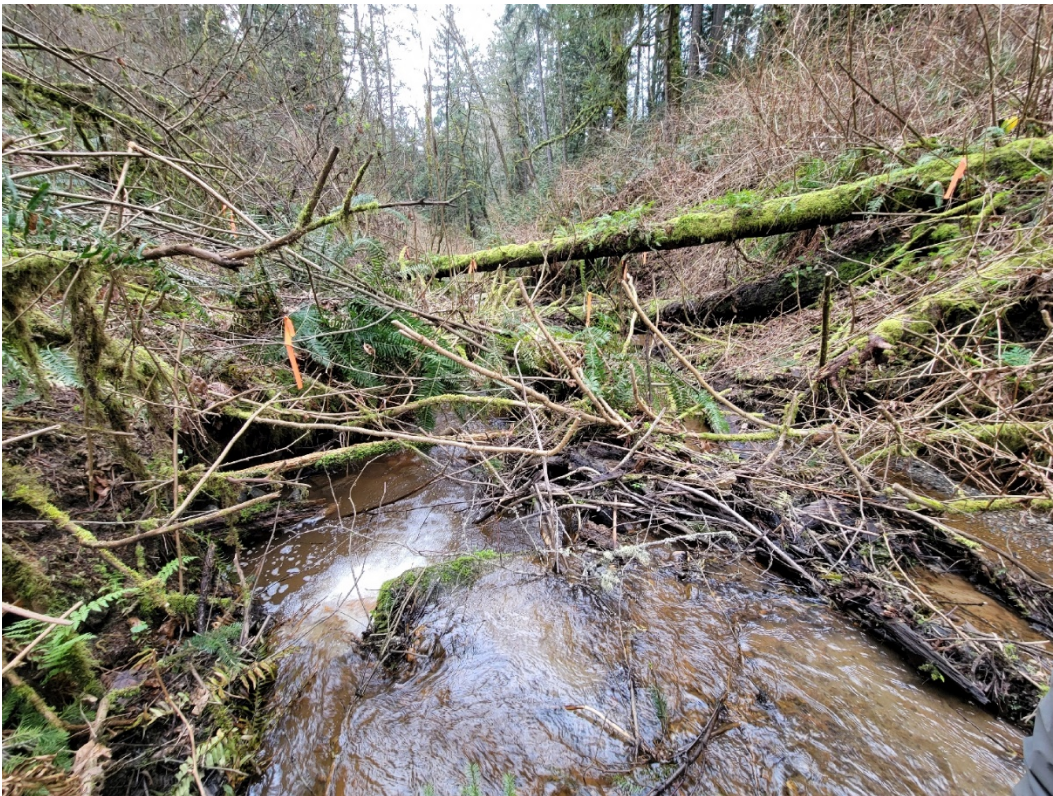
*Figure 29: Water surface drop from boulder and small woody material accumulation*

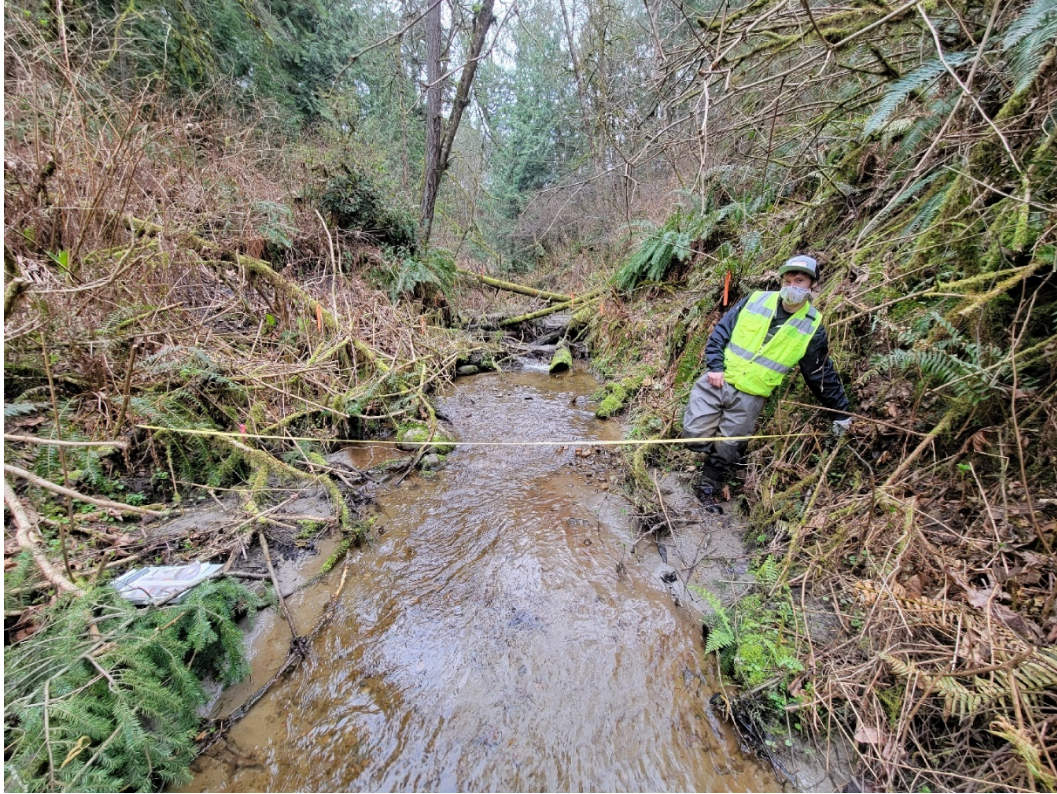
*Figure 30: BFW measurement 8*

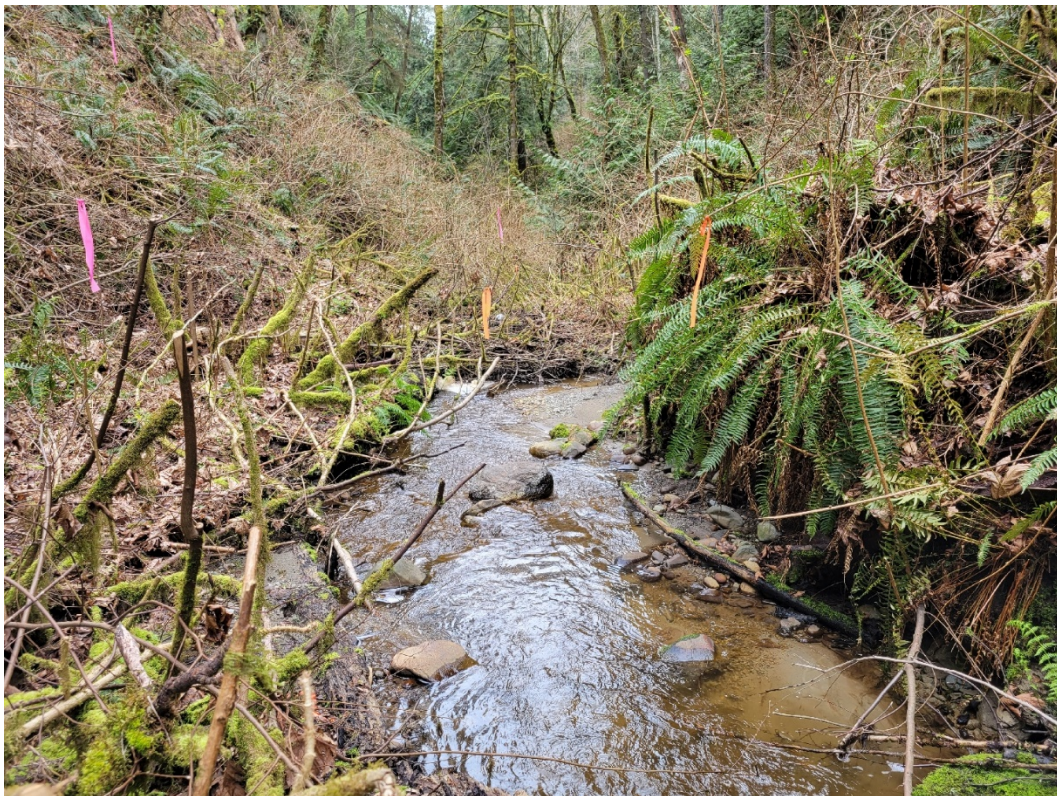
*Figure 31: Looking upstream from the end of survey*

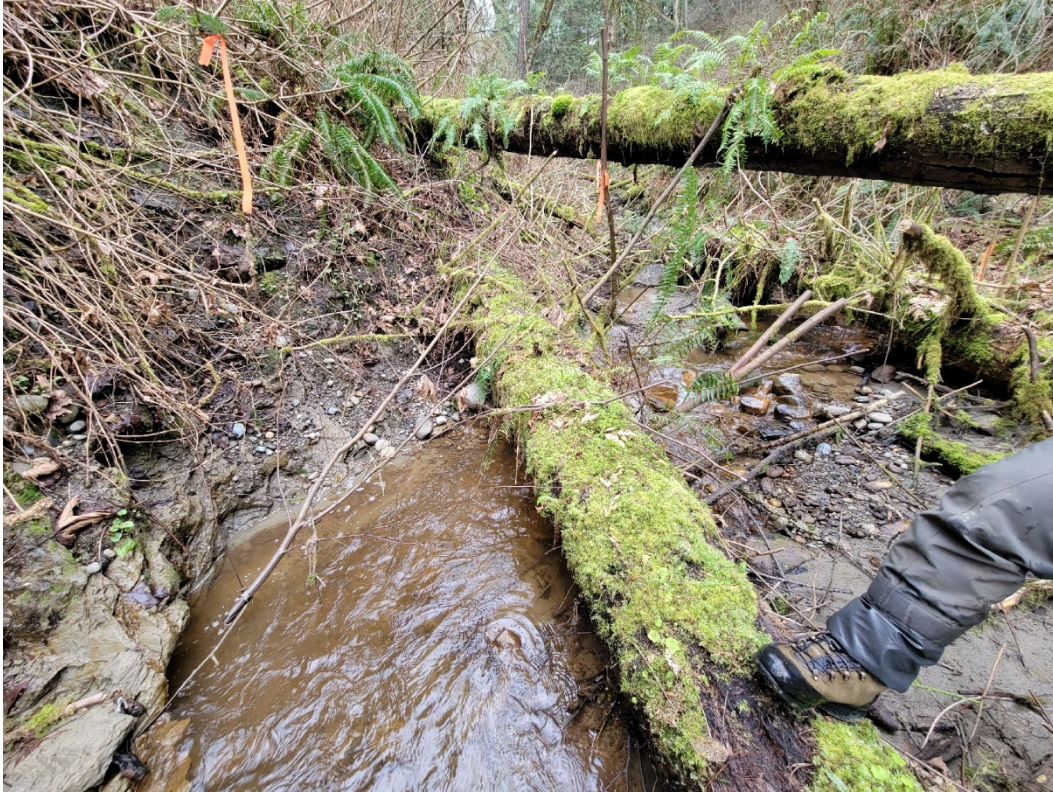
*Figure 32: Channel spanning LWM and clay bank*

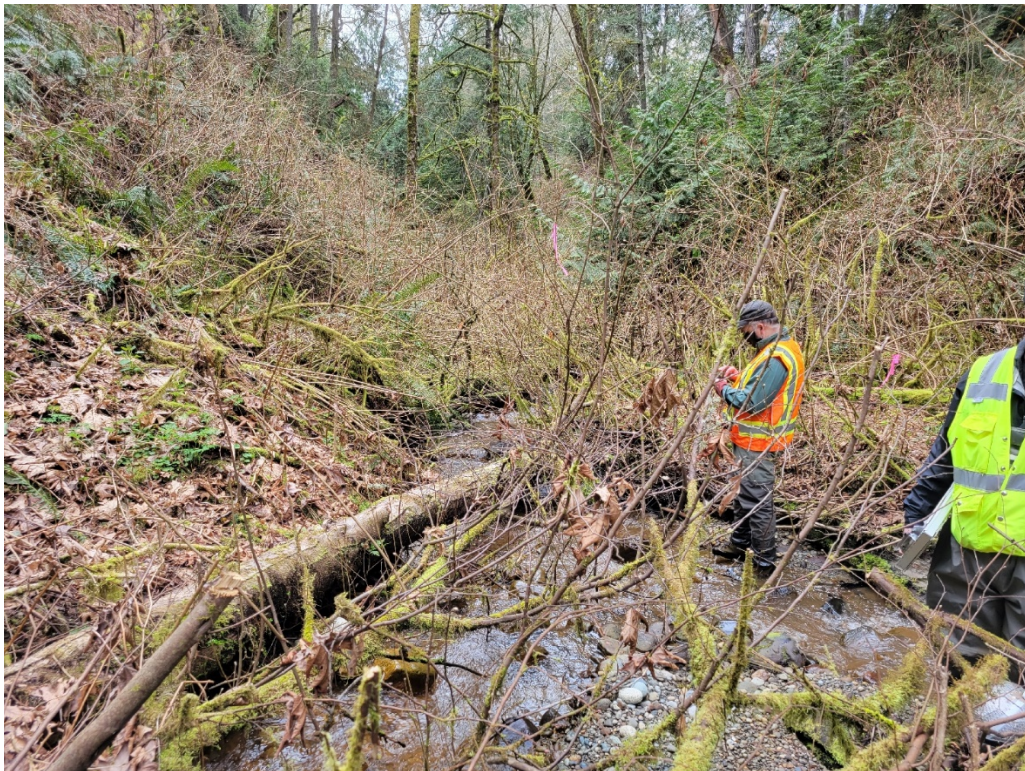
*Figure 33: Downstream survey extents*

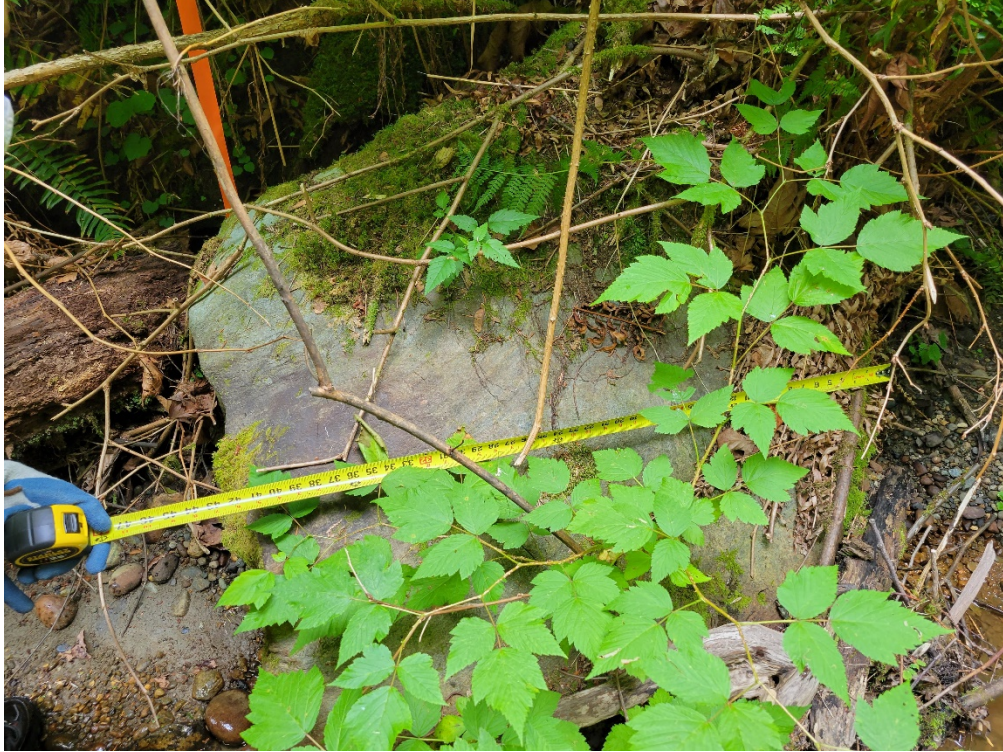
Three pebble counts were conducted to provide an accurate assessment of the streambed material distribution throughout the upstream and downstream reach. The upstream pebble count had resulted in a greater amount of fine sediment. The two downstream pebble counts were conducted in the near bankfull widths 7 and 8 (Figure 1) and the upstream pebble count was conducted near BFW 5. BFW 5 and BFW 8 pebble counts consisted of approximately 150 particles each. The pebble count in the reference reach near BFW 7 consisted of approximately 250 particles. Each individual pebble count and the cumulative distribution is provided in Figure 2 and Table 2. The material primarily consists of medium coarse gravels with only a few cobbles observed, most of which were observed within the reference reach at BFW 7. The largest particle observed was 24-inches in diameter found downstream of the reference reach (Figure 26). Boulders up to 46-inches were observed sporadically throughout the downstream reach (Figure 34).

*Figure 34: boulder observed during BFW concurrence*
