Hydraulics Section	Hydraulics Field Report		Project Number: Y12463																																																
	Project Name: Goodnough Creek SR 302 MP 16.15 (WDFW 105 K051518a)		Date: 3/26/2021 7/7/2021																																																
	Project Office: TBD		Time of Arrival: 3/26/2021: 8:00am 7/7/2021: 9:00am																																																
	Location: Goodnough Creek SR 16 MP 16.15		Time of Departure: 3/26/2021: 11:30am 7/7/2021: 10:45am																																																
Purpose of Visit: Site Reconnaissance	Weather: 3/26/2021: Partly Sunny 7/7/2021: Mostly Cloudy		Prepared By: Joe Griffin																																																
Meeting Location: Goodnough Creek, Pierce County, SR 302 MP 16.15																																																			
Attendance List:

Figure 1: Reference reach, bankfull width, and pebble count locations

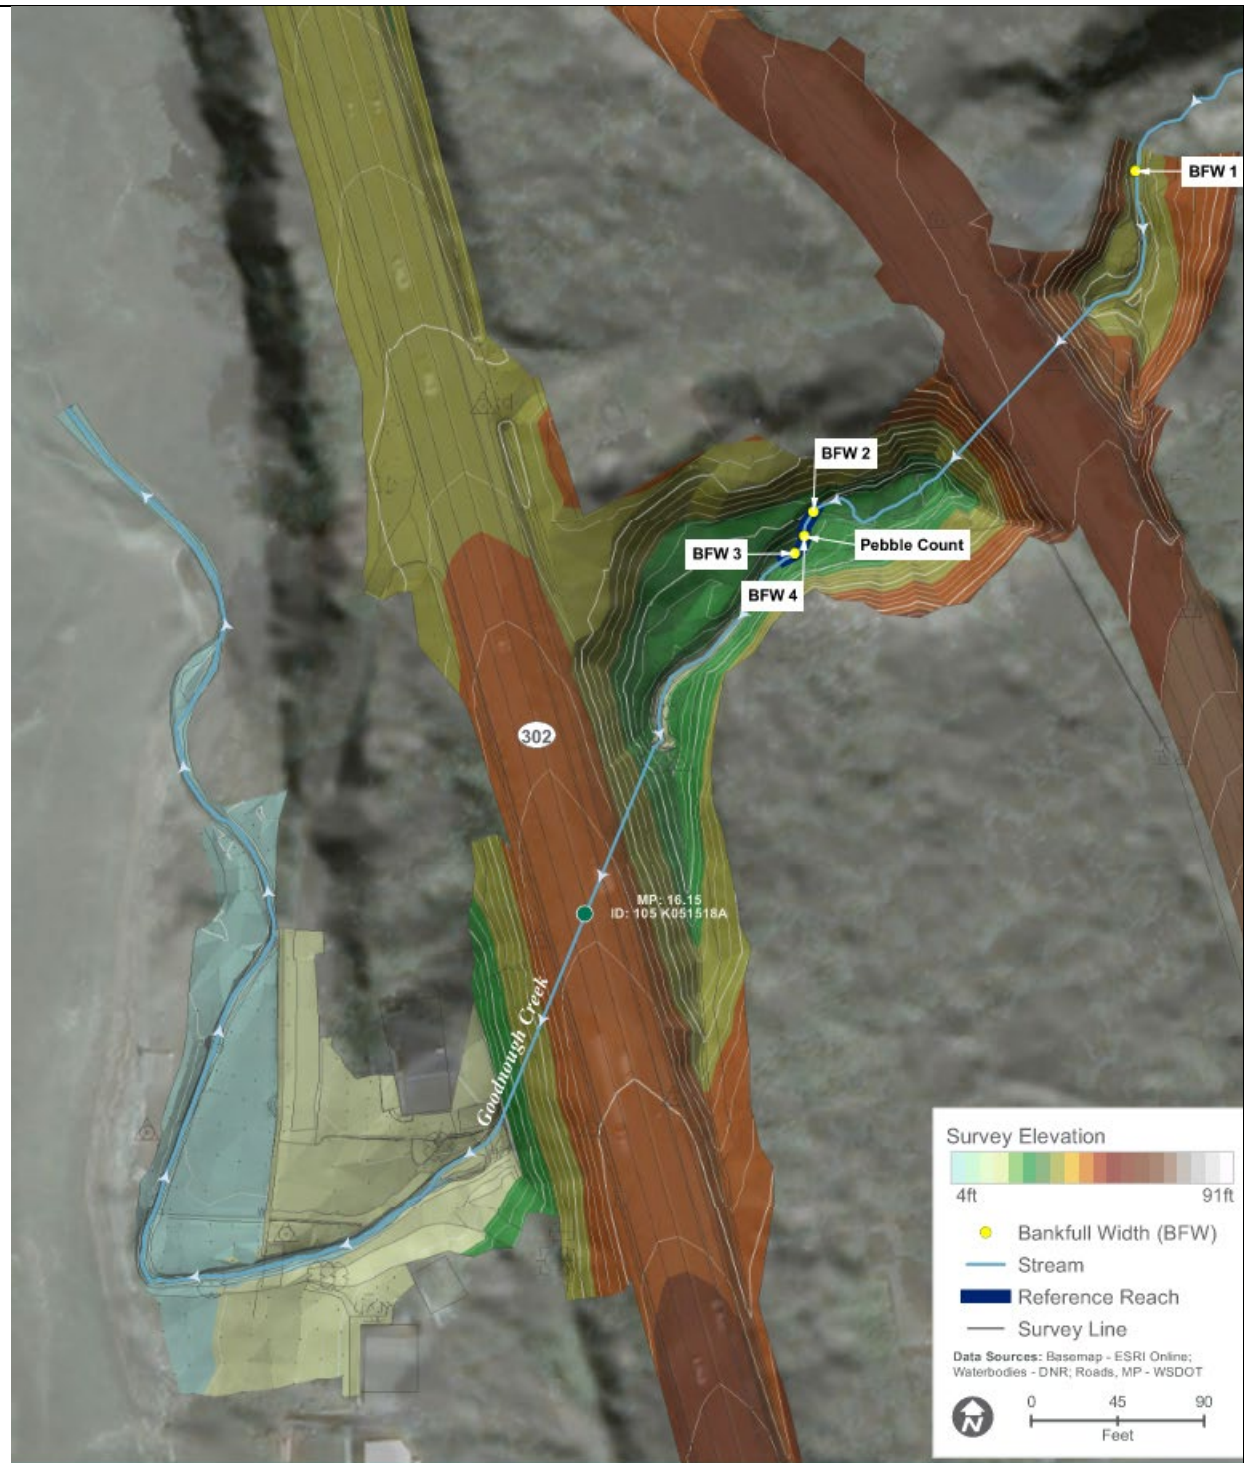
Reference Reach:
<p><i>Describe location, known history, summarize on site discussion, appropriateness, bankfull measurement</i></p> <p>The reference reach is located approximately 150 feet upstream of the SR302 culvert, shown in Figure 1 above. The reference reach is downstream of the Goodnough drive culvert influence and upstream of the more confined channel with incised banks that occur downstream of the reference reach. Cross section geometry in the reference reach will be used to inform the channel design. Bankfull widths 2, 3, and 4 were taken within the reference reach and a pebble count was conducted. During the second site visit with WSDOT, WDFW, and the tribes agreed with the reference reach appropriateness. Site conditions of the reference reach where the three bankfull width measurements were taken can be viewed in Figure 12 and Figure 14.</p>
Data Collection:
<p><i>Describe who was involved, extents collection occurred within</i></p> <p>HDR conducted an independent site visit on March 26th, 2021. HDR walked the stream approximately 100 feet upstream of the Goodnough Drive crossing to the downstream end of Goodnough Creek where it enters Henderson Bay. HDR took three bankfull width measurements: one upstream of Goodnough Drive and two upstream of SR302. A pebble count was conducted upstream of the SR302 culvert crossing.</p>

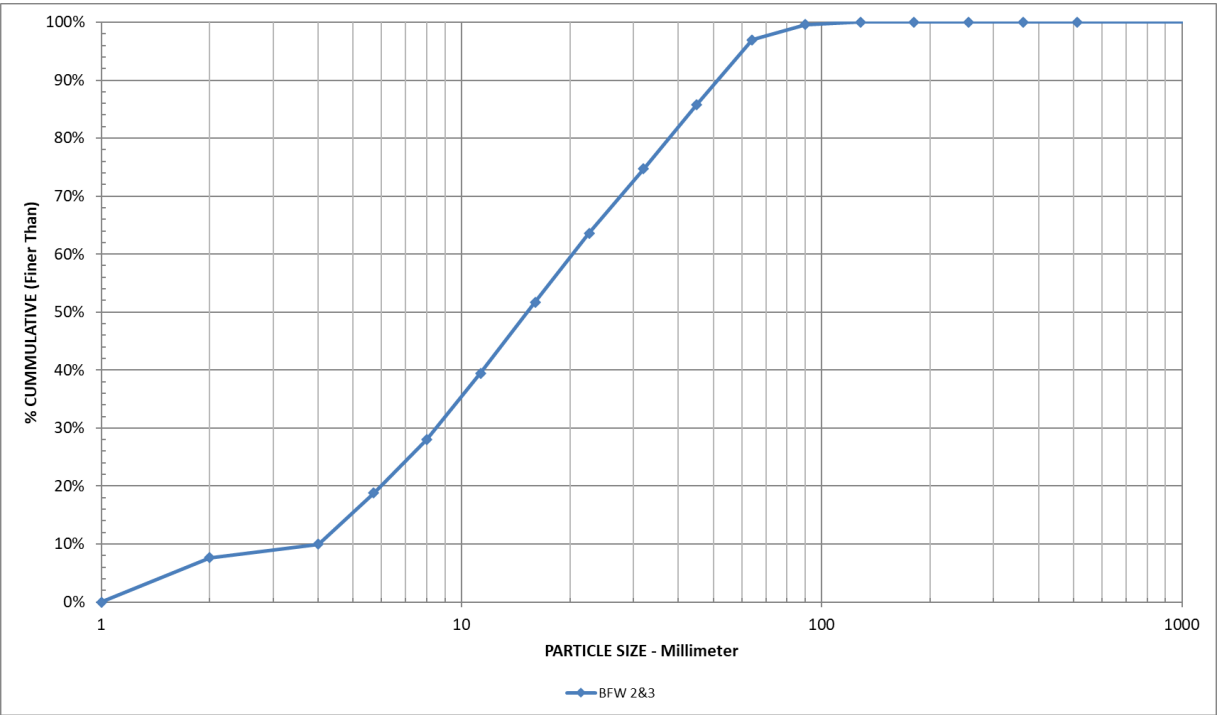
A pebble count was conducted to provide an accurate assessment of the streambed sediment distribution throughout the reference reach. The pebble count was conducted in the reference reach and consisted of approximately 250 particles. The sediment size distribution can be seen in Figure 2 and a summary of the particle diameters is provided in Table 2. Figure 13 shows a typical photo of the material found throughout the reference reach. The entire reach investigated during the site assessment had very similar size to the reference reach, with the reach just downstream of the SR 302 similar but lacking the few small cobbles observed upstream. The largest particle observed was approximately 4-inches in diameter within the reference reach and recorded in the pebble count.

Figure 2: Reference reach sediment size distribution

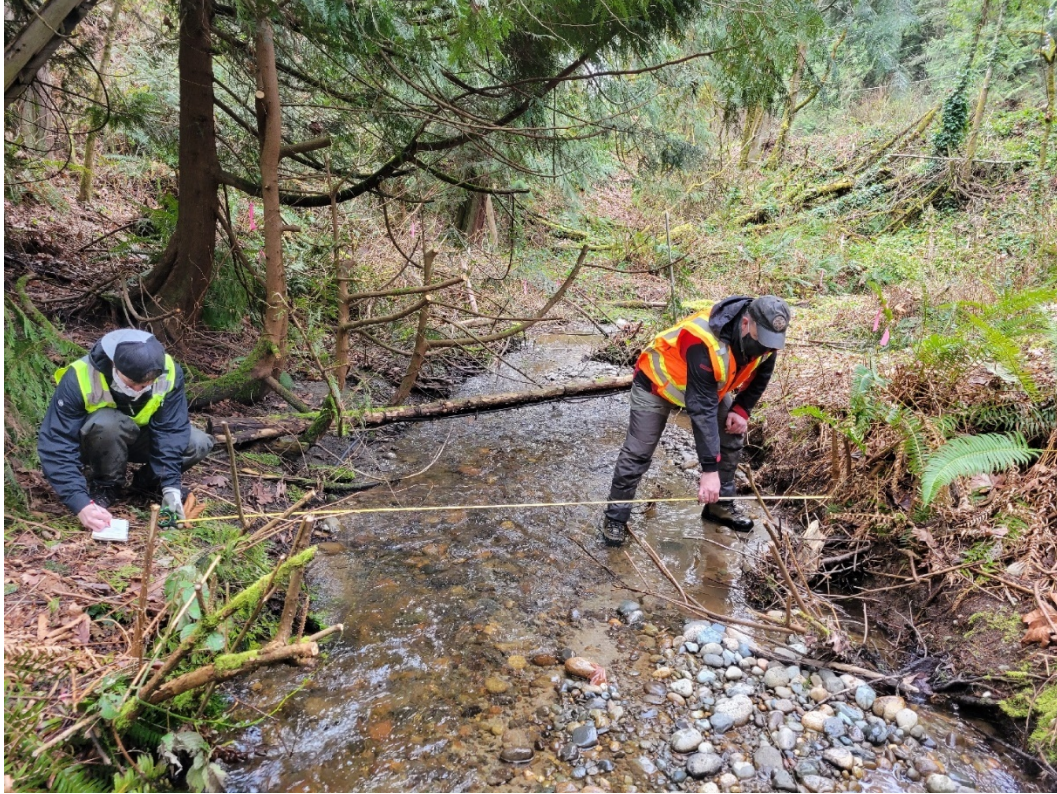
Figure 3: BFW 1 upstream Goodnough Drive at survey extents

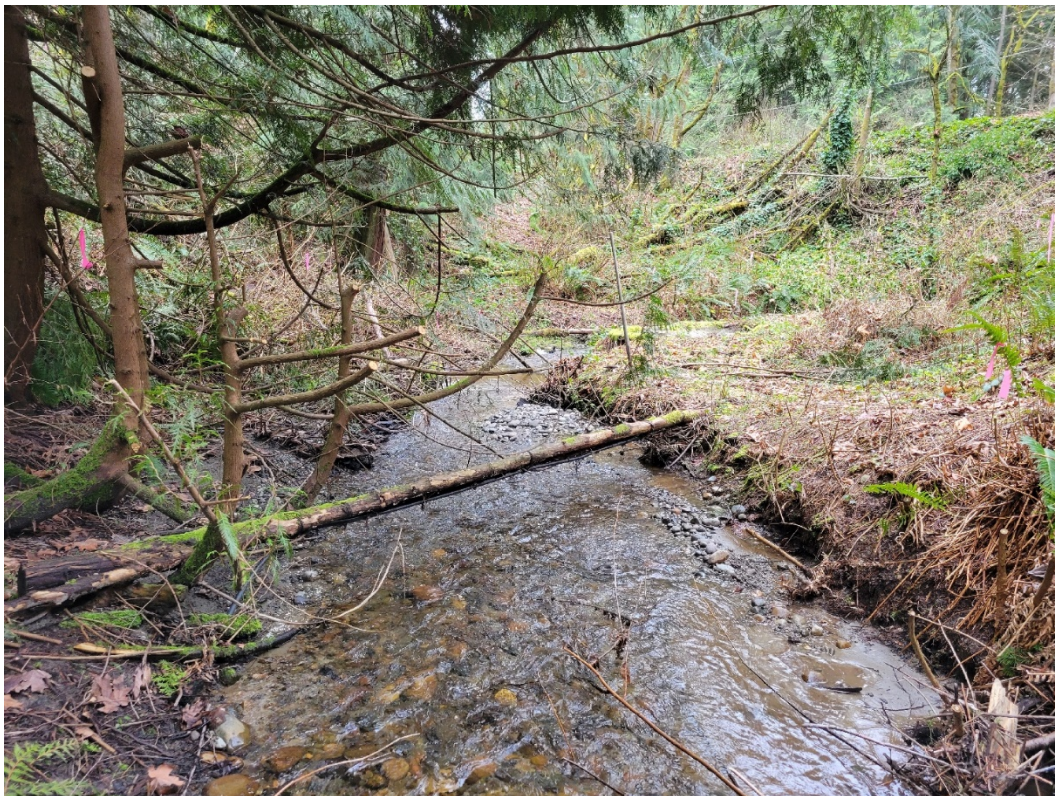
Figure 4: Upstream channel looking towards Goodnough Drive

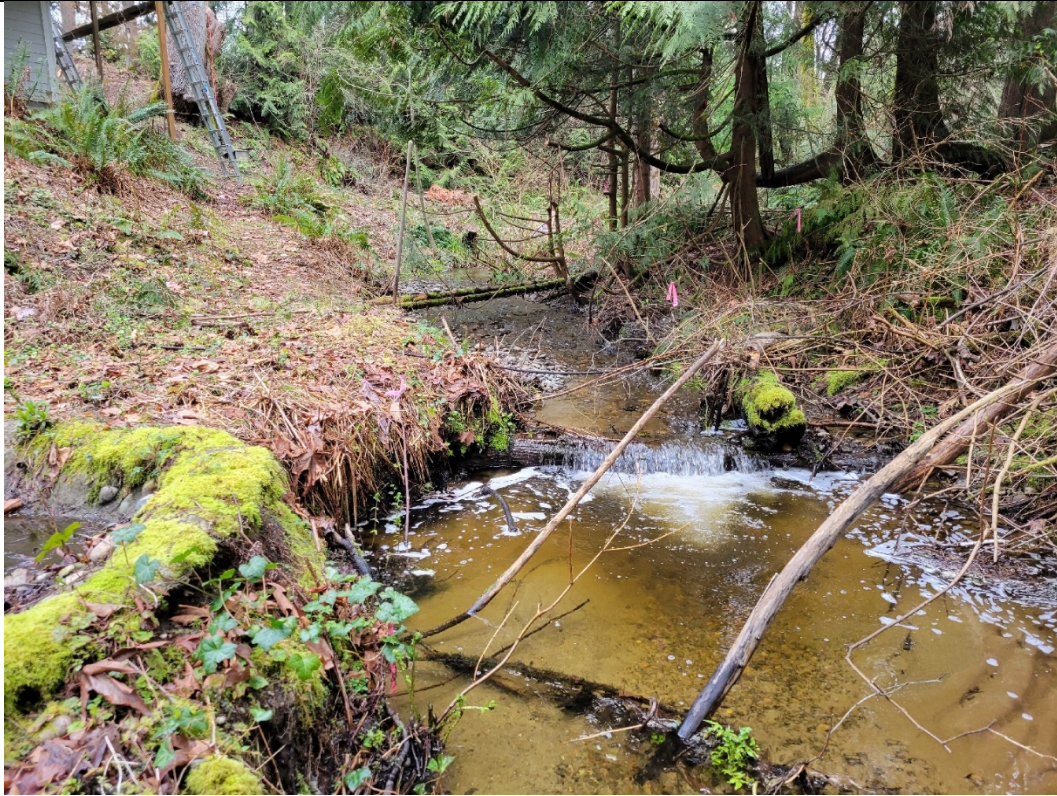
Figure 5: Small drop from log weir and small concrete pond (left side)

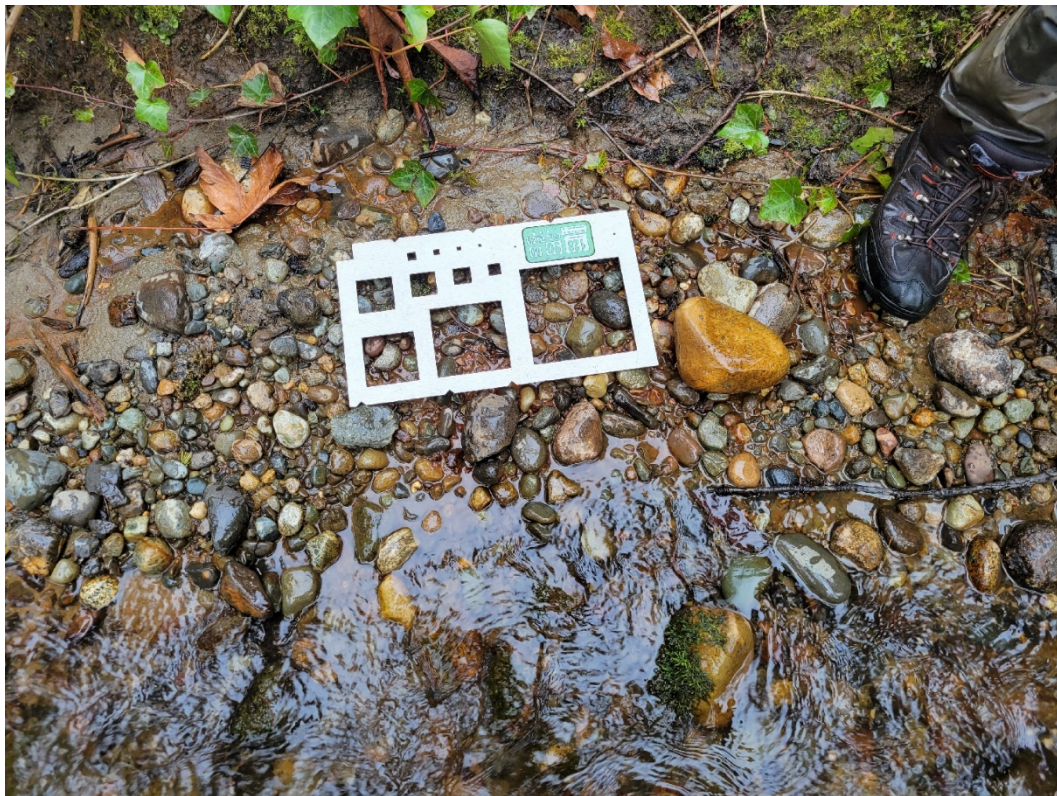
Figure 6: Streambed material upstream of Goodnough Drive

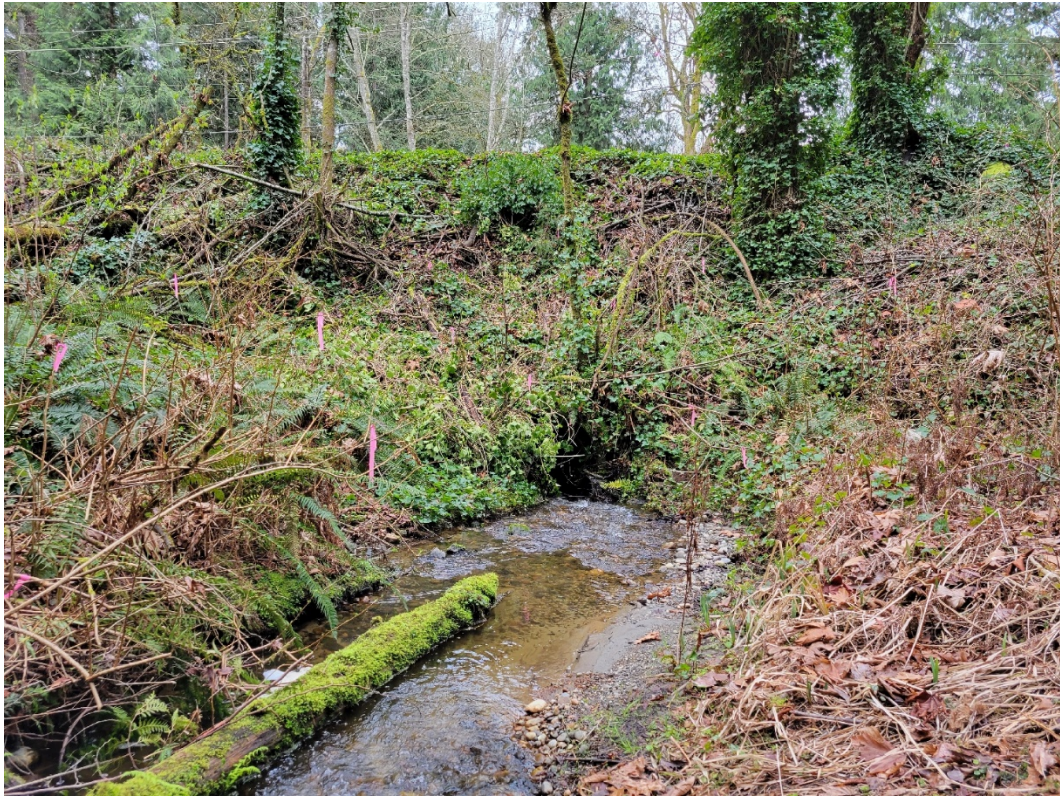
Figure 7: Goodnough Drive culvert entrance

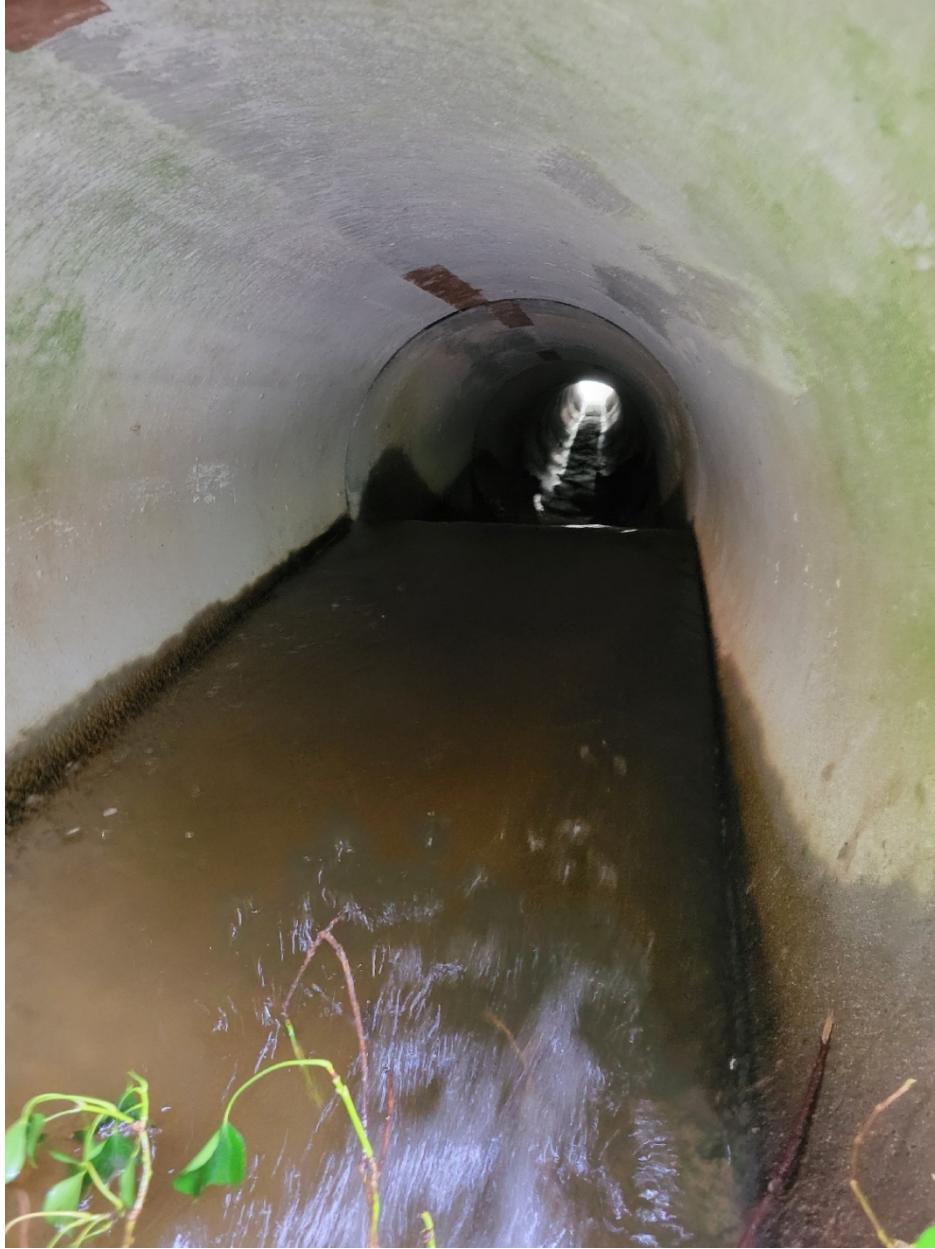
Figure 8: Elevation drop midway through Goodnough Drive Culvert

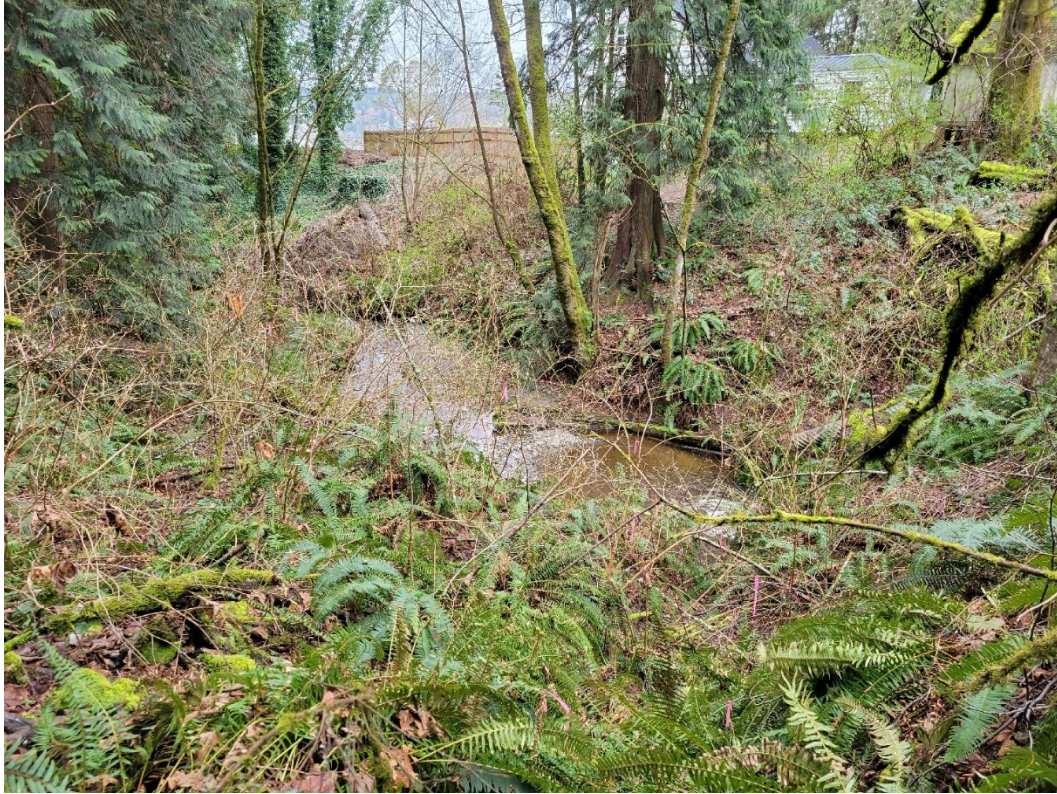
Figure 9: Downstream of Goodnough Drive culvert outlet

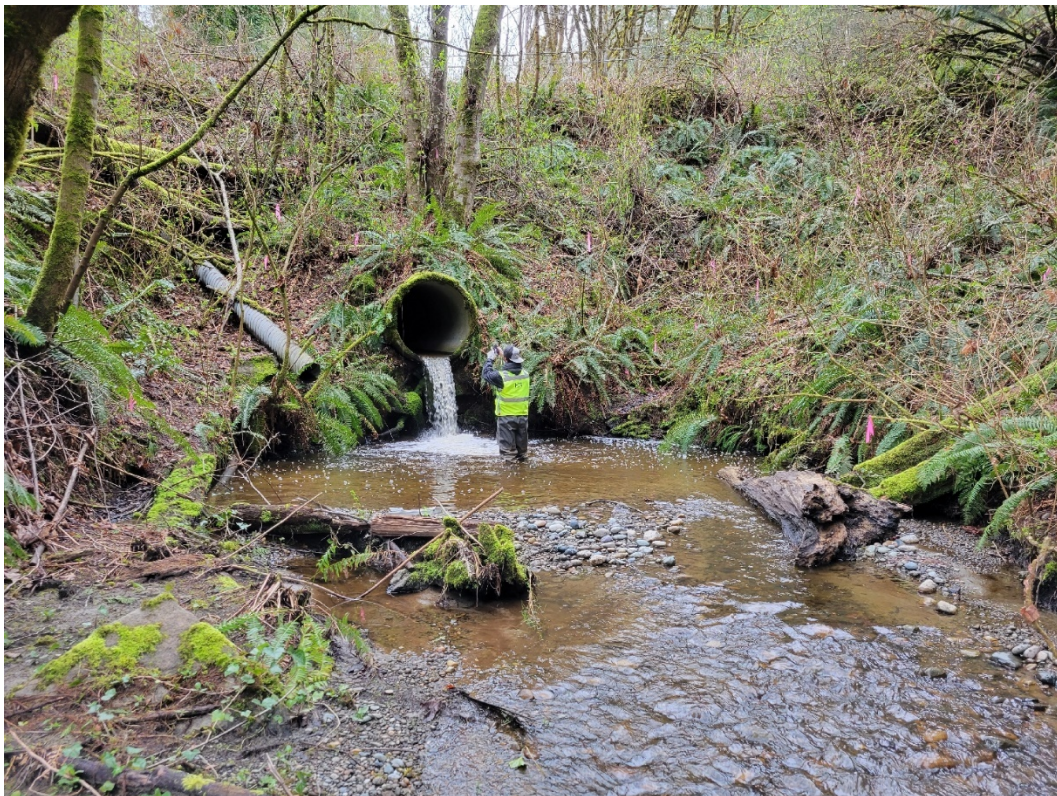
Figure 10: Goodnough Drive perched culvert outlet and existing scour hole

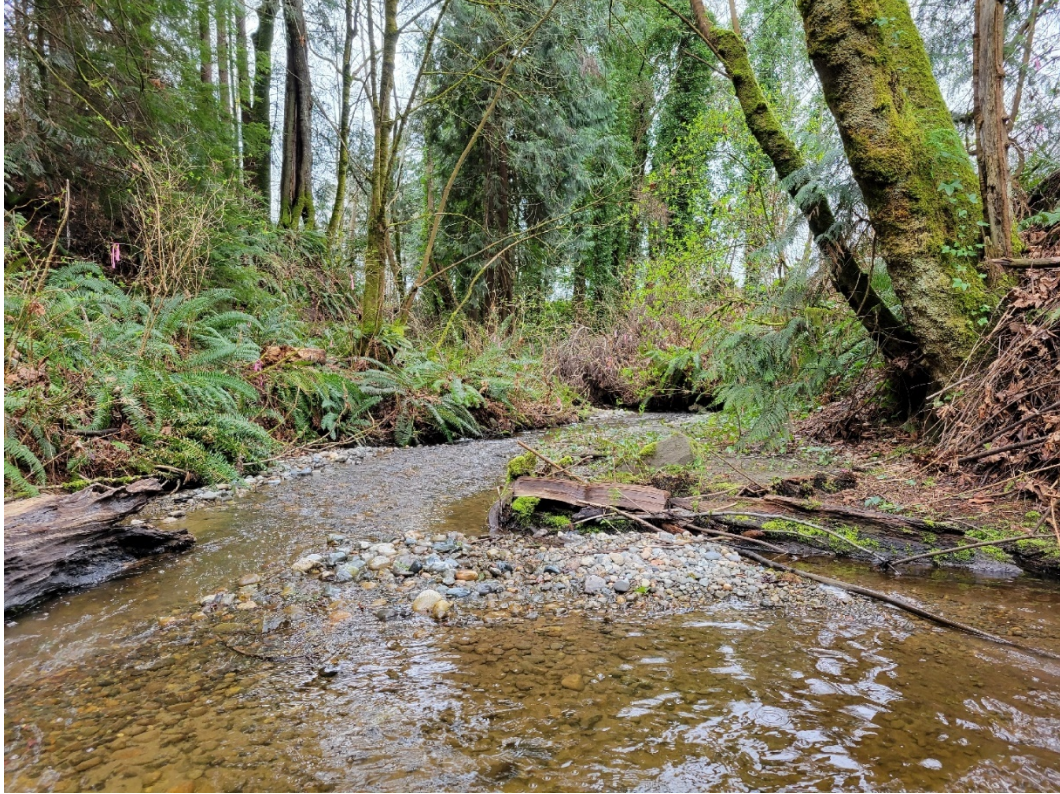
Observations:
<p><i>Describe site conditions, channel geomorphology, habitat type and location, flow splits, LWM location and quantity, etc.</i></p> <p>Upstream of Goodnough Drive</p> <p>Upstream of the County owned culvert at Goodnough Drive the channel is in a small ravine with accessible floodplains on each bank. The right bank floodplain was developed by the property owner and cleared of most brush with some small bushes and ivy present. The left bank floodplain contained some smaller trees and bushes but was clear of most foliage. A single bankfull width measurement was taken approximately 85 feet upstream of the County culvert to provide a greater insight into the extended Goodnough creek reach (Figure 3). Ultimately, this BFW was not included in the design as it was outside the reference reach and smaller than the two measurements within the reference reach. The slope upstream of the county culvert is approximately 2.5% and the channel flow depth observed at the first bankfull measurement was approximately 17" during the site visit (Figure 4). Further downstream of the first bankfull measurement a small, natural log weir has created a shallow water surface drop. The log weir consists of two logs, one spanning the channel and the other along the left bank (Figure 5). Near the entrance of the county culvert on the right bank in the floodplain is a small man-made concrete pond with unknown purpose (FIGURE). The streambed sediment through the upstream reach is a mix of sands, gravels, and a few cobbles(Figure 6 and Figure 7). The county culvert is a 4-foot smooth circular concrete pipe. Roughly five feet into the broken back culvert is an approximate 10-foot elevation drop (Figure 8).</p> <p>Upstream of SR302</p> <p>Downstream of the county culvert, the creek meanders within a narrow ravine containing trees and light brush (Figure 9). A 4 to 5-foot water surface drop from the exit of the County culvert (Figure 10) that has created a large scour pool. The scour pool extends from toe to toe of the ravine. Downstream of the culvert outlet the channel has moderate sinuosity and is single threaded with small accessible floodplains within the confined ravine with a pool riffle morphology (Figure 11).</p>

Figure 11: Channel sinuosity downstream of culvert

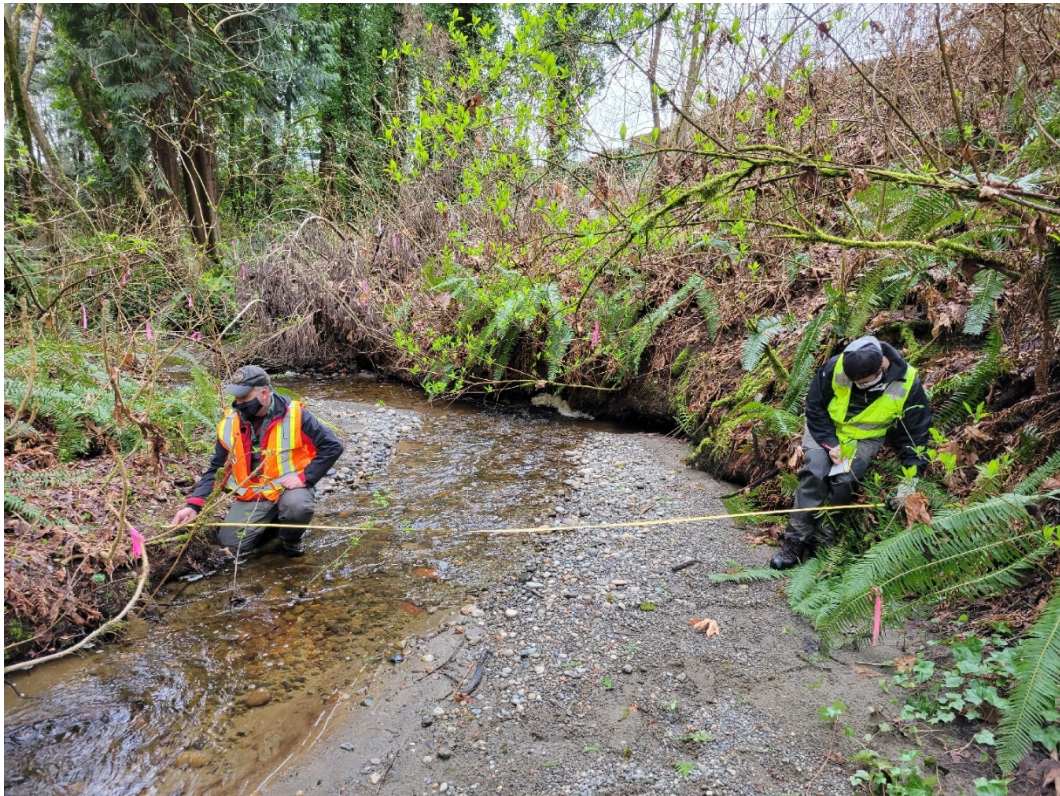
Figure 12: BFW 2

Above the banks in the floodplain are larger trees and dense brush. Approximately 160 feet upstream of the SR302 culvert, a second bankfull width was taken before a bend in the channel. This bankfull width marks the upstream end of the reference reach (Figure 12).

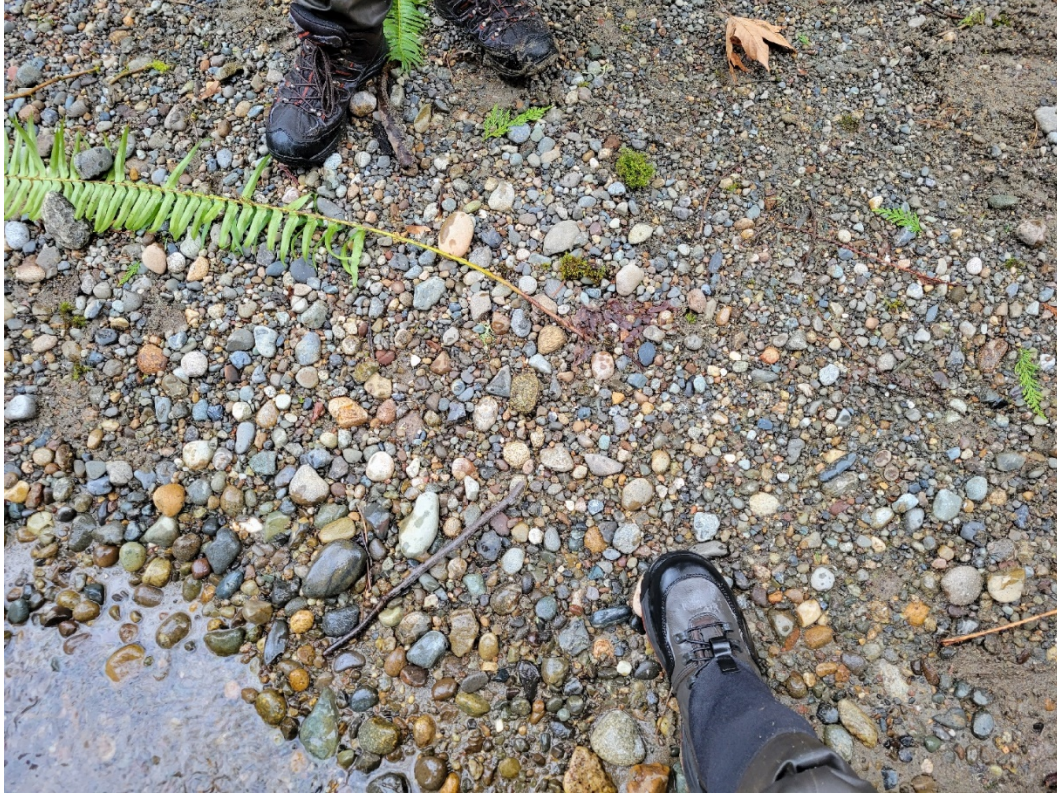
The bankfull channel depth throughout the reference reach is approximately 14 to 24 inches and the slope developed from the long profile from survey data was 1.9 percent. A pebble count consisting of approximately 250 particles was conducted between BFW measurements 2 and 3 (Figure 13) and was uniformly graded mix of gravels with some sand and a few cobbles. The largest material observed in the pebble count was roughly 4 inches in diameter. Bankfull width 3 taken 130 feet upstream of the SR302 crossing was collected near the downstream end of the reference reach (Figure 14). The right bank was slightly incised, and the floodplains contained small brush such as ferns with a scattering of large trees.

Figure 13: Pebble count substrate

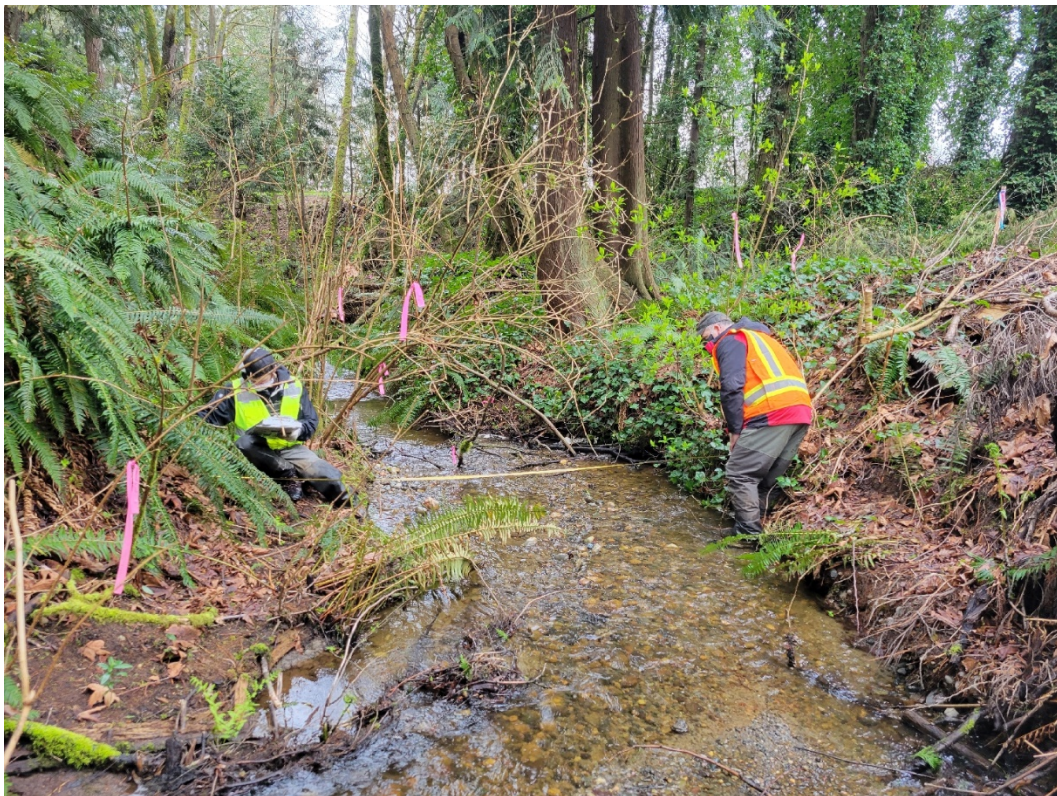
Figure 14: BFW 3 and reference reach

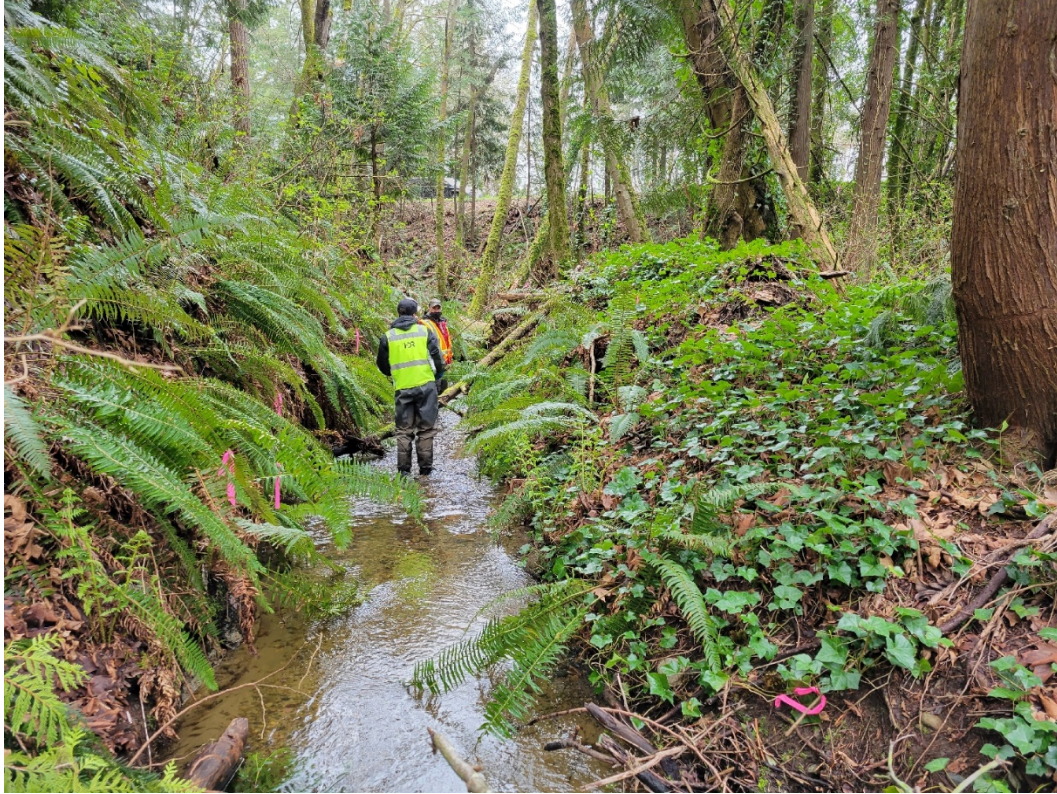
Downstream of the reference reach the channel becomes more confined and the stream narrows with much less accessible floodplains (Figure 15). Approximately 40 feet upstream of the SR 302 culvert entrance, a large, 2-foot diameter tree with rootwad has fallen and is partially blocking flow along the right bank of the channel (Figure 16). The tree partially broke after hitting another on the left bank and headwall of the culvert entrance (Figure 17). During the second site visit WDFW and WSDOT indicated that the fallen tree should be restored in channel by the contractor after construction. The channel turns left approximately 5 feet downstream of the root ball towards the entrance of the culvert. Before the start of the concrete headwall, rip rap was observed on the right bank protecting the road embankment toe from the channel erosion (Figure 18). The culvert headwall is 5 feet tall on the left side, the right side is parallel to the channel and tapers down from 5 to 2 feet. The culvert is a 4.5-foot smooth, circular concrete pipe (Figure 19). A small baffle on the inside bottom right of the culvert entrance was observed.

Figure 15: Confined channel downstream of reference reach

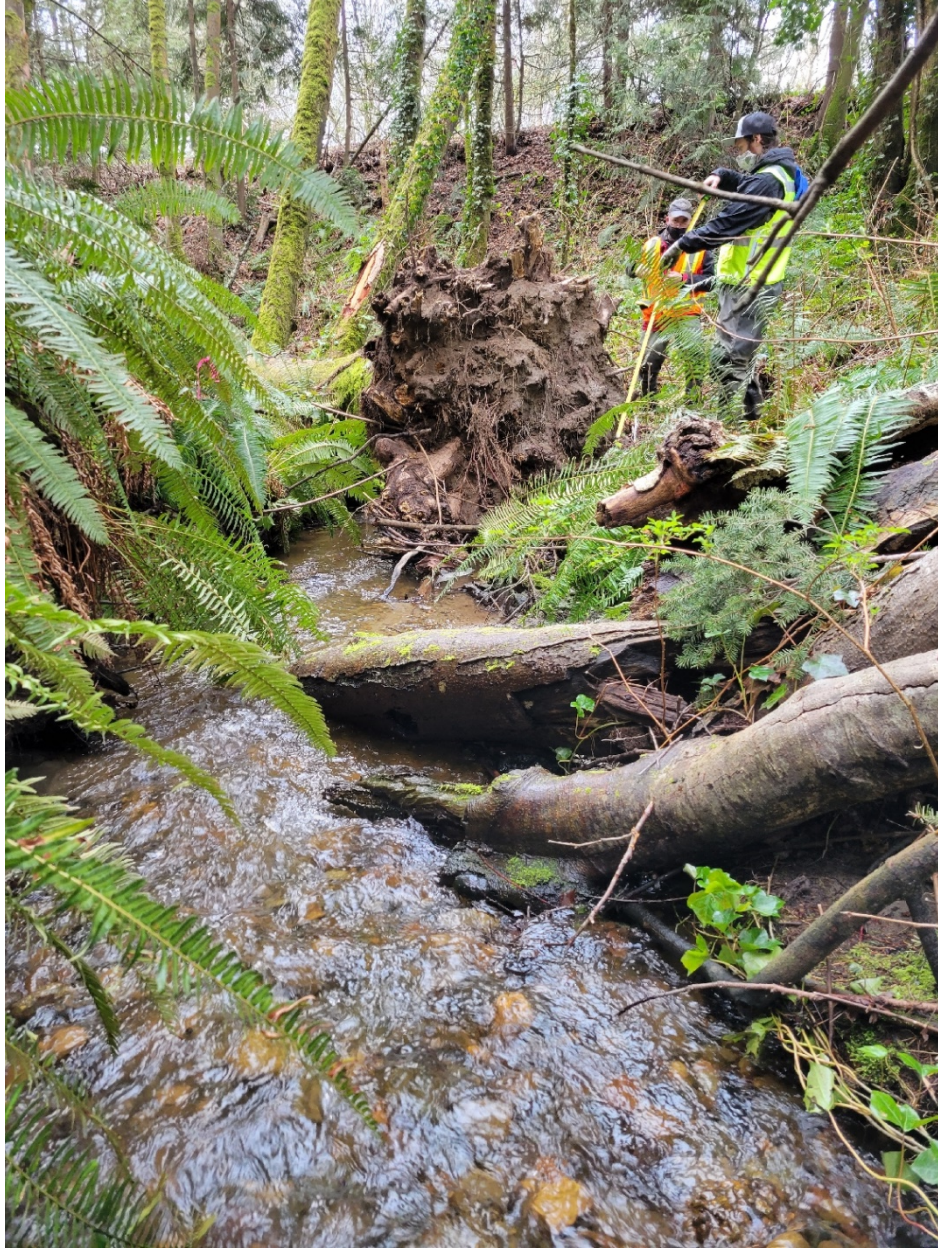
Figure 16: LWM in channel

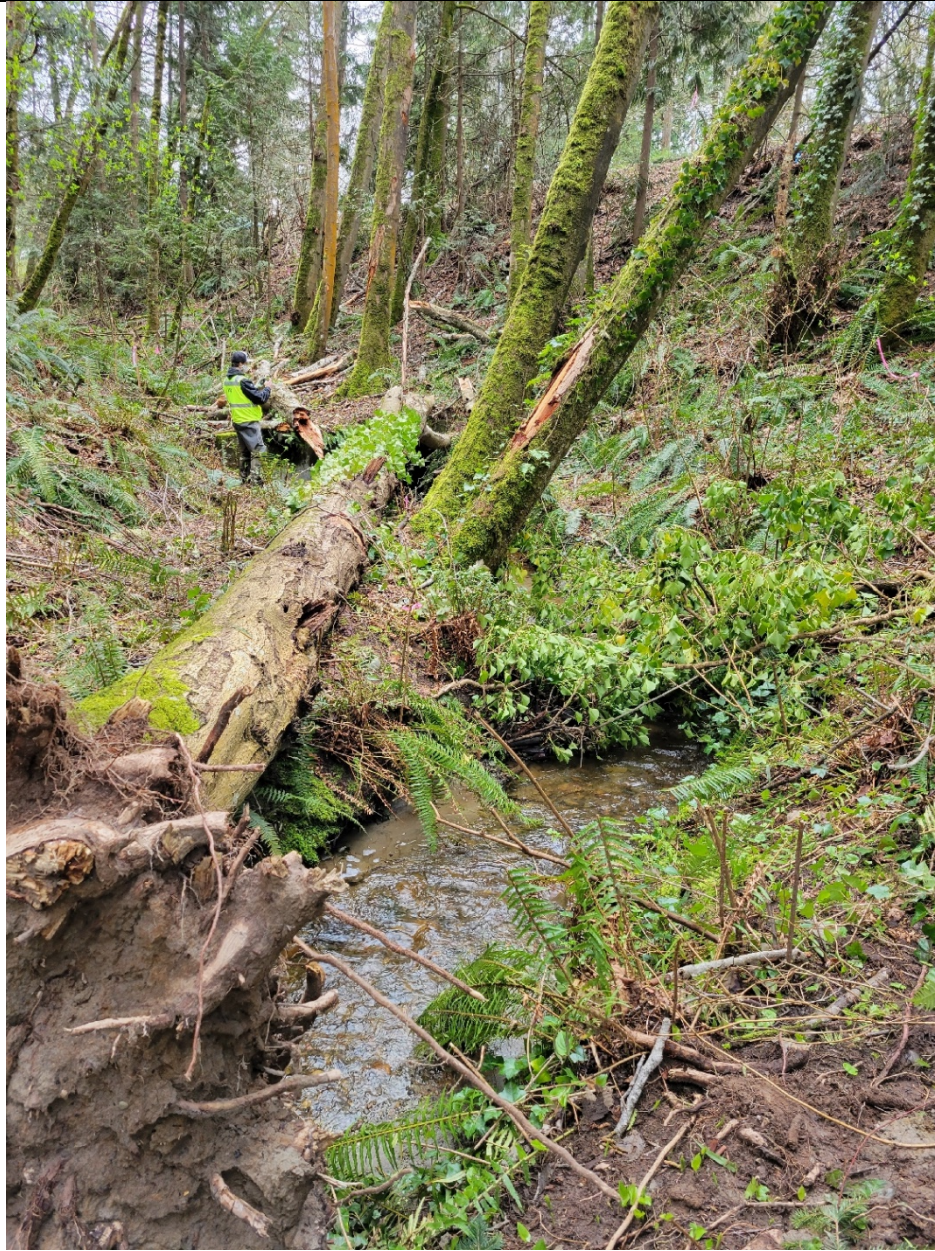
Figure 17: LWM above channel and culvert

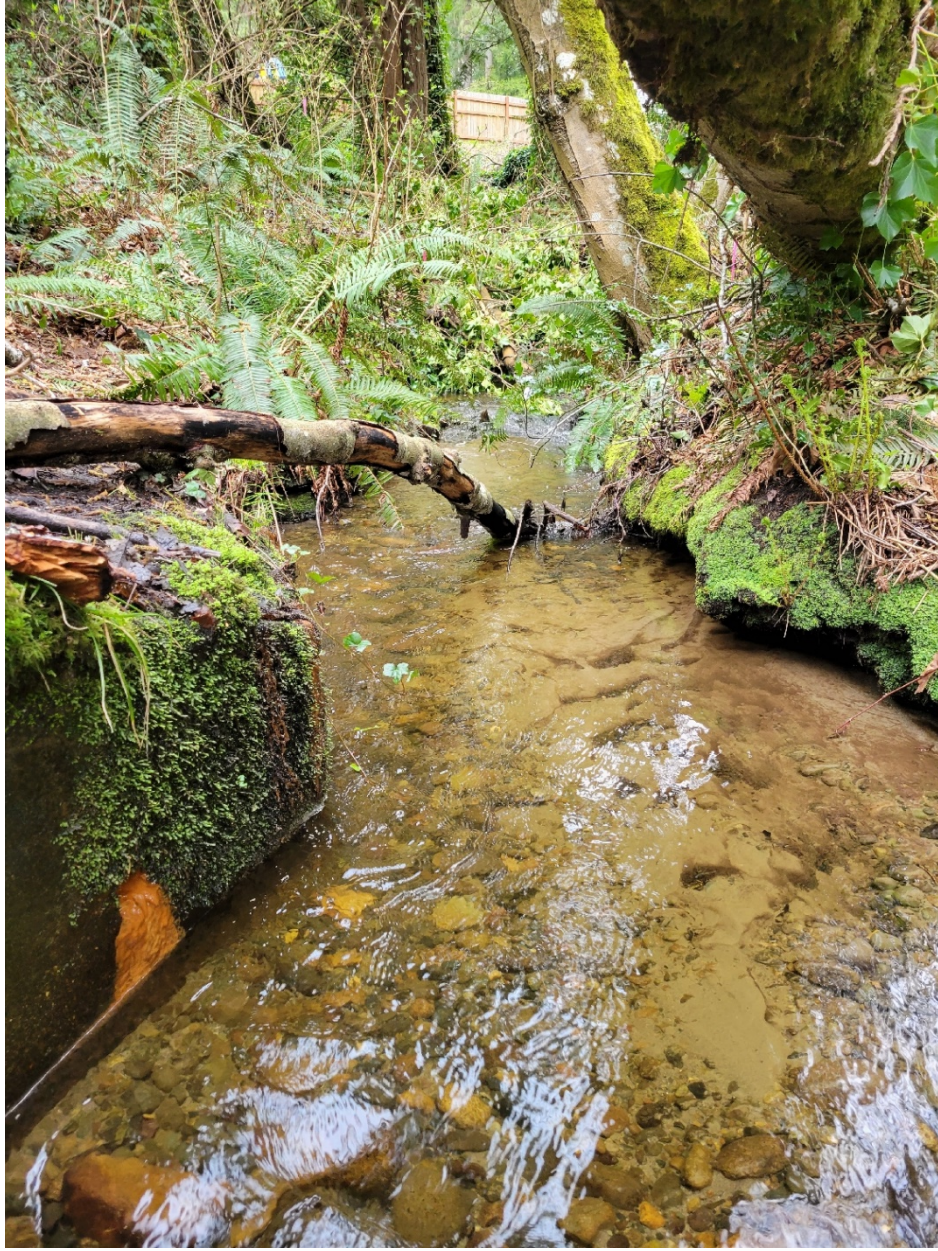
Figure 18: Looking upstream at SR302 culvert entrance

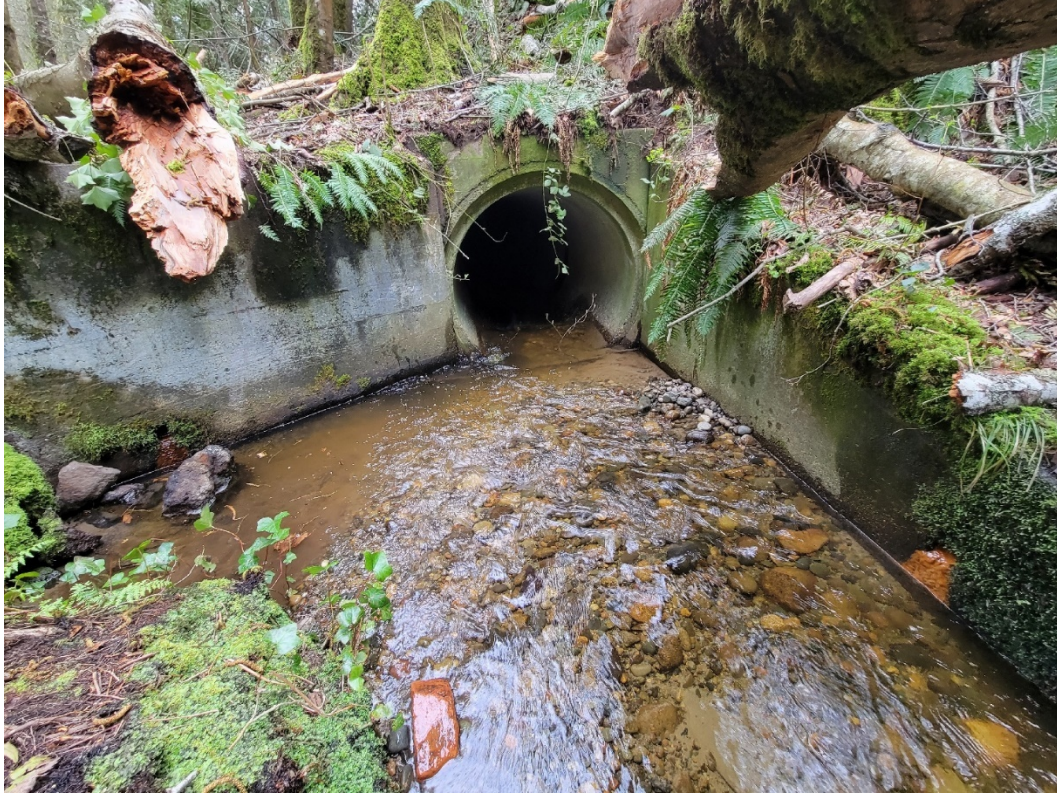
Figure 19: SR302 Culvert entrance and headwalls

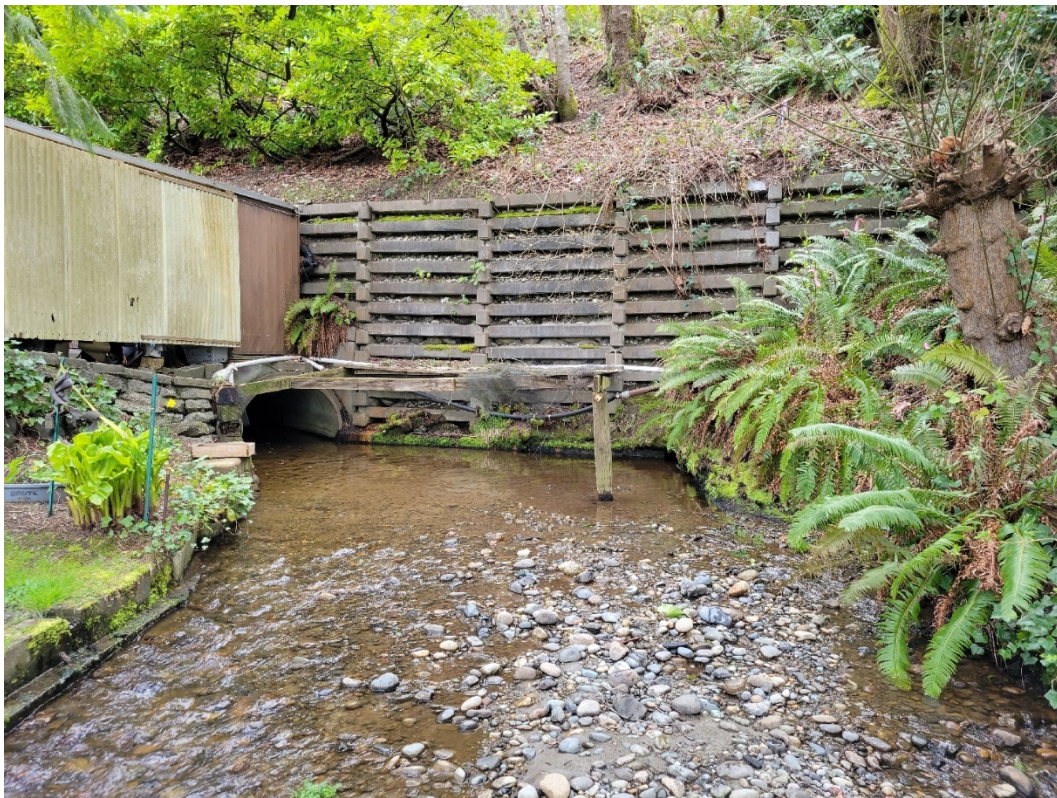
The downstream outlet of the culvert is partially filled with fine sediment material. Immediately downstream of the culvert is a crib wall retaining the road embankment on the left bank. On the right bank is a small shed that stores the property owner's boat (Figure 20) that encroaches on the existing culvert. Further downstream of the culvert the channel material is comprised primarily of gravels. The downstream channel is a well maintained, landscaped, 7-foot-wide stream (Figure 21). The channel is plane bed with a uniform depth and width throughout the two downstream properties until reaching the beach. 150 feet downstream of the culvert exit is a small wooden pedestrian bridge with a 13-inch chord depth (Figure 22). Approximately 60 feet downstream of the pedestrian bridge is a reinforced 90 degree bend right in the channel that prevents the creek from flowing straight into Henderson Bay but through the northern properties lawn (Figure 23). The channel floodplains are grass as it flows through the property owner's lawn for approximately 200 feet (Figure 24). Further downstream, the channel spreads out onto the beach (Figure 25) and finally into Henderson Bay (Figure 26). The downstream reach is tidally influenced but the tidal affect does not extend up to the inlet of the SR302 culvert. The downstream outlet invert of the SR302 culvert is at 13.6-feet and the max king tide elevation observed at the nearest gauge in the same datum was 12.1-feet. At the time of the site visit on March 26th the tide was receding and about to change into flood.

Figure 20: Downstream SR302 culvert exit

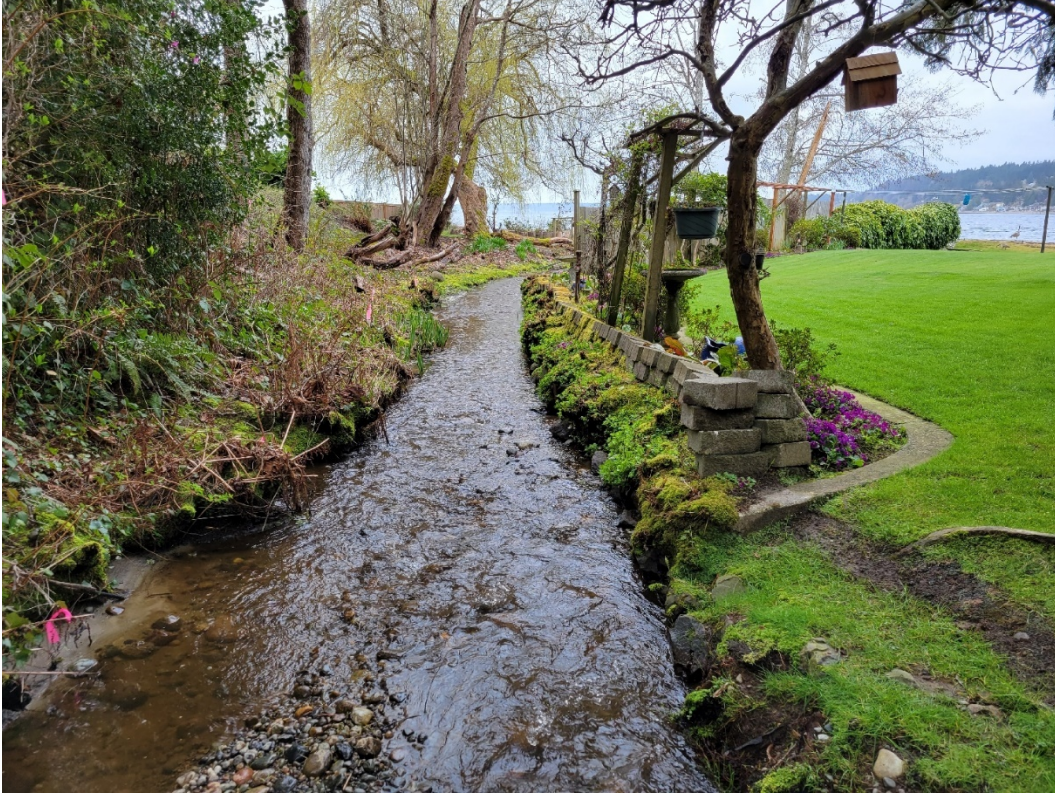
Figure 21: Downstream maintained channel reach
