Hydraulics Section	Hydraulics Field Report		Project Number: Y12463																																																
	Project Name: Goodnough Creek SR 302 MP 16.15 (WDFW 105 K051518a)		Date: 3/26/2021 7/7/2021																																																
	Project Office: TBD		Time of Arrival: 3/26/2021: 8:00am 7/7/2021: 9:00am																																																
	Location: Goodnough Creek SR 16 MP 16.15		Time of Departure: 3/26/2021: 11:30am 7/7/2021: 10:45am																																																
Purpose of Visit: Site Reconnaissance	Weather: 3/26/2021: Partly Sunny 7/7/2021: Mostly Cloudy		Prepared By: Joe Griffin																																																
Meeting Location: Goodnough Creek, Pierce County, SR 302 MP 16.15																																																			
Attendance List:

Figure 1: Reference reach, bankfull width, and pebble count locations

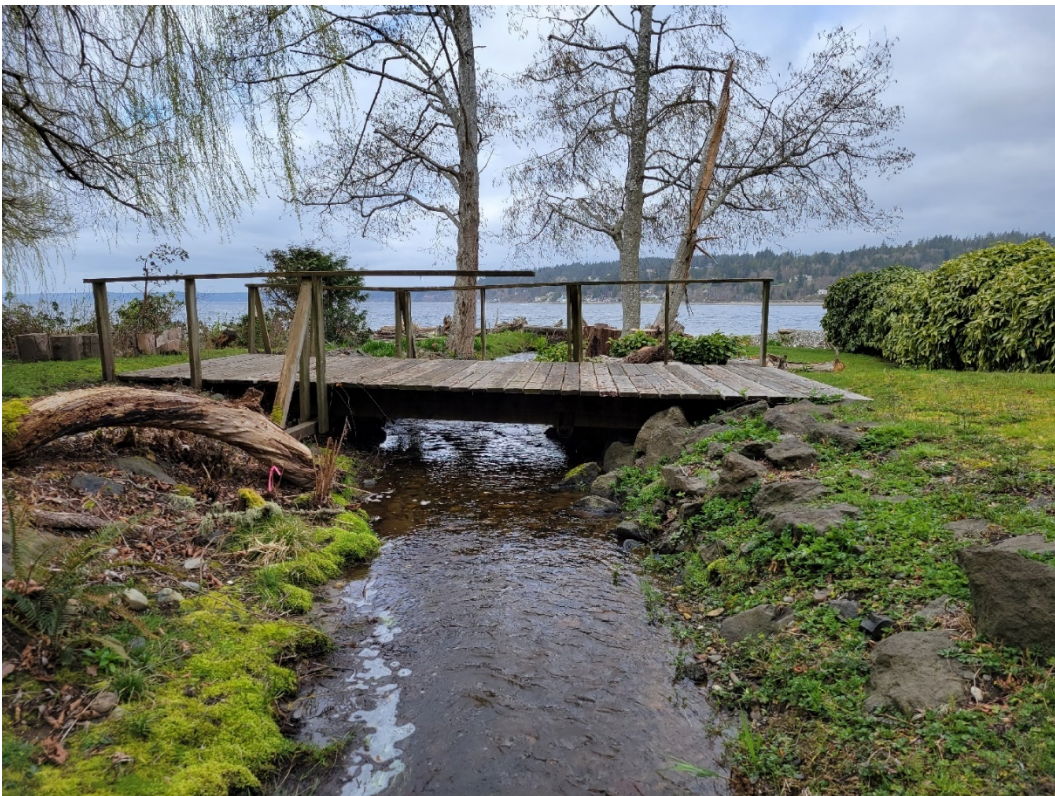
Figure 22: Wooden pedestrian bridge

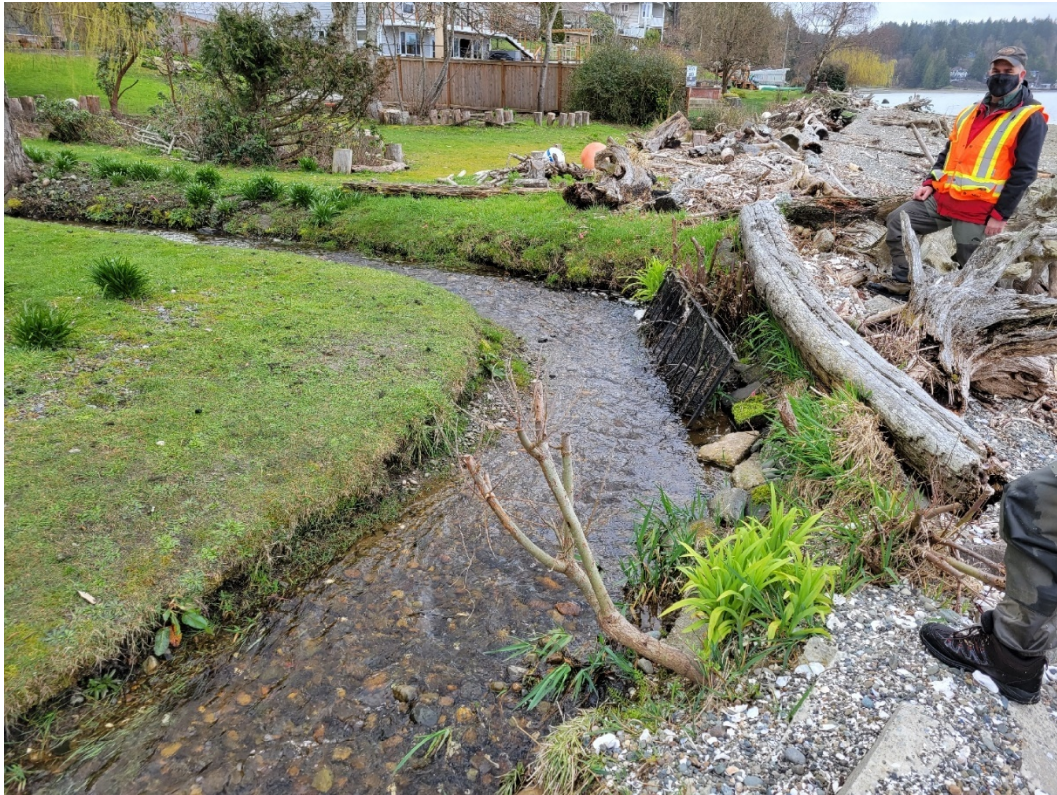
Figure 23: Reinforced channel bend

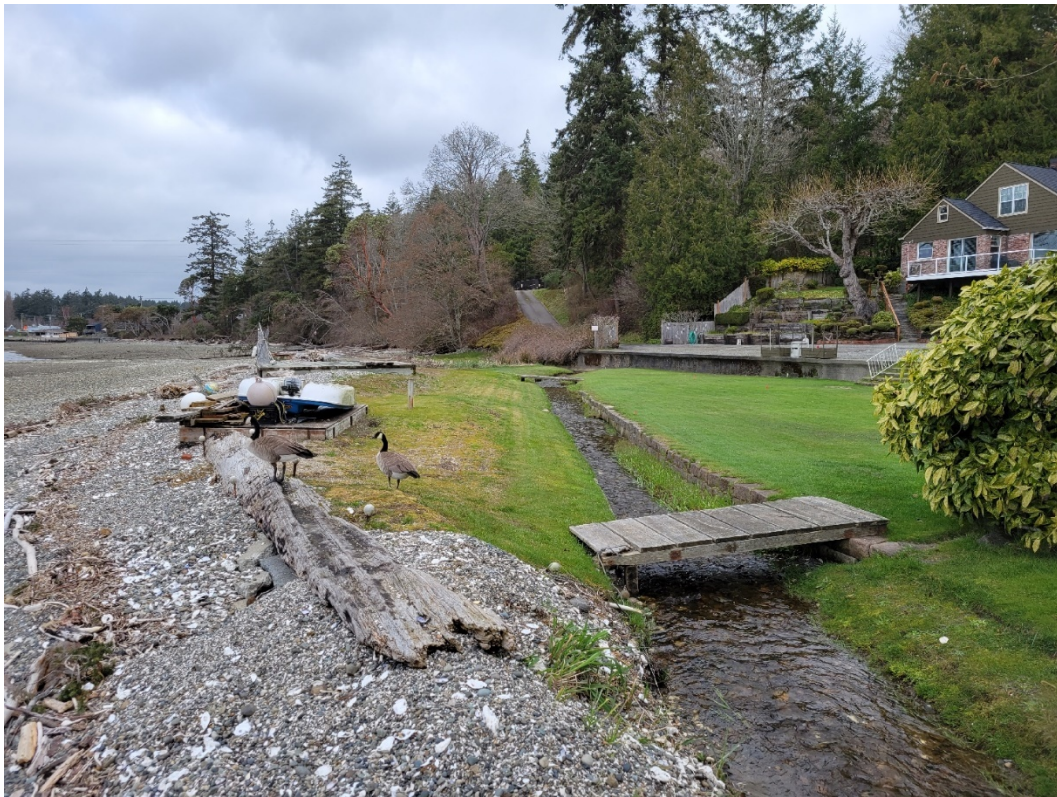
Figure 24: Downstream channel through maintained landscaping

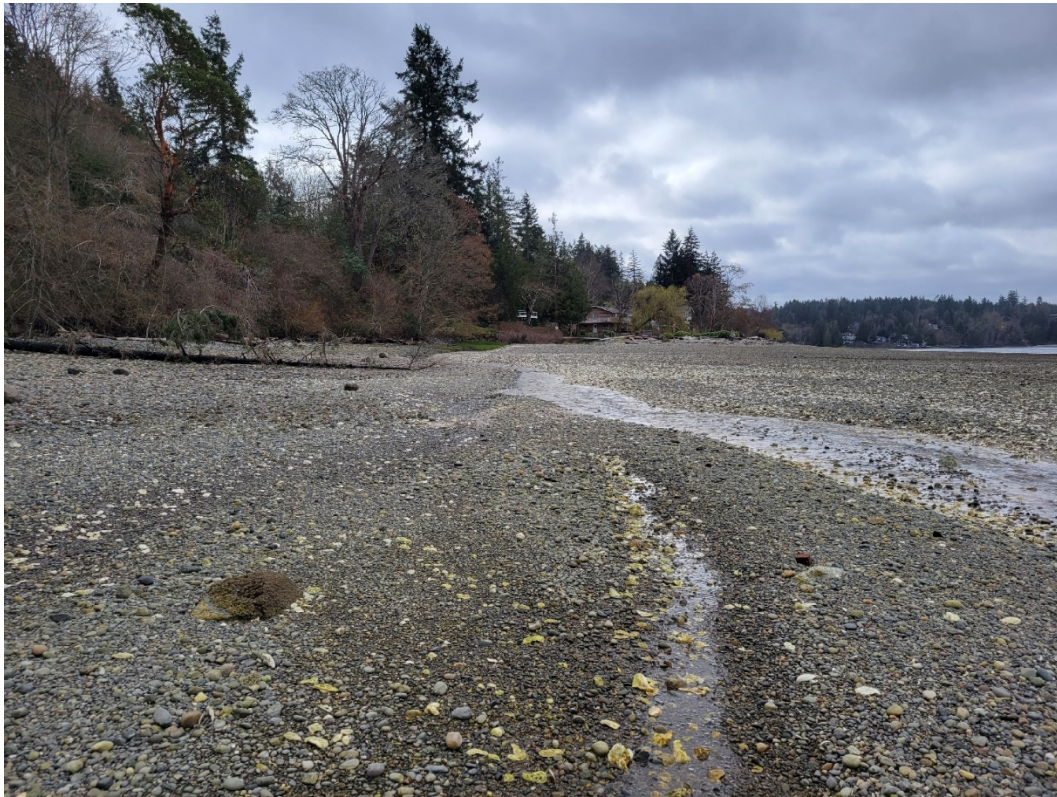
Figure 25: Typical channel on beach

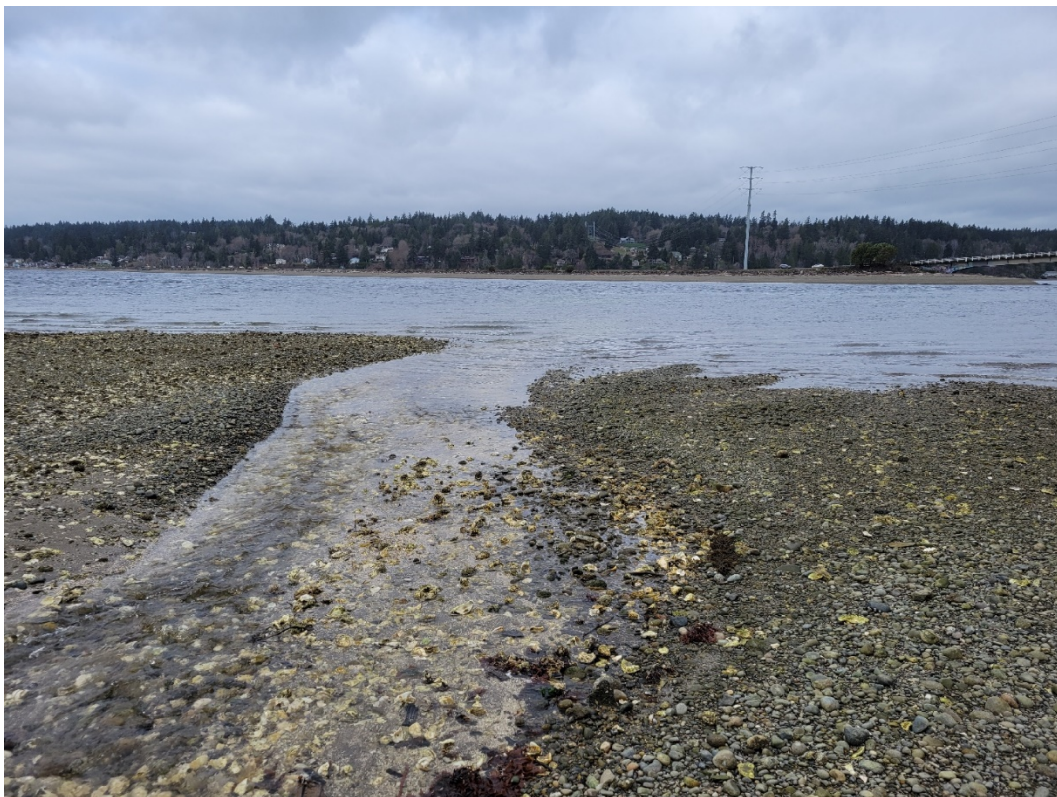
Figure 26: Confluence with Henderson Bay
