## BRIDGE INSPECTION REPORT

Br. No. 303/12

Br. Name PORT WASHINGTON CS1840

Intersecting PORT WASHINGTON NARROWS

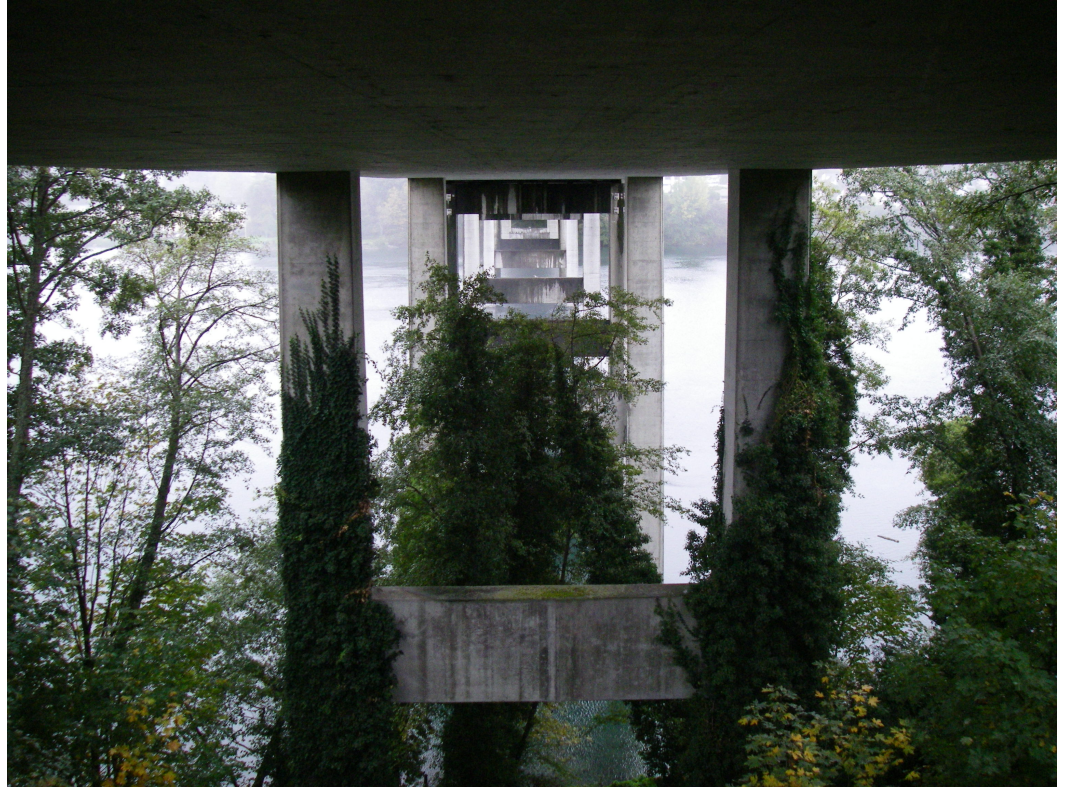
- 0 Bridge is oriented south to north.  
 The City of Bremerton has stockpiled sand below Spans 12 and 13. Lebo Blvd. is under Span 14.  
 The area below Span 15 is enclosed by a chain link fence. In 2014 the area was accessed from Lebo Blvd. by removing two fence ties and pulling back the fence.  
 Trees obstruct UBIT access below Spans 10 and 11 (Photos #72). REPAIR #14239.

At Piers 10 and 11 trees obstruct Ubit access.

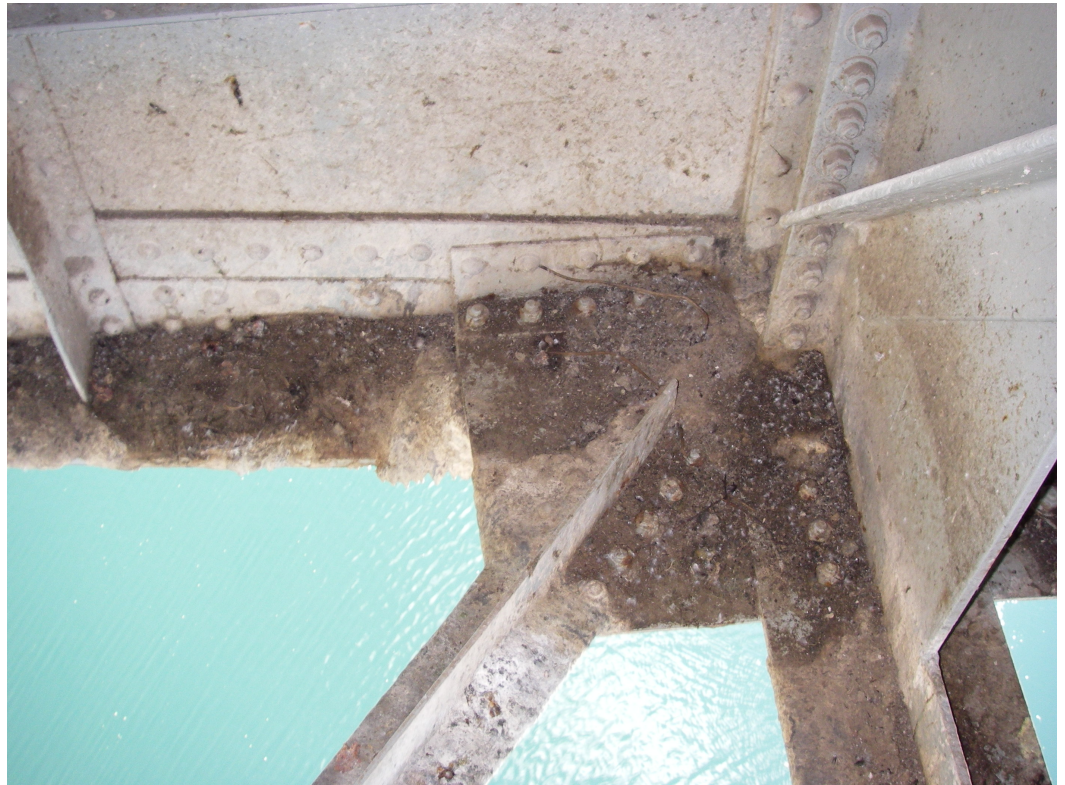
## MI-26

- 91 The girders are located in Spans 5, 6, and 7.  
Both girders in Spans 5, 6 and 7 have cormorants roosting on the bottom flange.  
In numerous locations the bottom flange is caked with excrement the consistency of concrete up to 3" deep (Photos #26, #31 and #84). REPAIR #13779.  
See Visual Fracture Critical Inspection Report in the Files tab for further information.

91 Steel Riveted Girder  
Photo Type: R - Repair  
Orientation: E  
Date: 10/23/2006  
Repairs: 13779  
Cormorant guano and debris on bottom flange of plate girder.

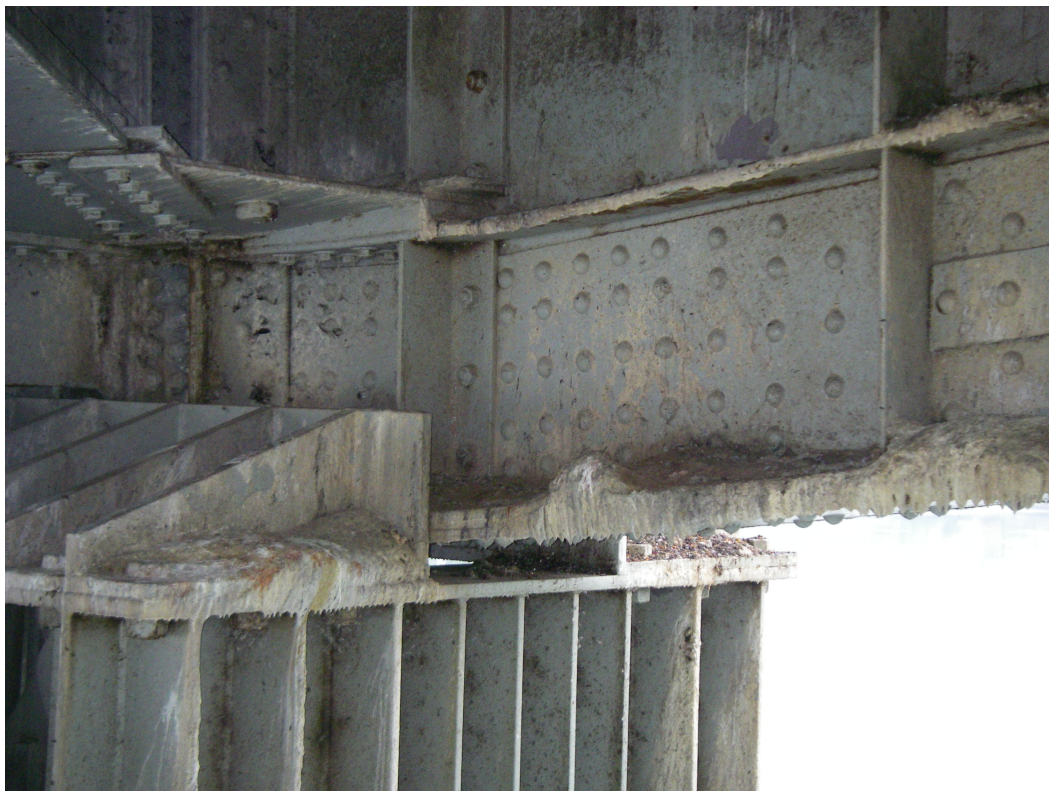
## SI-31

91 Steel Riveted Girder  
Photo Type: R - Repair  
Orientation: NE  
Date: 10/27/2008  
Repairs: 13779  
Typical Cormorant guano at panel points.

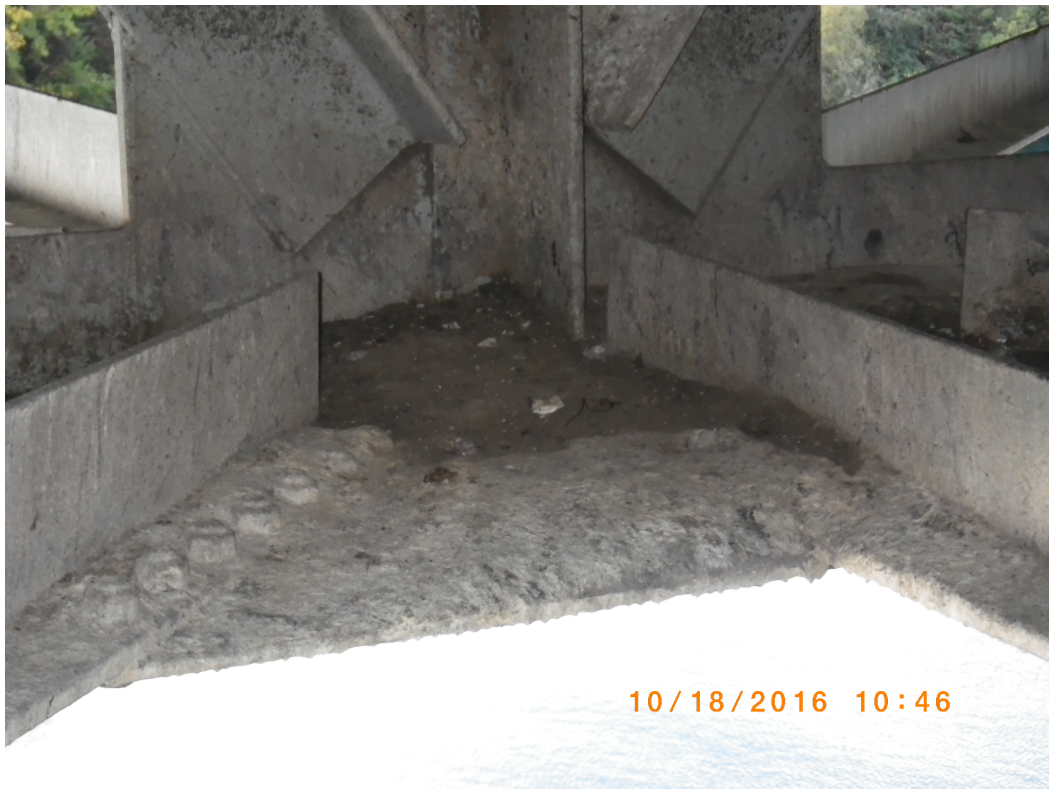
## SI-84

91 Steel Riveted Girder  
Photo Type: R - Repair  
Orientation: NW  
Date: 10/18/2016  
Repairs: 13779  
Mid-span lower sway brace connection on a typical floorbeam showing the amount of bird excrement buildup.

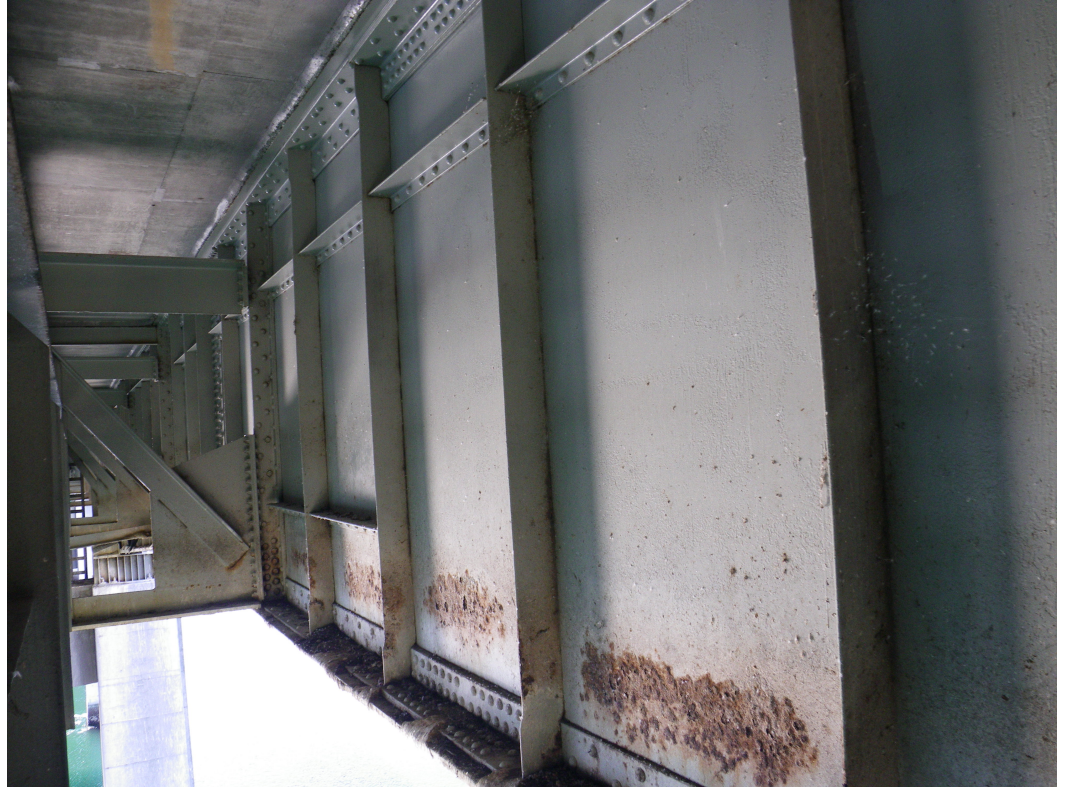
Girder 7A typical failed paint and laminar rust in webs.

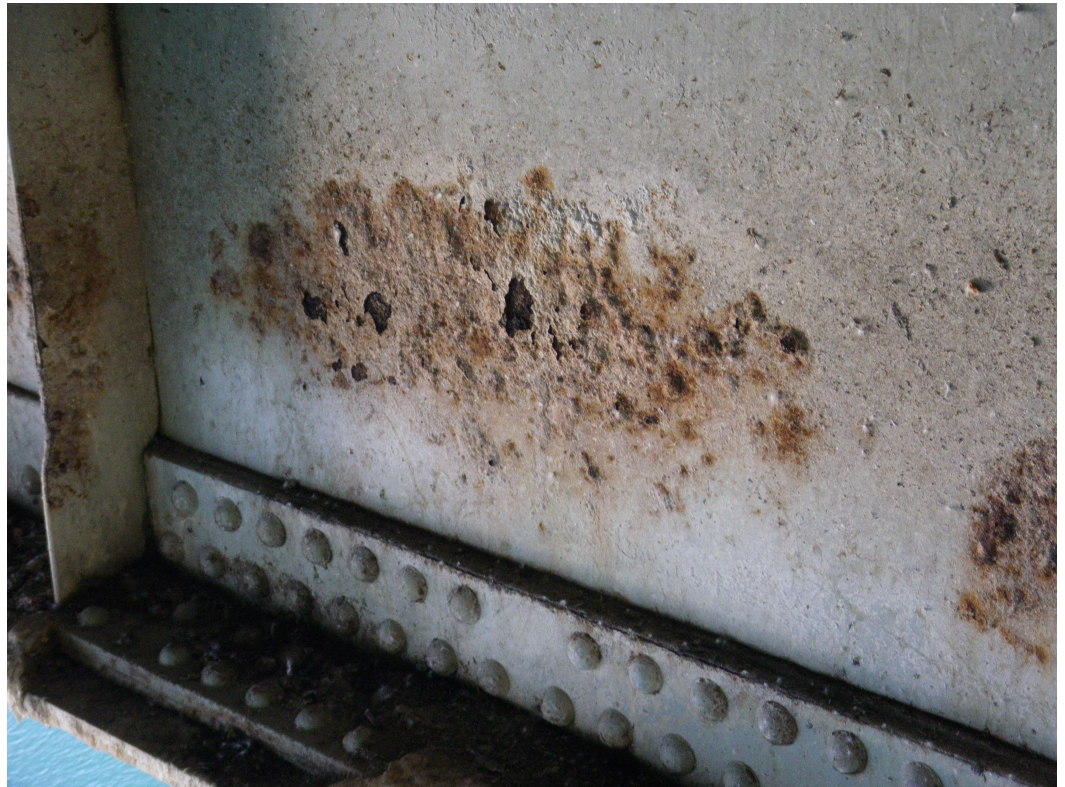
## SI-67

Close up of Girder 7A laminar rust under failed paint.

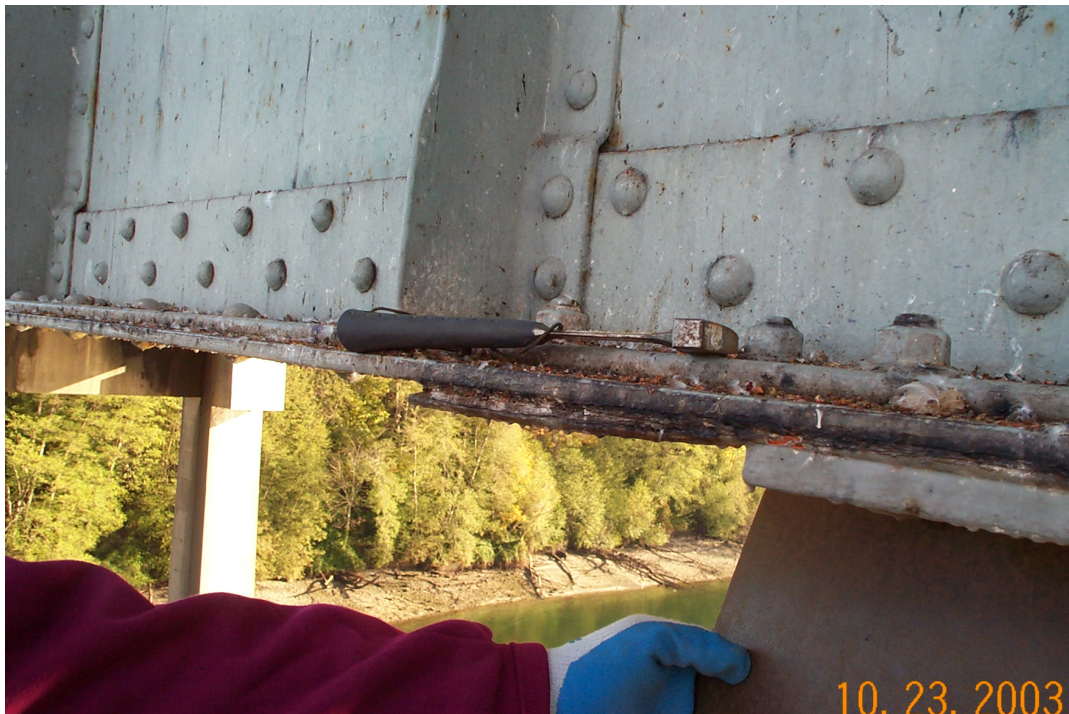
1/2" thick pack rust at bottom splice plate  
west girder in Span 7 .

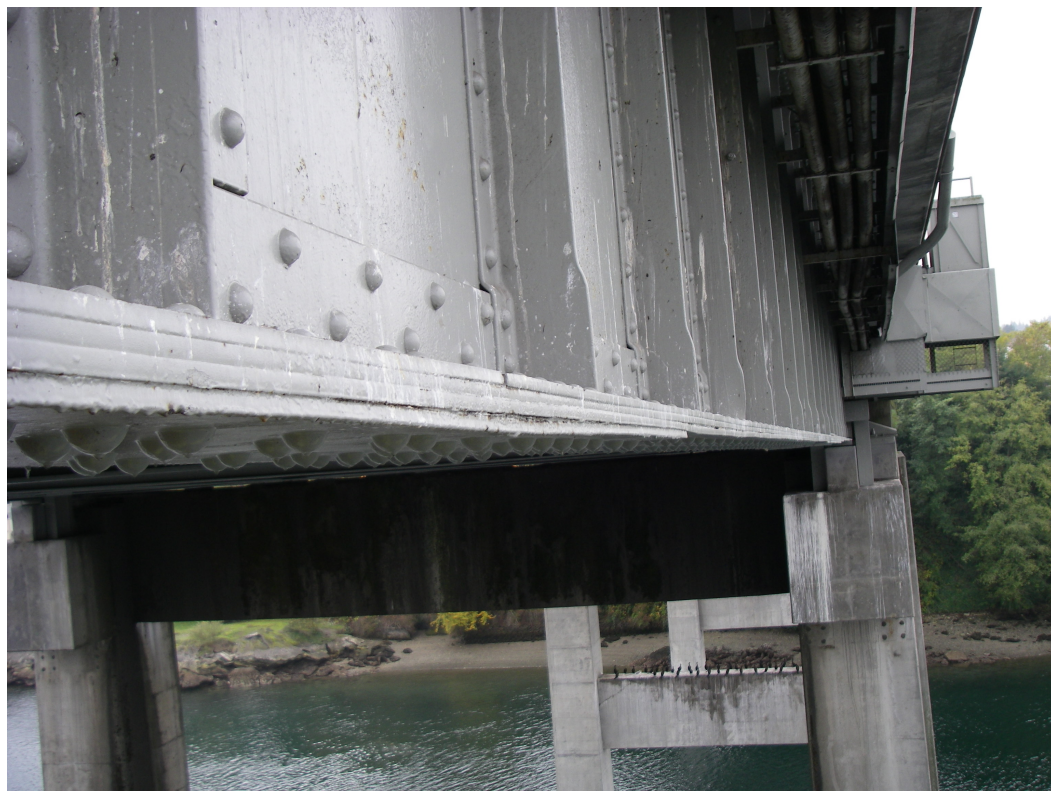
## SI-30

Typical pack rust between Girder cover  
plates in bottom flange.

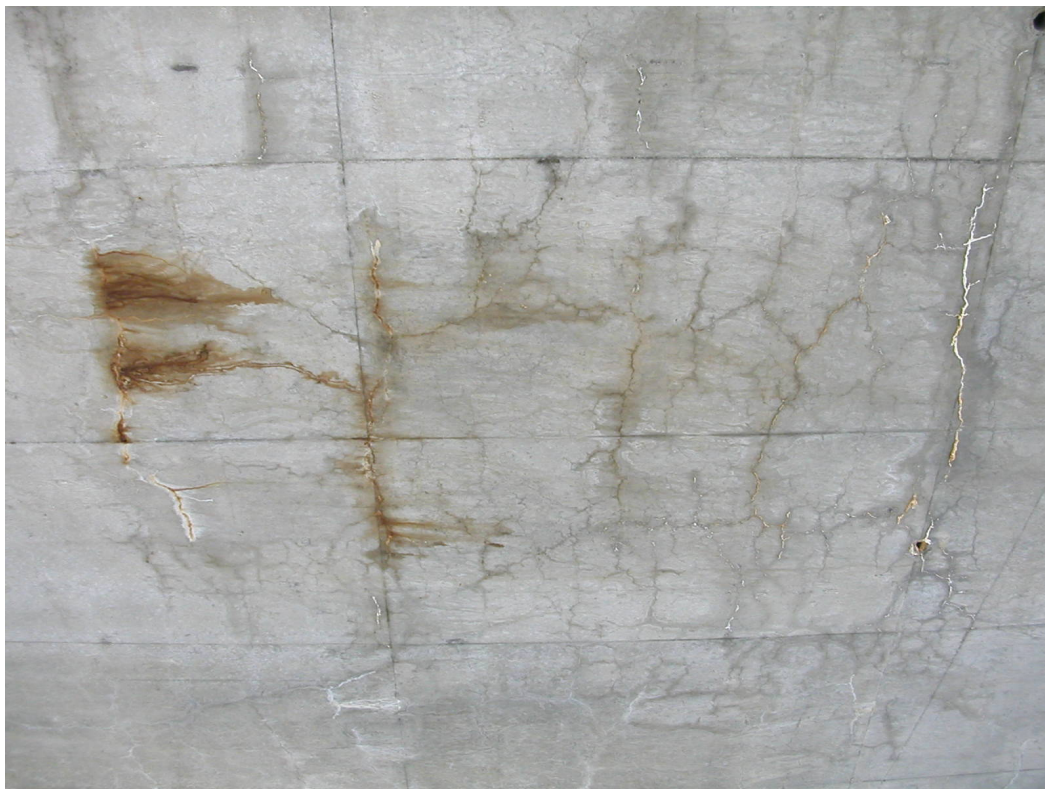
Areas of leaching cracks in Spans 8 and 9 due to plugged drain ports.

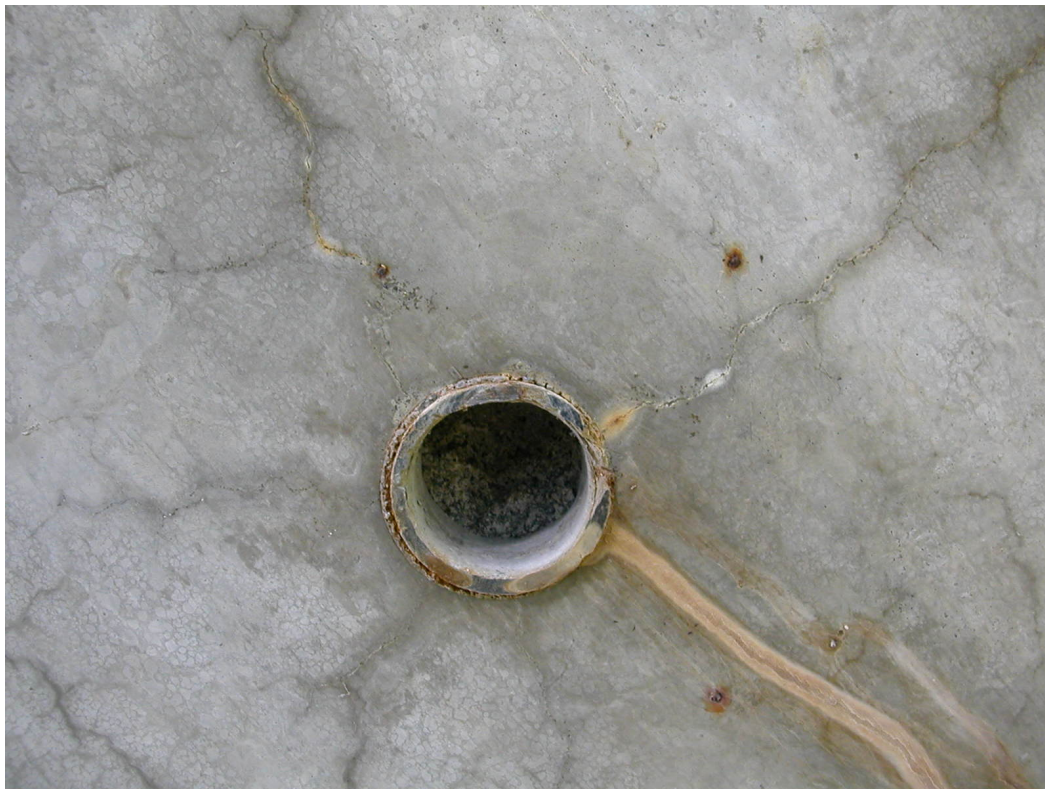
## MI-24

Plugged drain port (typical) in spans 8 and 9.

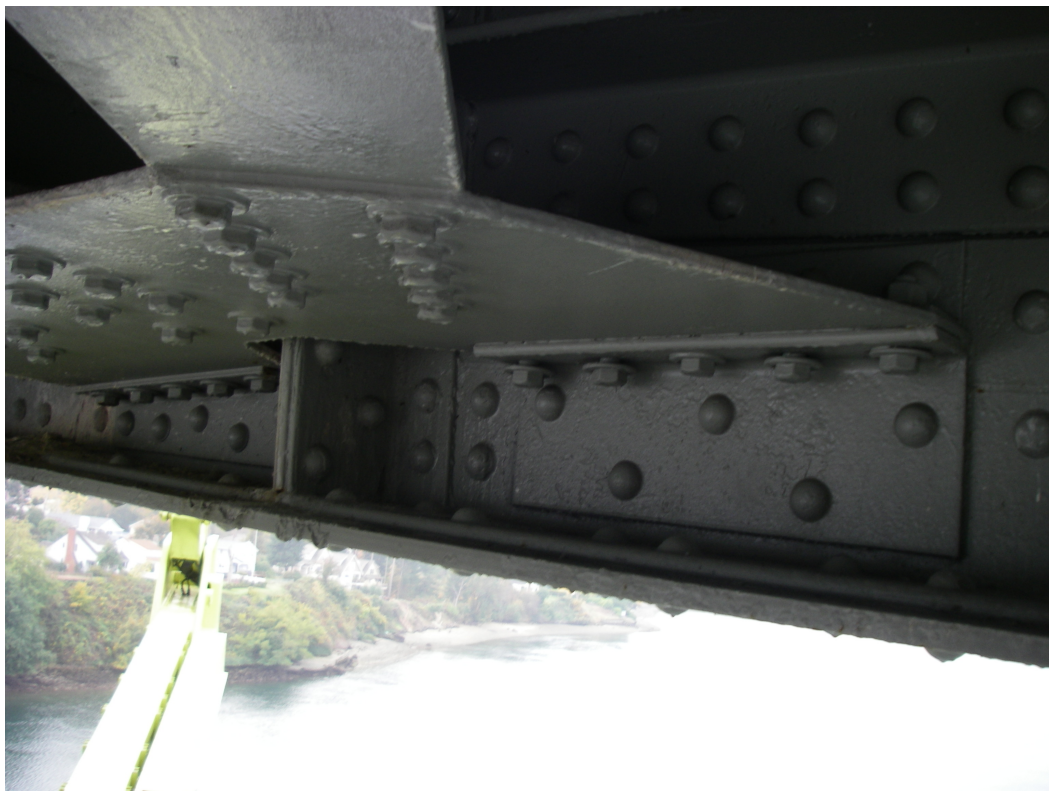
Loose bolts in Floorbeam 6/Girder 5A connection

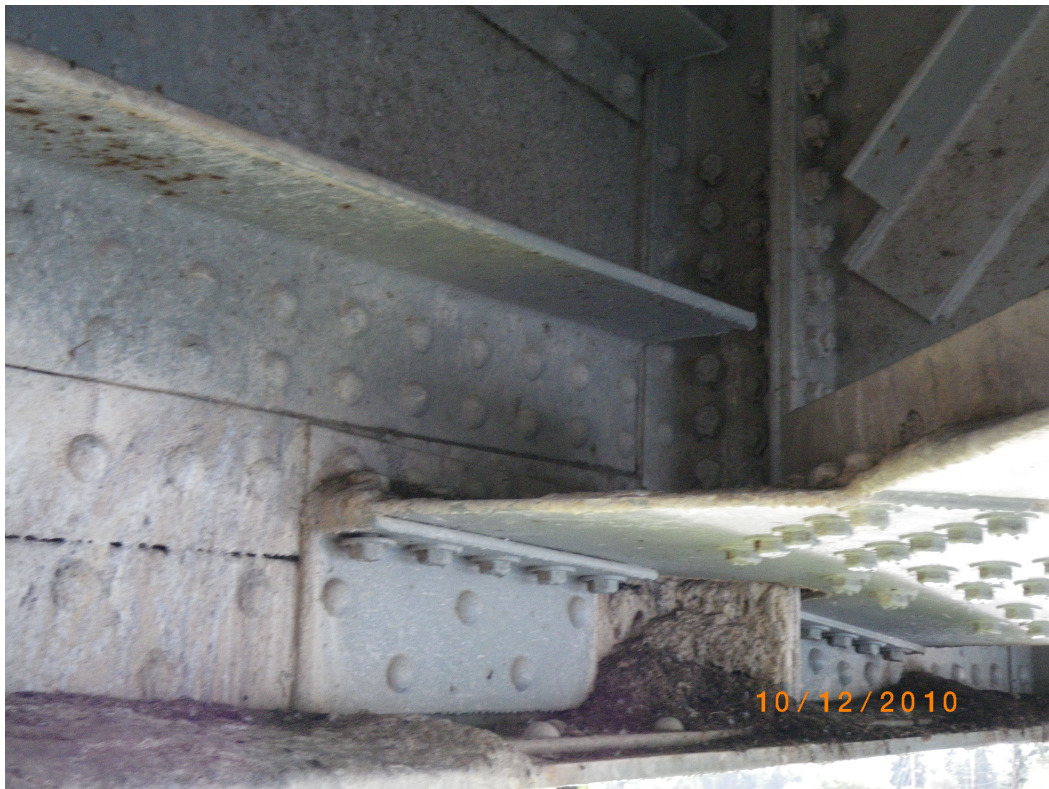
## SI-44

Loose bolt in Span 5 Floorbeam 6 lateral gusset to east girder.

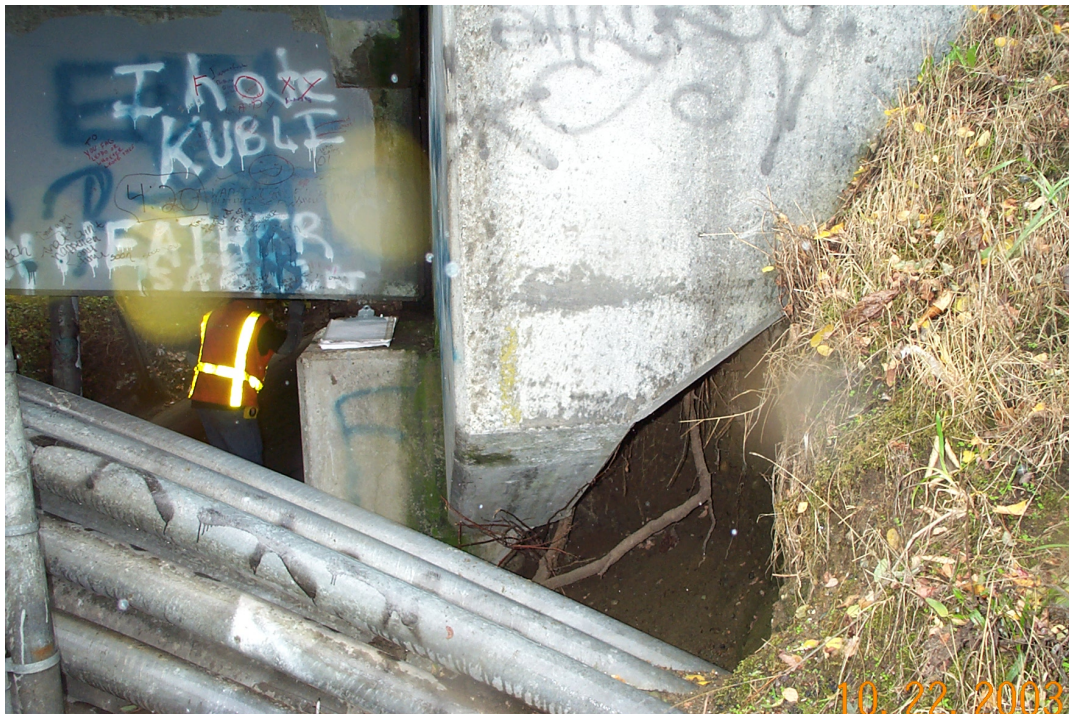
- 200 Pier 1 and Pier 16 have concrete slope protection in place.  
 On the west end of the south abutment wingwall there is a 3 ft. deep x 3 ft. wide x 6 ft. long erosion hole (Photo #13). REPAIR #13774.

Erosion under wing wall at west end of south abutment.

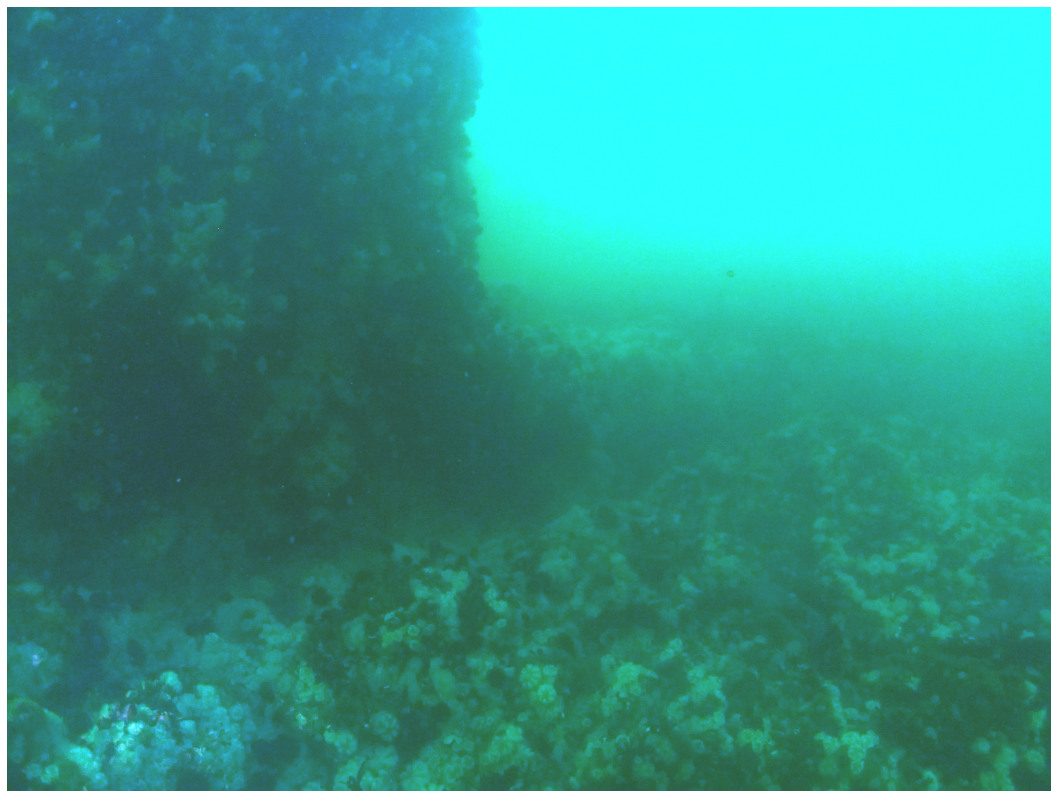
## UW-2

- 220 Underwater Inspection Findings:  
 Quantity includes the seven submerged footings that are exposed, Piers 3 through 9. All submerged concrete is heavily encrusted with marine growth (Photo #UW-2). All pedestal and footing top surfaces are very irregular and vary in elevation several feet. There are some steel cofferdam remains in place around the footings at Pier 4, 5 and 9. Pier 7 has some poor consolidation voids/lenses in the footing (CS3). REPAIR #14242.

Typical heavy marine growth on submerged surfaces.

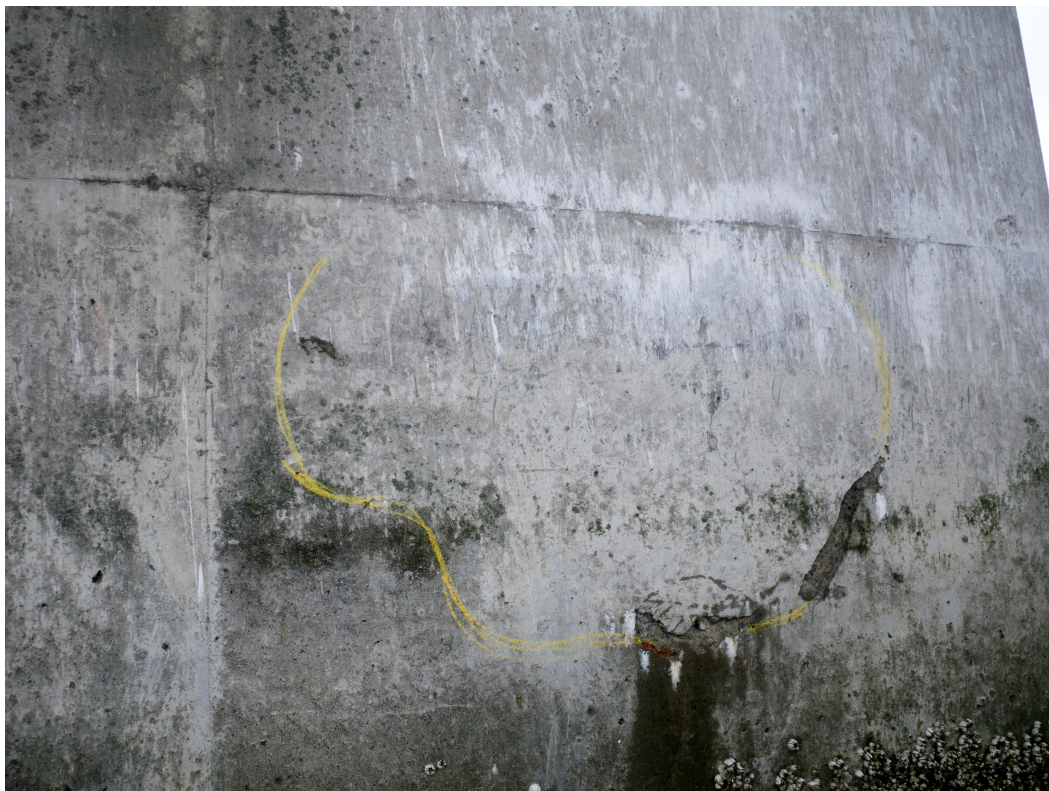
Pier 6, Column A, east face; 3-ft x 2-ft delam/spall just above the ITZ.

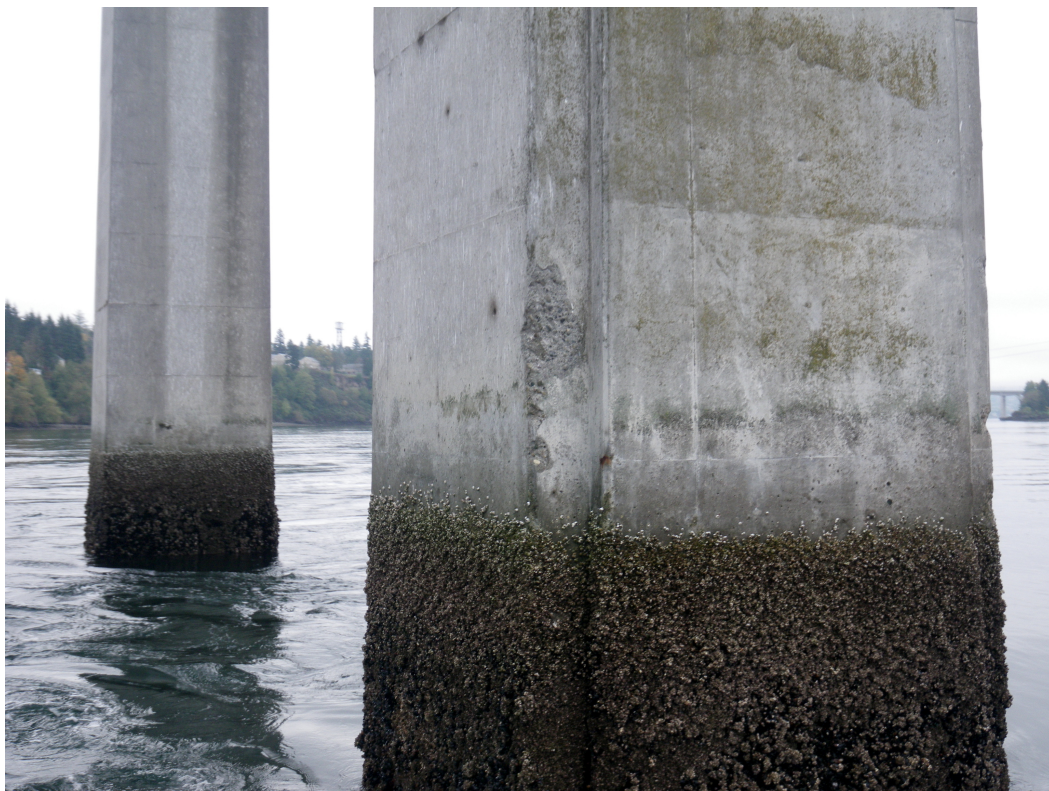
## UW-4

Pier 7, Column A, NW corner; shallow impact spalls. Typical of other corners on Pier 7 columns.

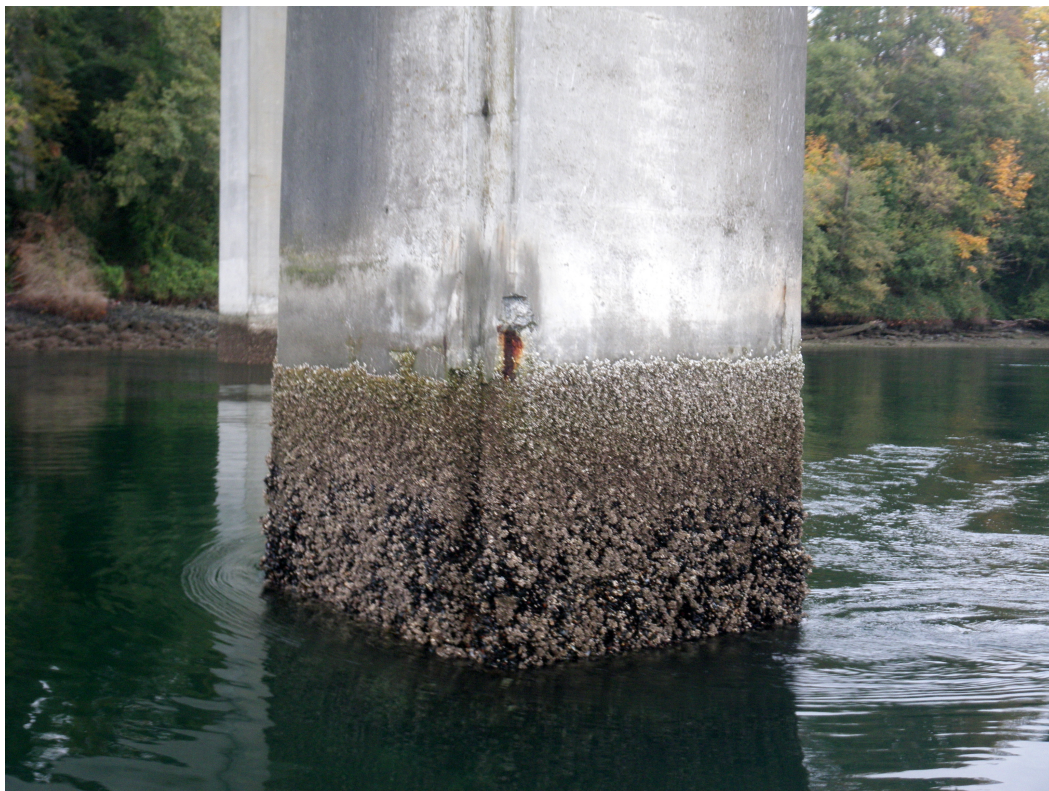
- 221 Top corner of footings are spalled away 2" deep.
- 227 Piers 2-10 included in quantity.  
 Piers 3, 4, 5 and 6 struts have diagonal leaching cracks.  
 Pier 6 Column A, east face has a 3-ft x 2-ft delaminated area just above the intertidal zone (Photo #UW-3).  
 Pier 7 outside corners have shallow impact spalls just above the intertidal zone (Photo #UW-4).  
 Pier 8 columns have vertical cracks up to 4 ft. long in the intertidal zone. Some are delaminated with rust staining. The SW corner of Column A has spalled, exposing the corner vertical rebar (Photo #UW-5).

Pier 8, Column A, SW corner; spalled corner with exposed rebar. Other Pier 8 corners have vertical cracking with rust staining.

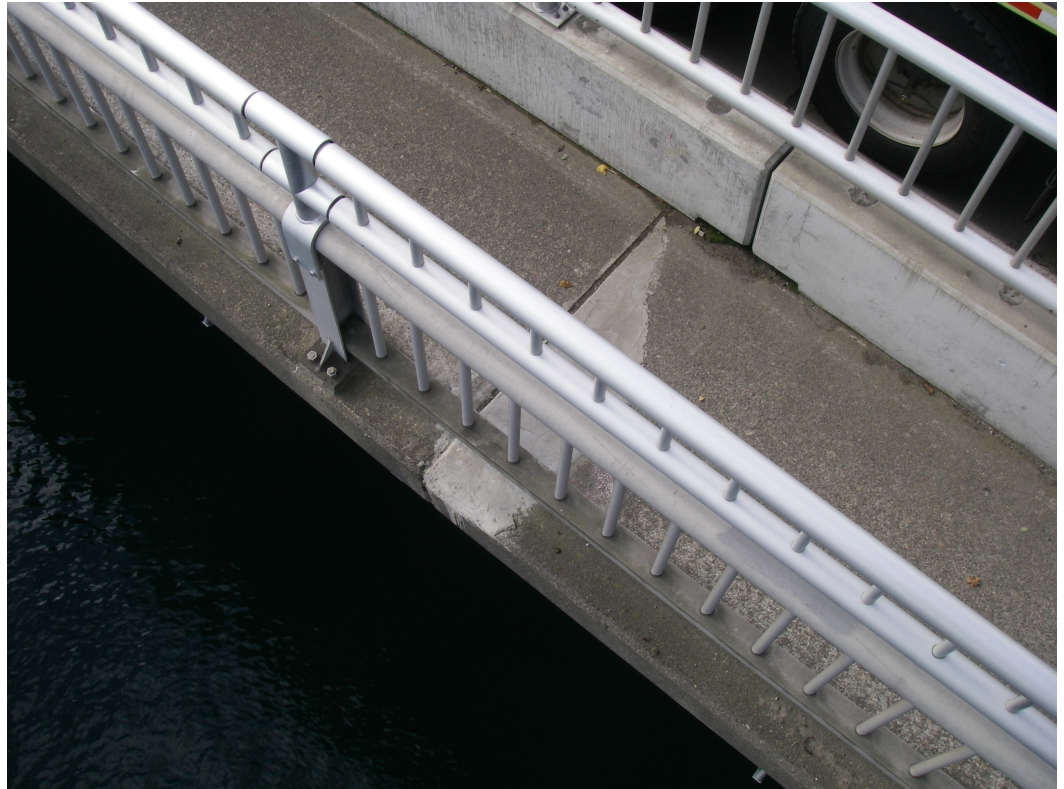
- 266 The sidewalk joints have some 'D' spalls and the surface has scattered transverse cracks. Near the floorbeams the surface has been patched in several locations (Photo #77).  
 The overhangs of the box girder spans have transverse leaching cracks with some showing rust stains.  
 In the west overhang of Span 5 near Piers 5 and 6 there are a couple of spalls with 2 ft. of exposed rebar.  
 Span 5 east sidewalk edge near Floorbeam 1 has an 18" diameter spall with exposed rebar.  
 Span 7 east overhang has 2 sq. ft. of spalls/delaminations.  
 Span 16 west corbel has 3 ft. x 6" x 6" spall with exposed rebar.

Patched sidewalk at Span 5 Floorbeam 6 east. (Typical at many locations)

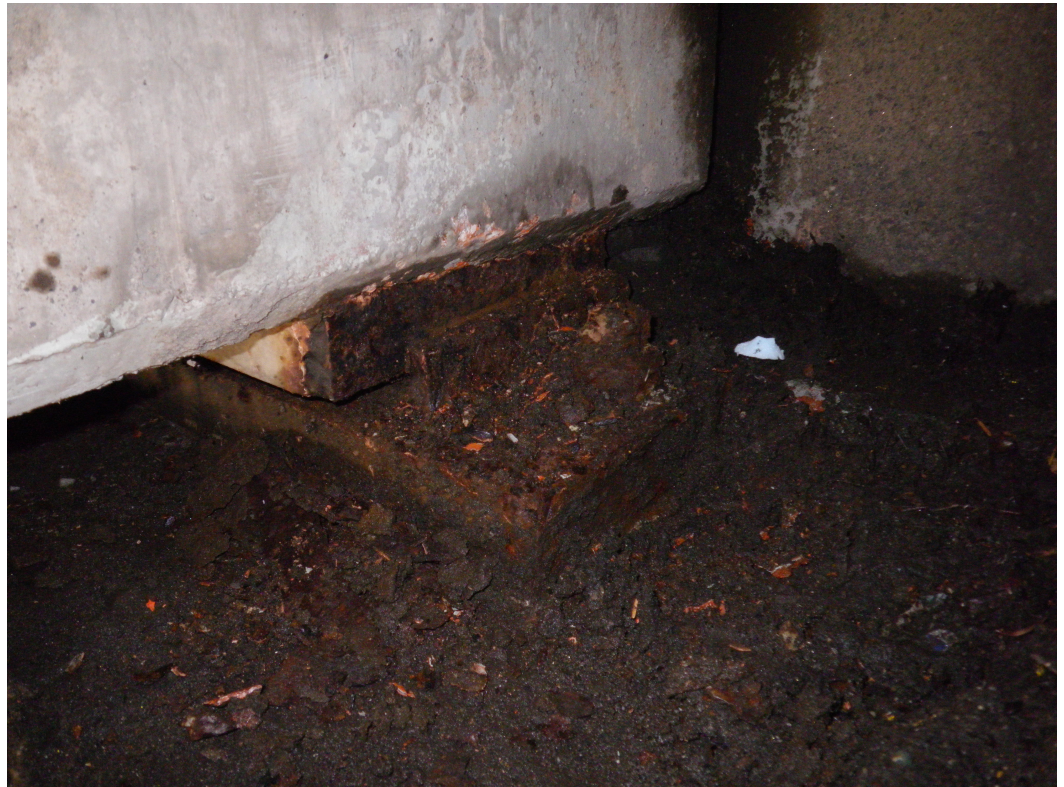
## SI-56

- 310 Elastomeric bearings are at Piers 5 and 8.  
 The grout under the bearings have some vertical leaching cracks.
- 311 Sliding bearings for the concrete spans are at Piers 1, 2, 11, and 16 have moderate to severe laminar rust with minor section loss to masonry plates. The nuts have moderate section loss as well. The worst location is at Pier 16 (Photo #56). REPAIR #14234.  
 The bearings are typically covered with debris from the roadway above (Photo #25). REPAIR #14234.

Typical bearing at Pier 16.

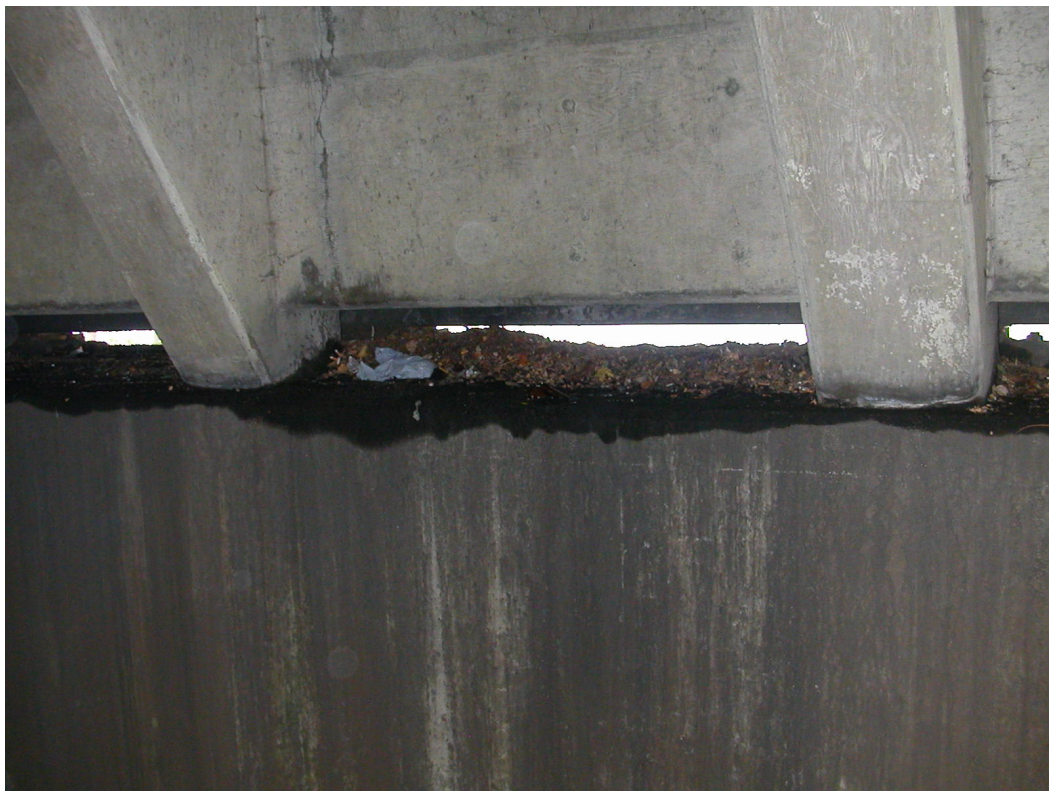
## MI-25

311 Moveable Bearing (roller, sliding, etc)  
Photo Type: R - Repair  
Orientation: N  
Date: 10/23/2006  
Repairs: 14234  
Debris on Pier 2 cap.

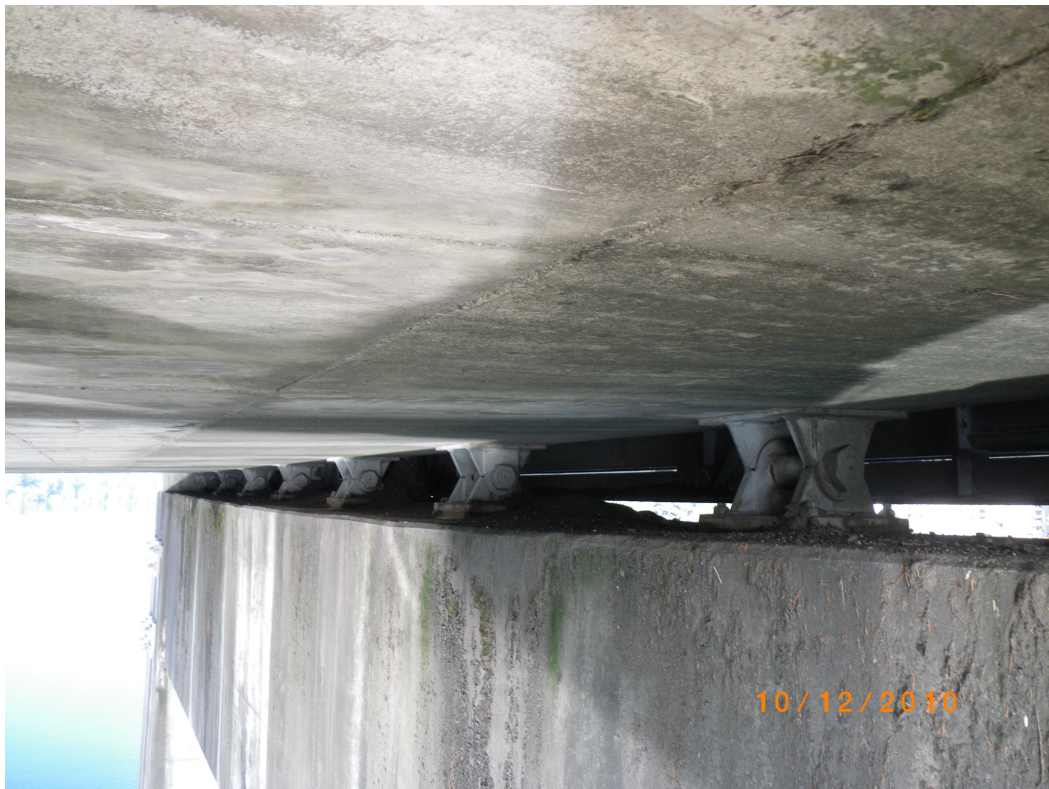
## SI-50

313 Fixed Bearing  
Photo Type: G - General  
Orientation: NW  
Date: 10/13/2010  
Repairs:  
Pier 5 bearings are covered with debris.

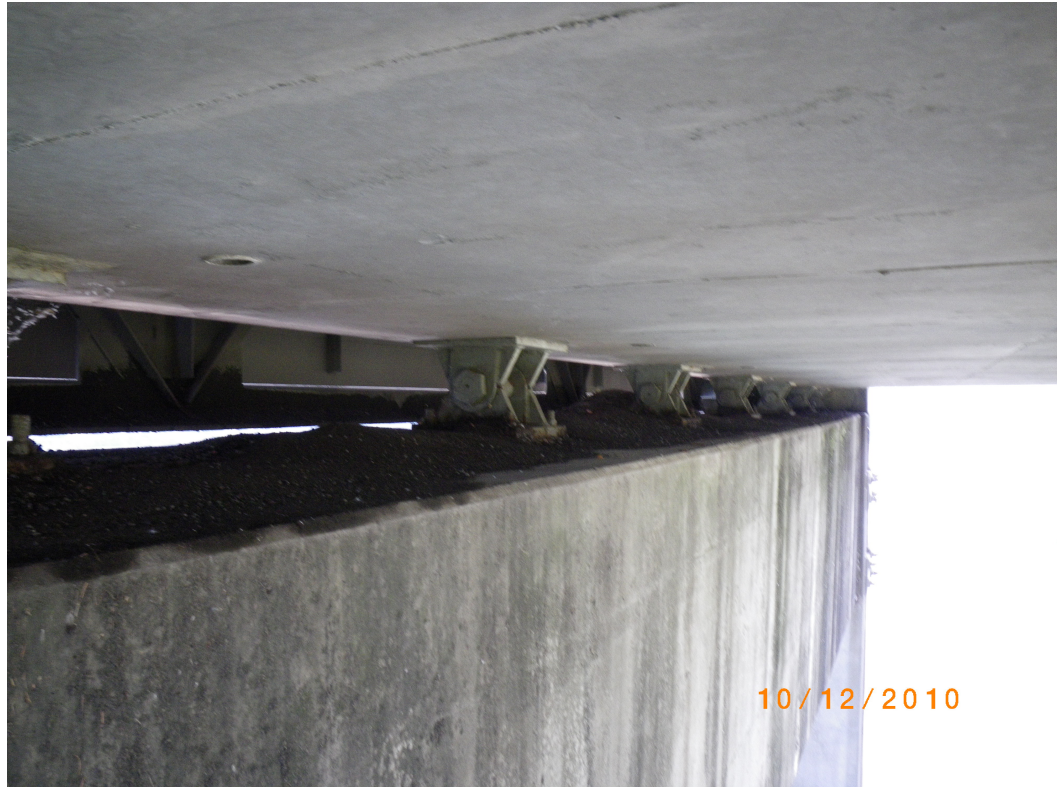
## SI-46

313 Fixed Bearing  
Photo Type: G - General  
Orientation: W  
Date: 10/13/2010  
Repairs:  
Pier 8 bearings are covered with dirt.

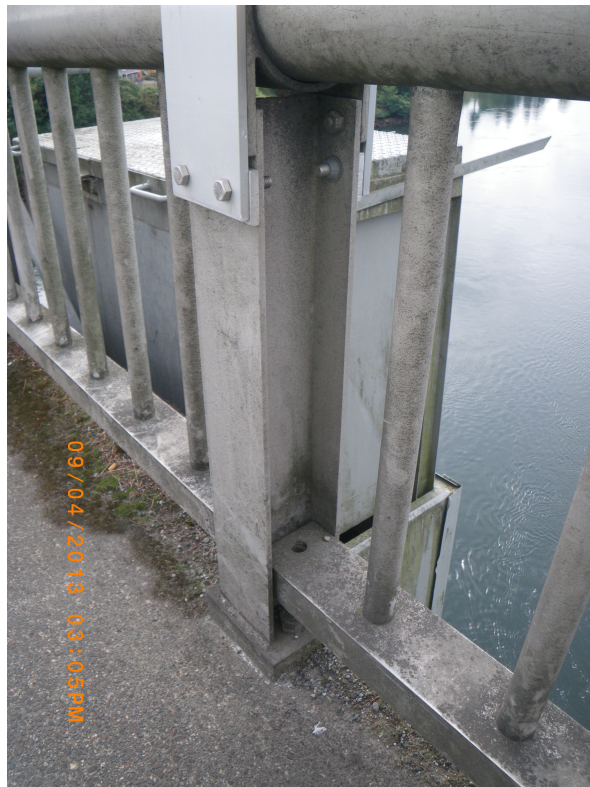
## SI-75

340 BP rails installed on top of bridge rail.  
 Pedestrian railing is missing a nut and bolt at the following locations:  
 Span 4 west side lower connection.  
 Span 5 west side lower connection.  
 (Photo #75) REPAIR #14238

340 Metal Pedestrian Railing  
Photo Type: R - Repair  
Orientation: SW  
Date: 9/4/2013  
Repairs: 14238  
Pedestrian railing Span 5 west side.

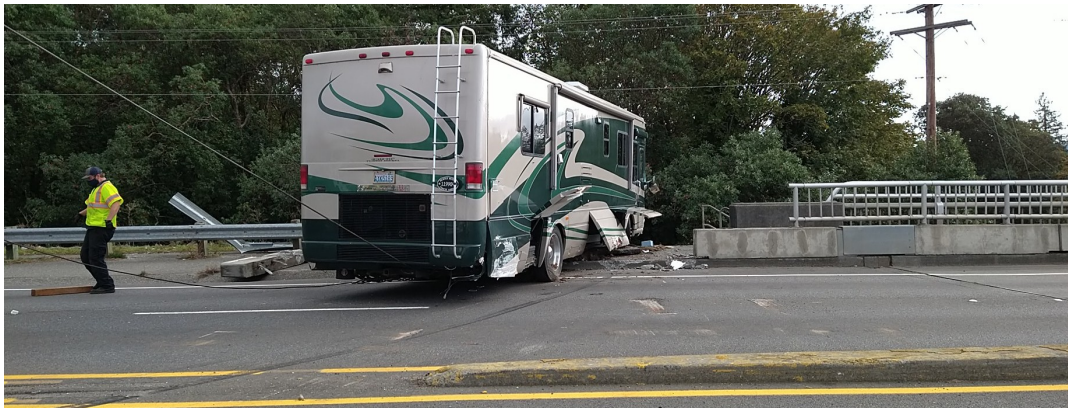
The east pedestrian rail just off the bridge was damaged due to an errant vehicle at the north end over an approximate 10 ft. length.  
 See photos #91, #92, and #93. REPAIR #14245.

Errant vehicle damaged the northeast corner guardrail, transition and pedestrian rail.

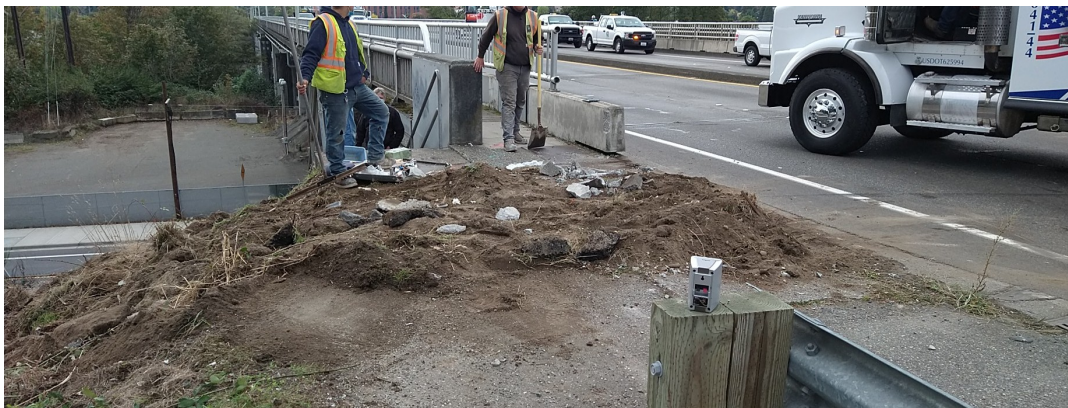
## SI-92

The northeast corner guardrail, transition and pedestrian rail are heavily damaged over approximately 30 ft.

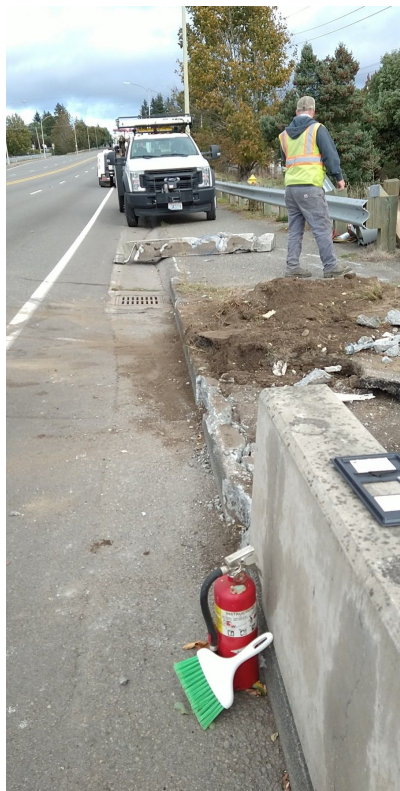
The northeast corner guardrail, transition and pedestrian rail are heavily damaged over approximately 30 ft.

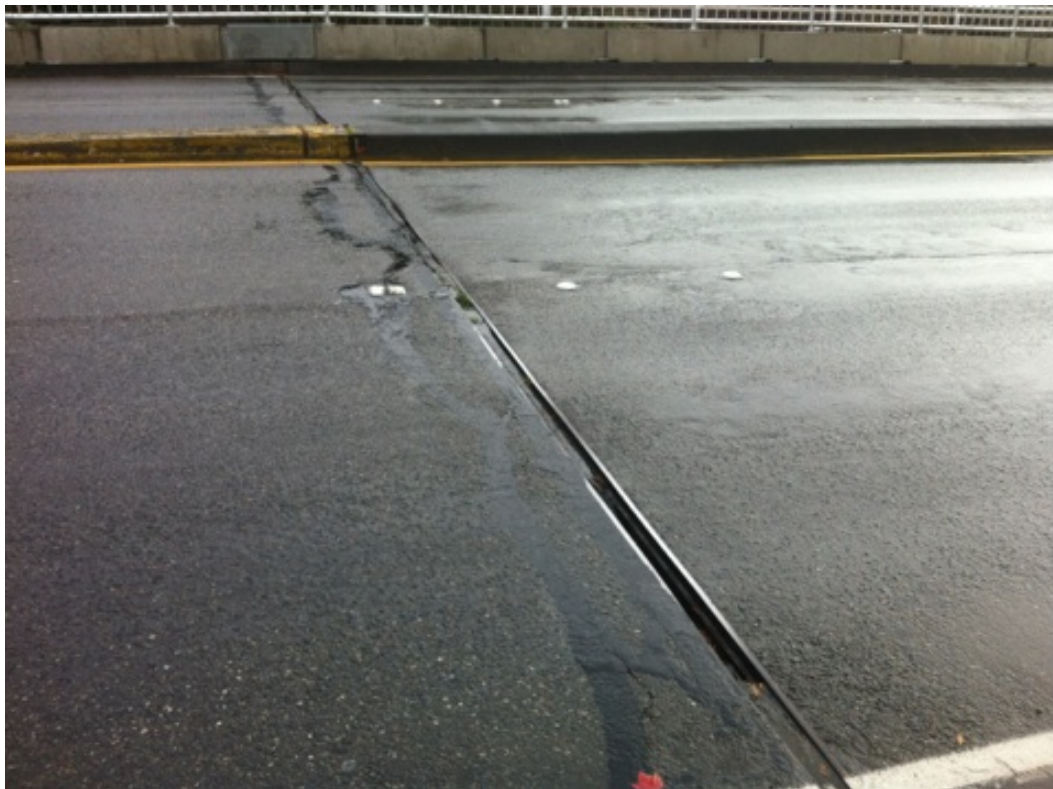
## SI-83

Pier 16 is missing the strip seal (Photo #83). REPAIR #14241.

Missing strip seal at Pier 16 SB lanes.

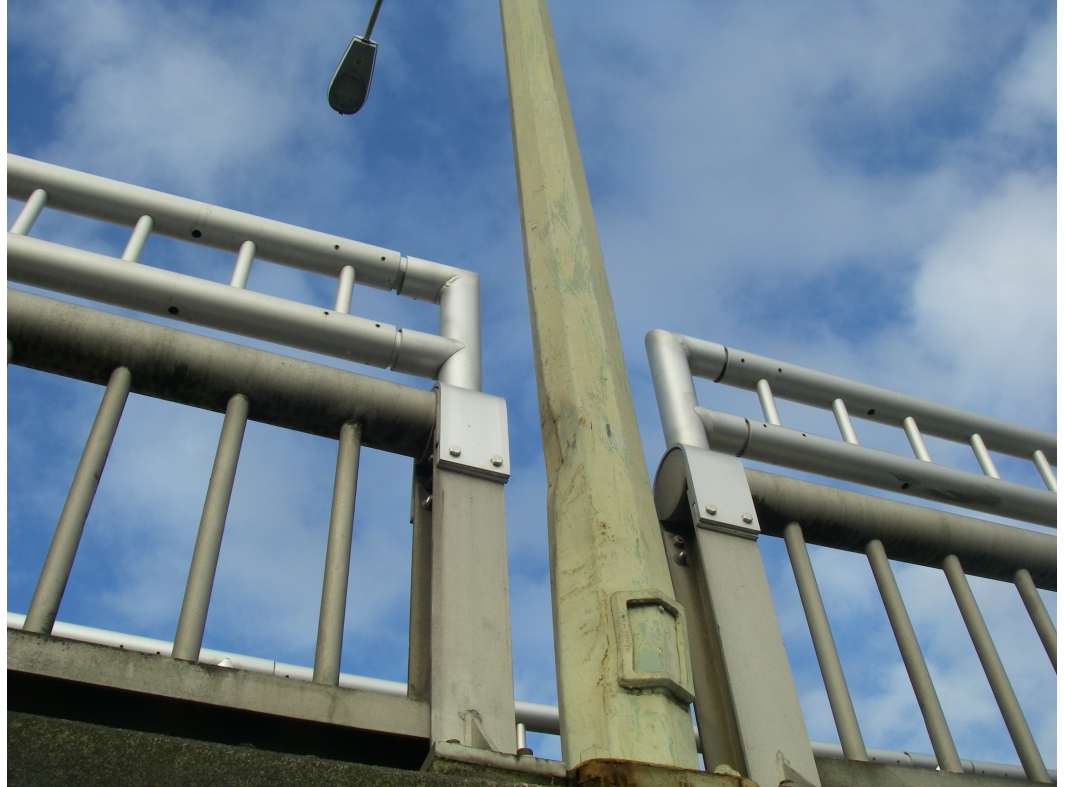
Luminaire Pole near Pier 3 east has minor impact damage, (Photo #76).

Luminaire near Pier 3 east has impact damage.
