## BRIDGE INSPECTION REPORT

Br. No. 303/12

Br. Name PORT WASHINGTON CS1840

Intersecting PORT WASHINGTON NARROWS

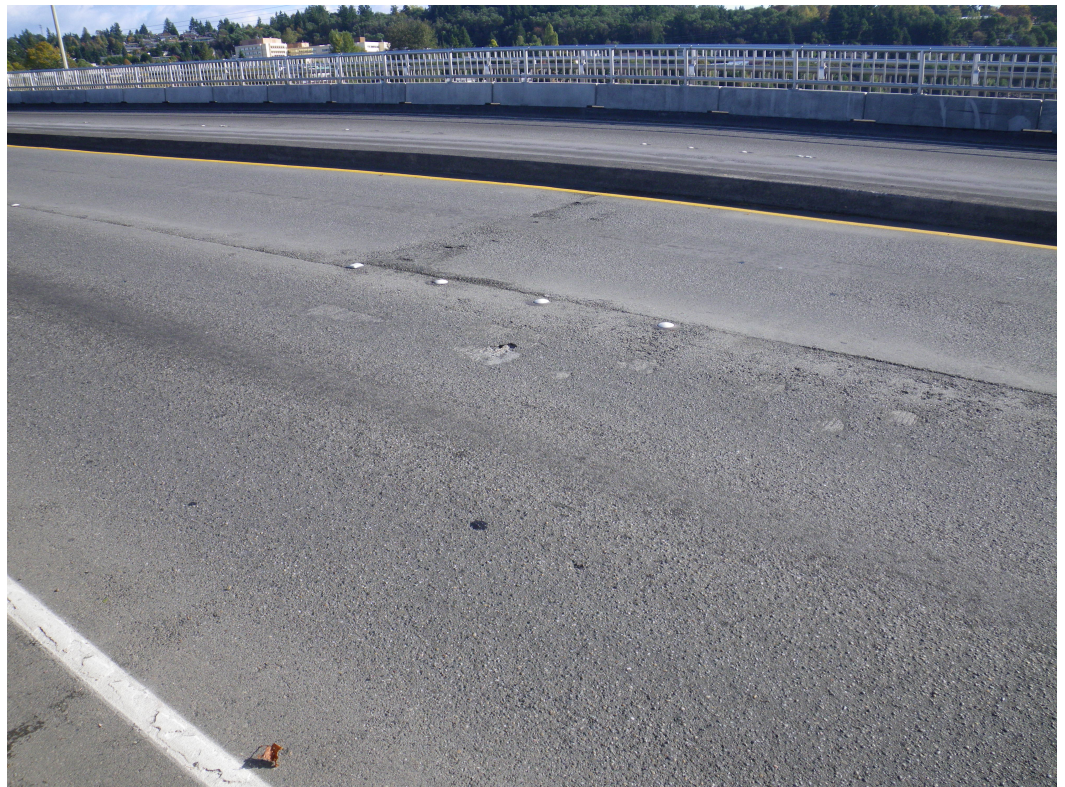
## SI-59

Span 3 near Pier 4 has a 1 ft. diameter spall with exposed rebar (Photo #59). REPAIR #14240.

Span 3 SB spall with exposed rebar.

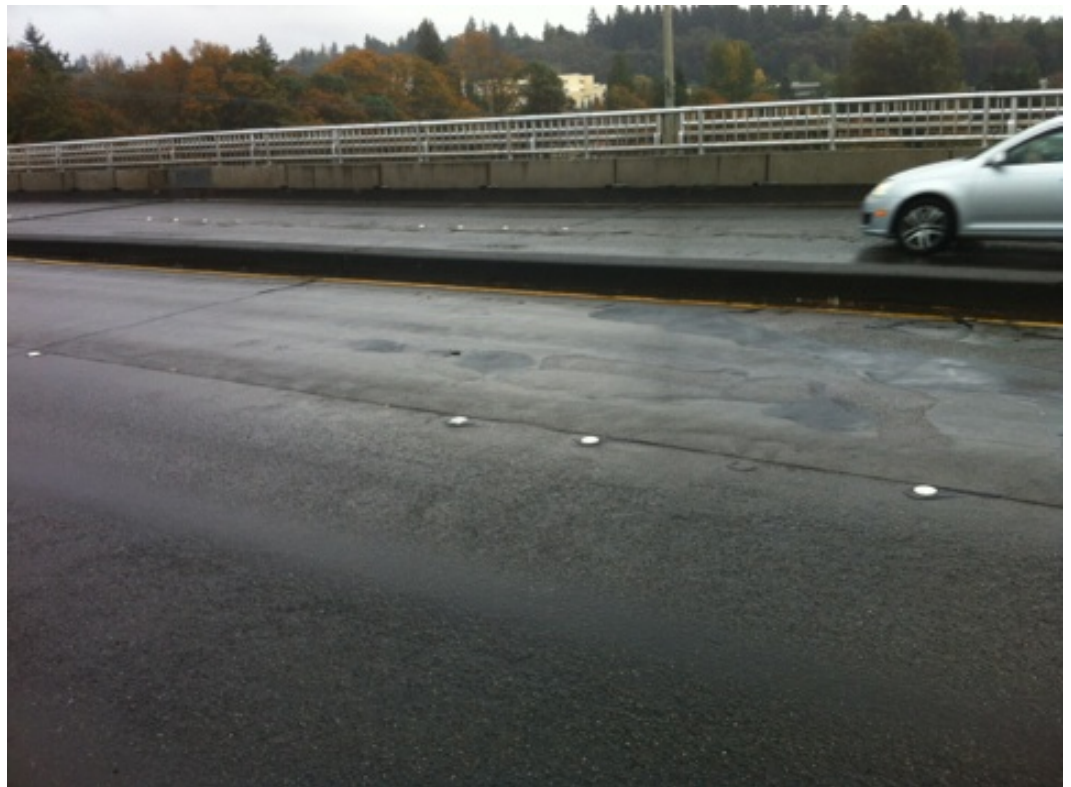
## SI-81

Panel 3 has 95 sq. ft. of patches and a 1 ft. diameter spall (Photo #81). REPAIR #14240.

804 Polyester Concrete Overlay  
Photo Type: R - Repair  
Orientation: NE  
Date: 10/28/2014  
Repairs: 14240  
Span 7 Panel 3 SB patches and spall.

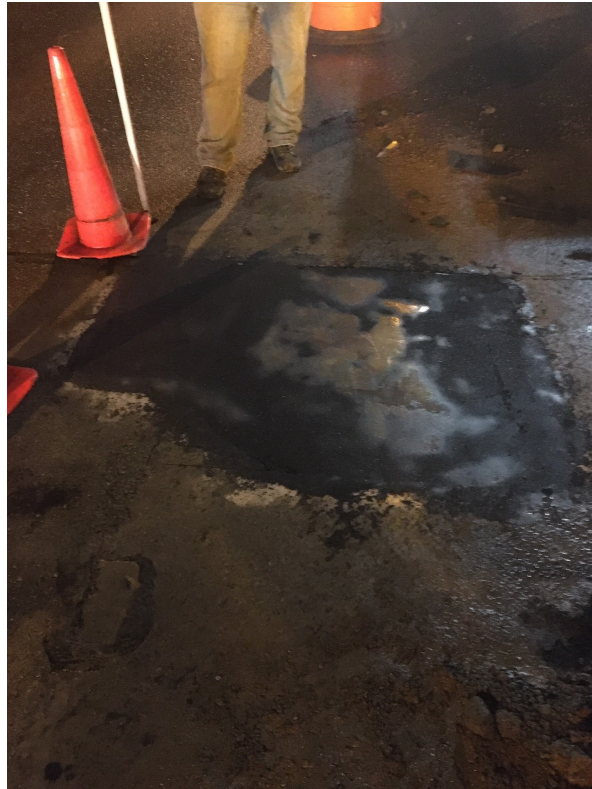
Span 7 Panel 3 SB 3' x 4' patched spall  
at south joint right lane.

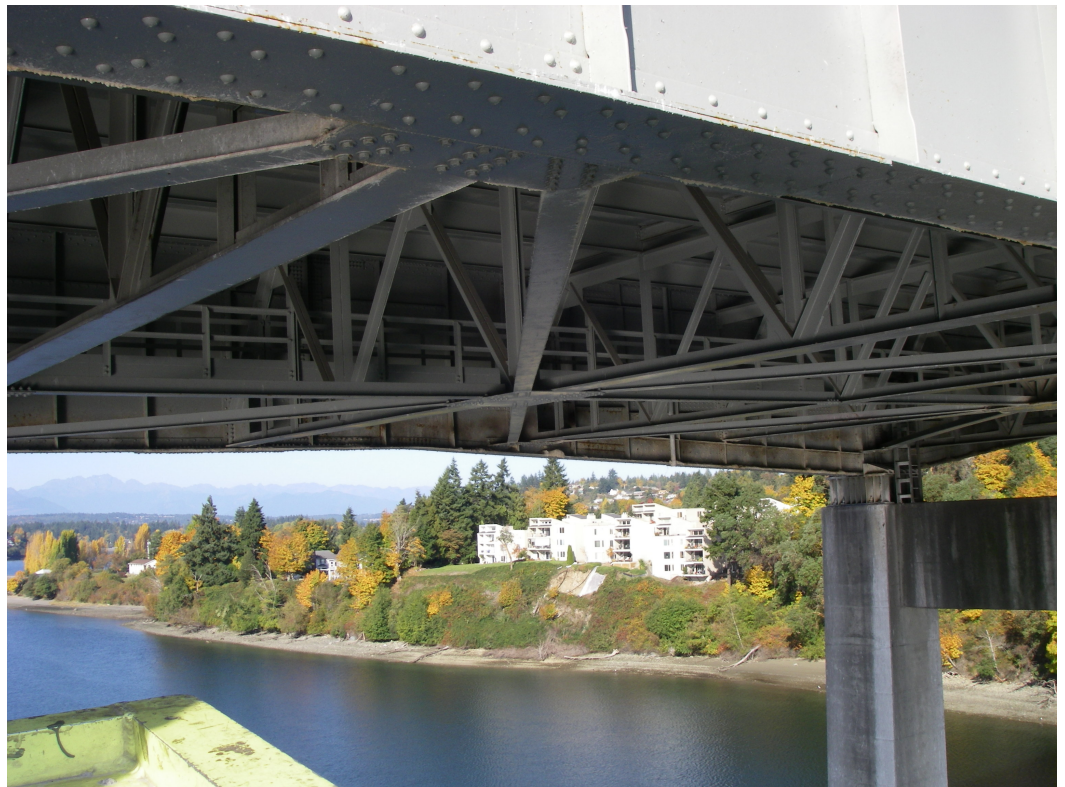
## SI-27

902 Paint has failed over lower third of Spans 6 and 7 typically where cormorants perch.

Typical paint condition.

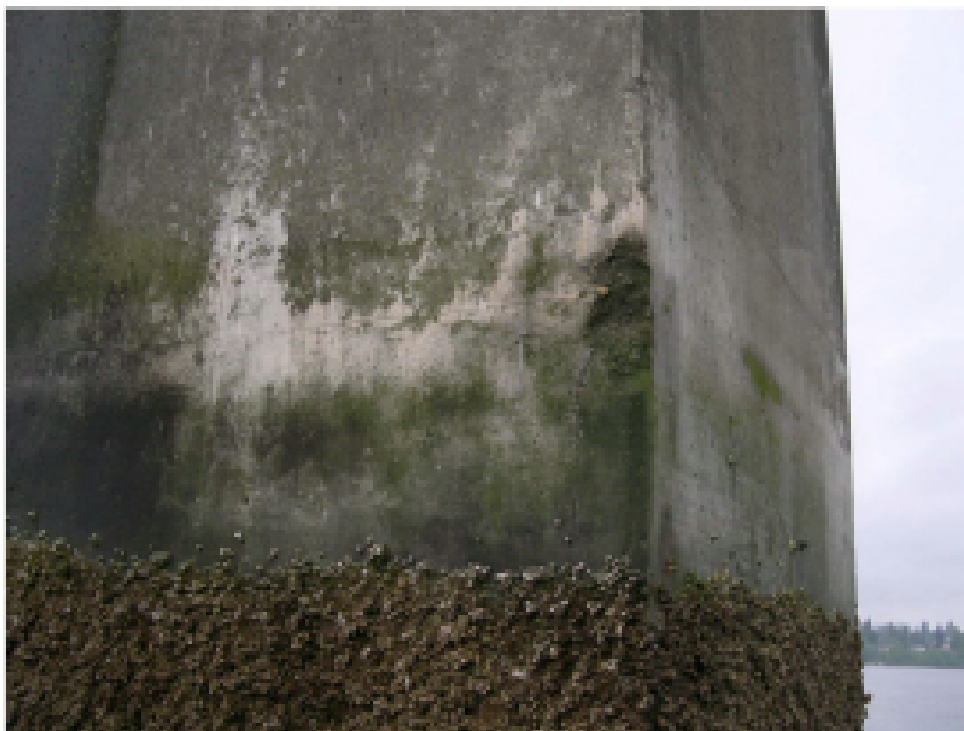
Photograph 2 : Corner spall and cracking on Column 8A, NE corner. All 4 corners of this column have vertical cracking in the ITZ.

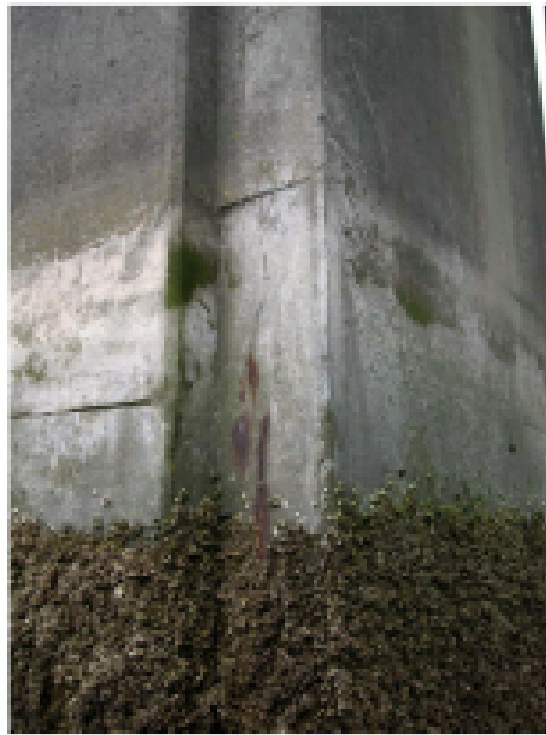
Photograph 3 : Column 8B, NE corner. Vertical cracking with rust bleed-through.

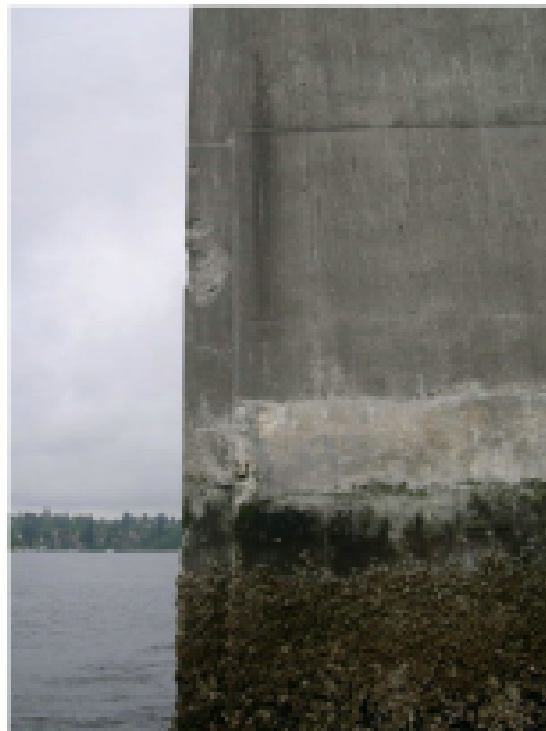
Photograph 4 : Impact spall on SE corner of Column 7B. Column 7A, NW and SW corners are similar.

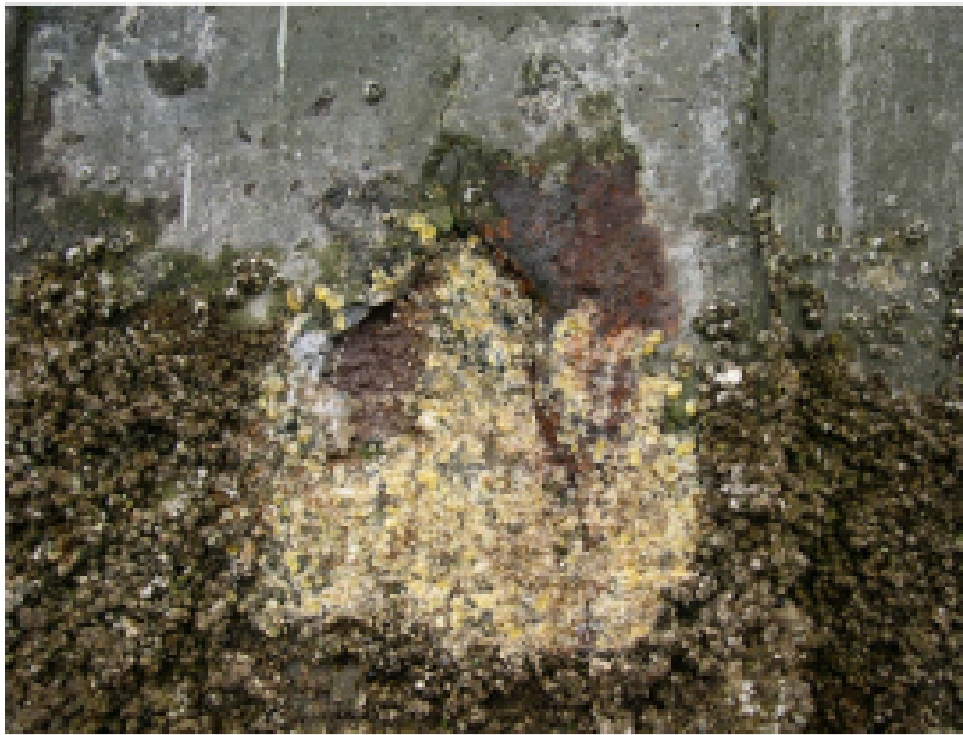
Photograph 5 : Level II cleaning at Column 5B, SE corner. Shallow delamination with rust bleeding.

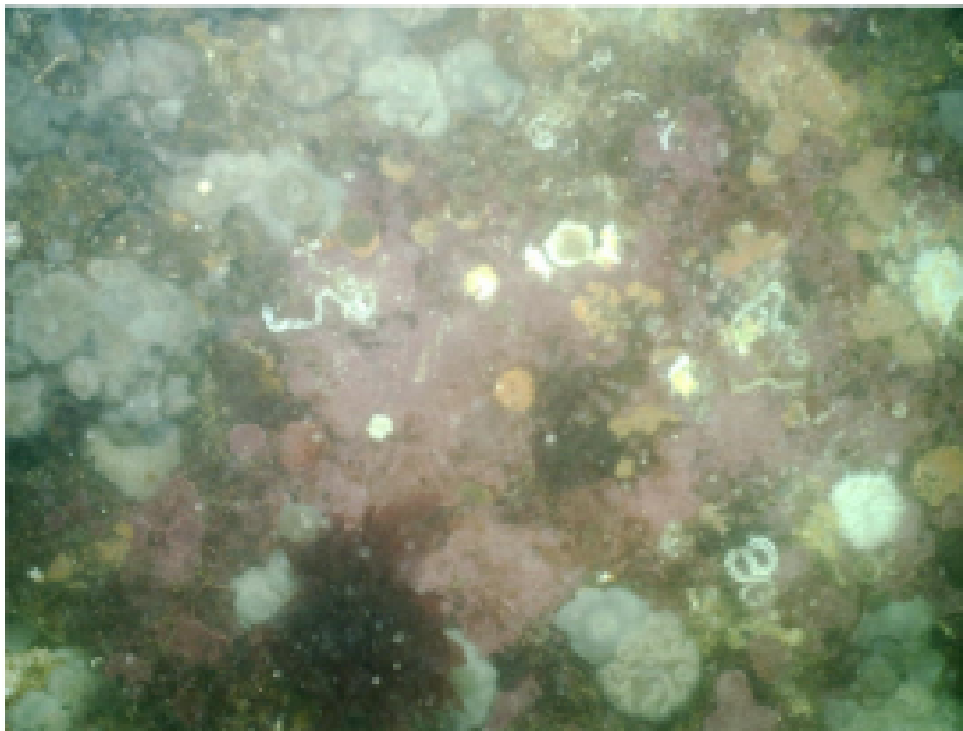
Photograph 6 : Typical moderate marine growth area after Level II cleaning. Submerged concrete portions were generally found to be hard and tight.
