**Washington State
Department of Transportation
Bridge Preservation Dive Team**

UNDERWATER INSPECTION REPORT FOR

PORT WASHINGTON CS1840

BRIDGE NO. 303/12

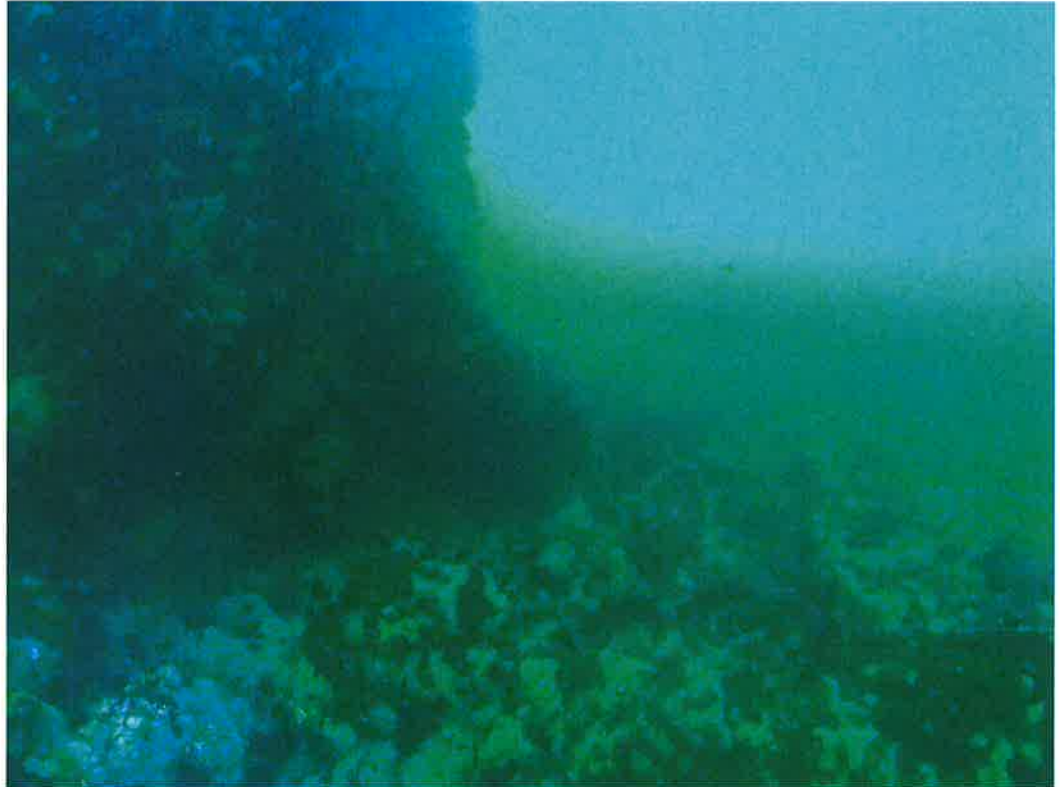
UW-2

Typical heavy marine growth on submerged surfaces.

Repair No	Pr	R	Repair Description	BMS	Noted	Maint	Verified
14242	1	S	Design and install scour countermeasures for all submerged piers to rebuild the channel bottom around the piers back to original design plans.	361	10/9/2018

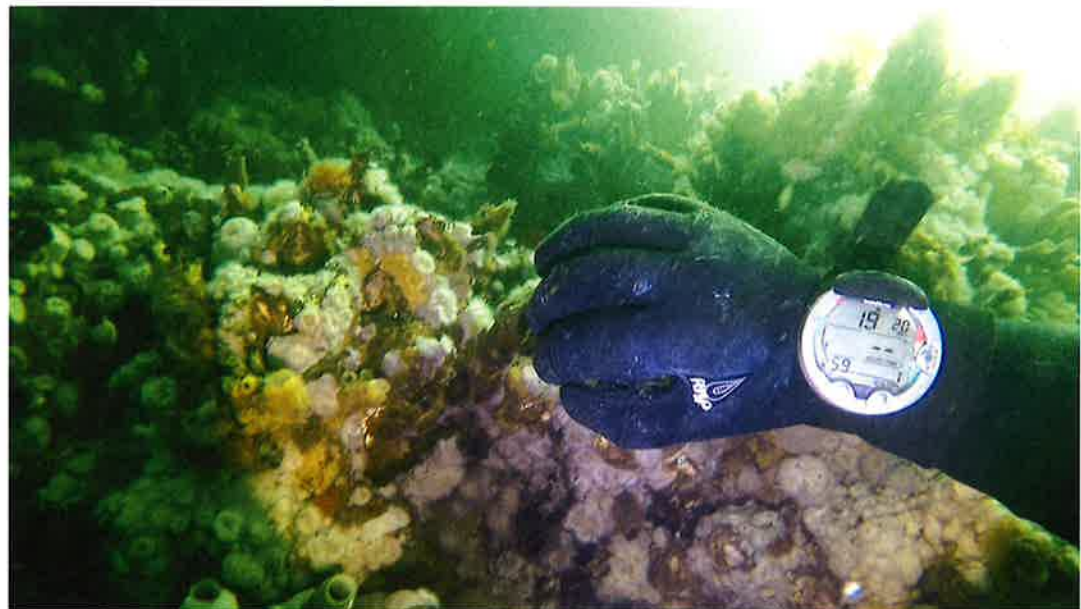
UW-7

Pier 8 top of footing showing typical heavy marine growth on submerged surfaces.

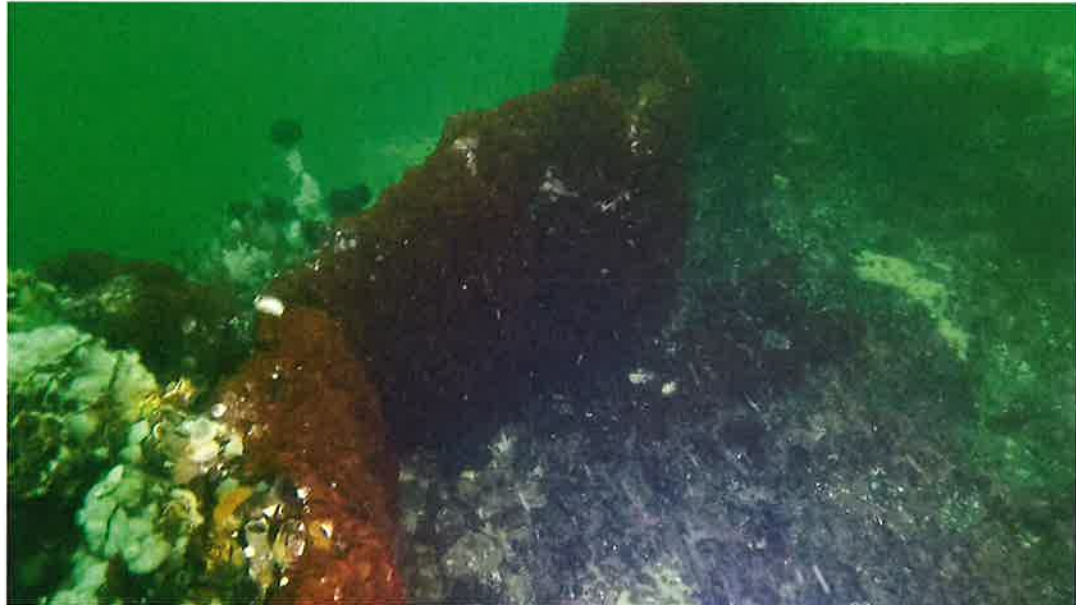
UW-8

North face Pier 4 top of footing and sheet pile cofferdam remains.

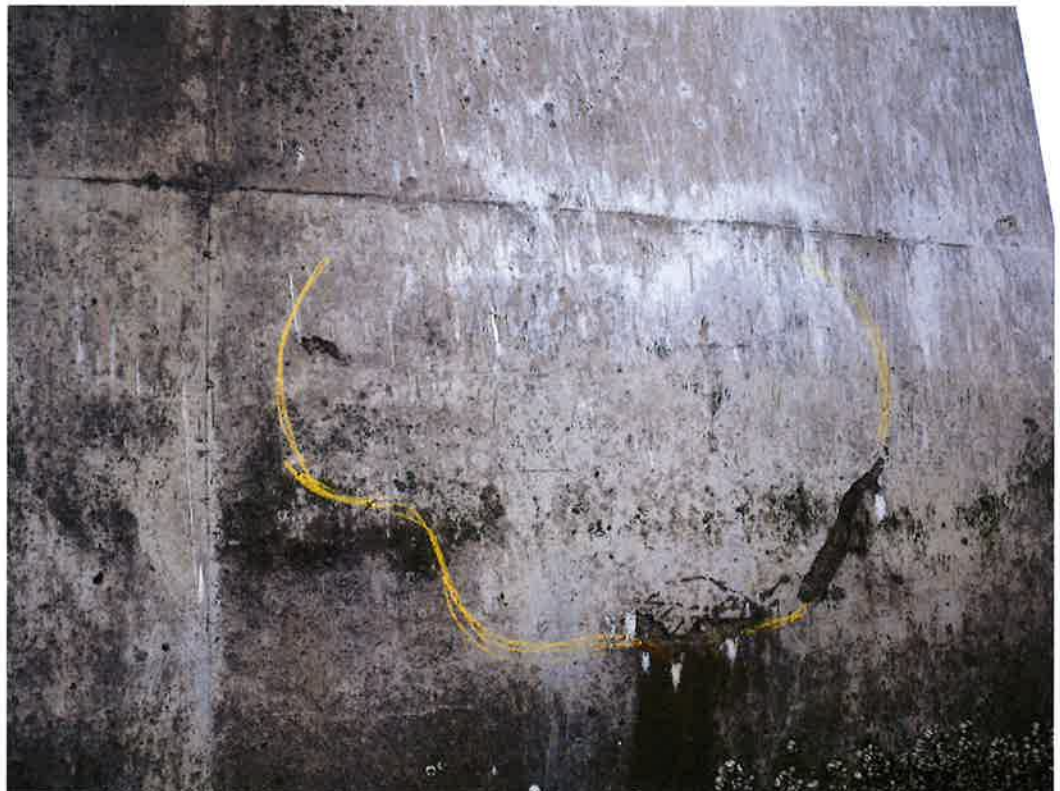
UW-3

227	<p>Piers 2-10 included in quantity. Piers 3, 4, 5 and 6 struts have diagonal leaching cracks. Pier 6 Column A, east face has a 3-ft x 2-ft delaminated area just above the intertidal zone (Photo #UW-3). Pier 7 outside corners have shallow impact spalls just above the intertidal zone (Photo #UW-4). Pier 8 columns have vertical cracks up to 4 ft. long in the intertidal zone. Some are delaminated with rust staining. The SW corner of Column A has spalled, exposing the corner vertical rebar (Photo #UW-5).</p> <p>Underwater Inspection Findings: All in water piers have two columns with a strut above and a shared footing below (Photo #UW-9). Heavy marine growth on submerged columns in Piers 3 through 9 (Photo #UW-10). Random cleaning in small areas revealed sound concrete. Pier 7 Column B has a poor consolidation void at the column/footing interface, 18-inches along the south and east faces.</p>

Pier 6, Column A, east face; 3-ft x 2-ft delam/spall just above the ITZ.

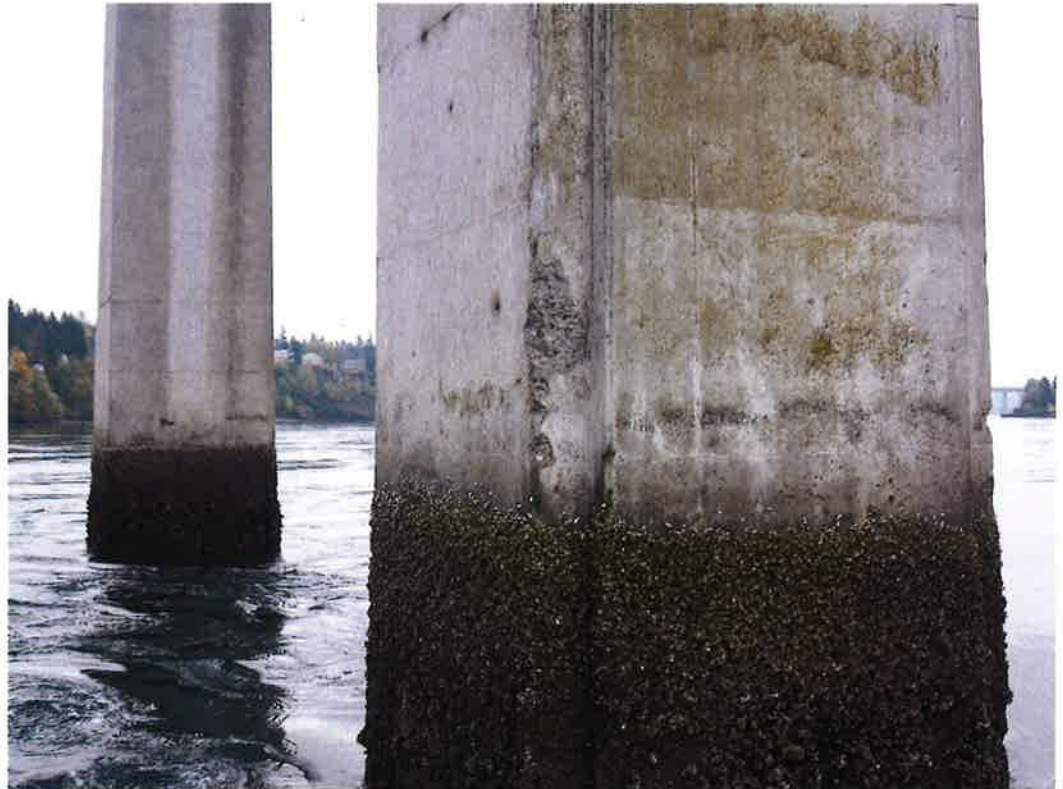
UW-4

Pier 7, Column A, NW corner; shallow impact spalls. Typical of other corners on Pier 7 columns.

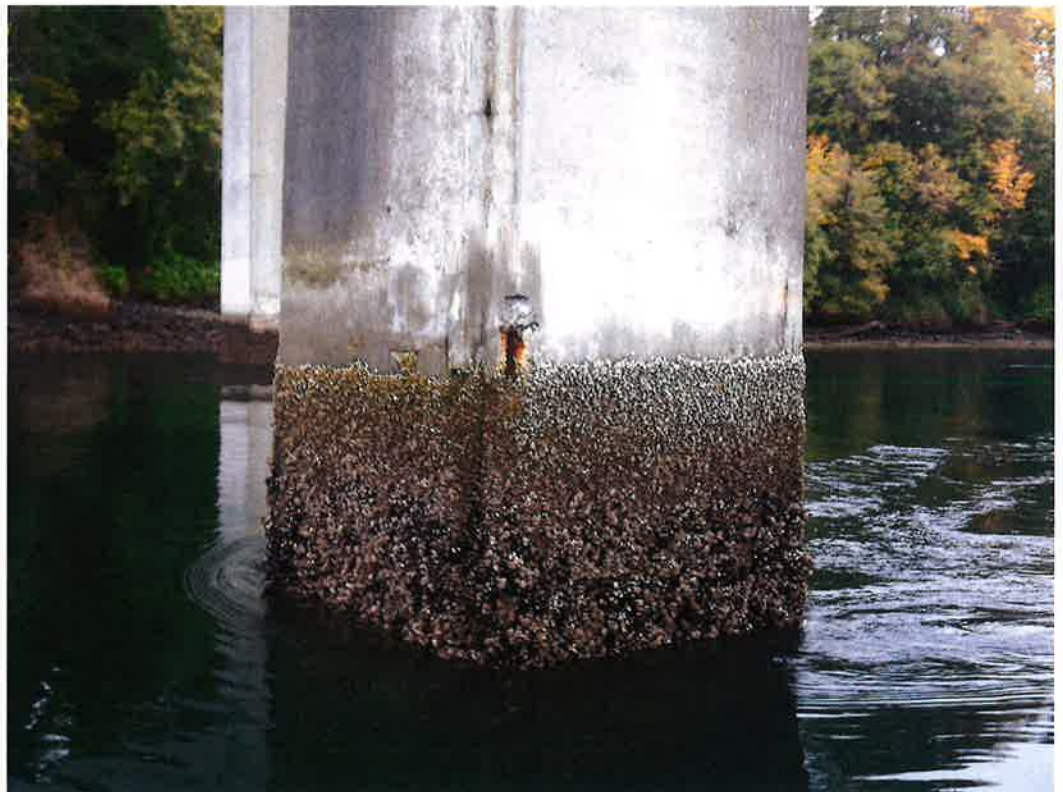
UW-5

Pier 8, Column A, SW corner; spalled corner with exposed rebar. Other Pier 8 corners have vertical cracking with rust staining.

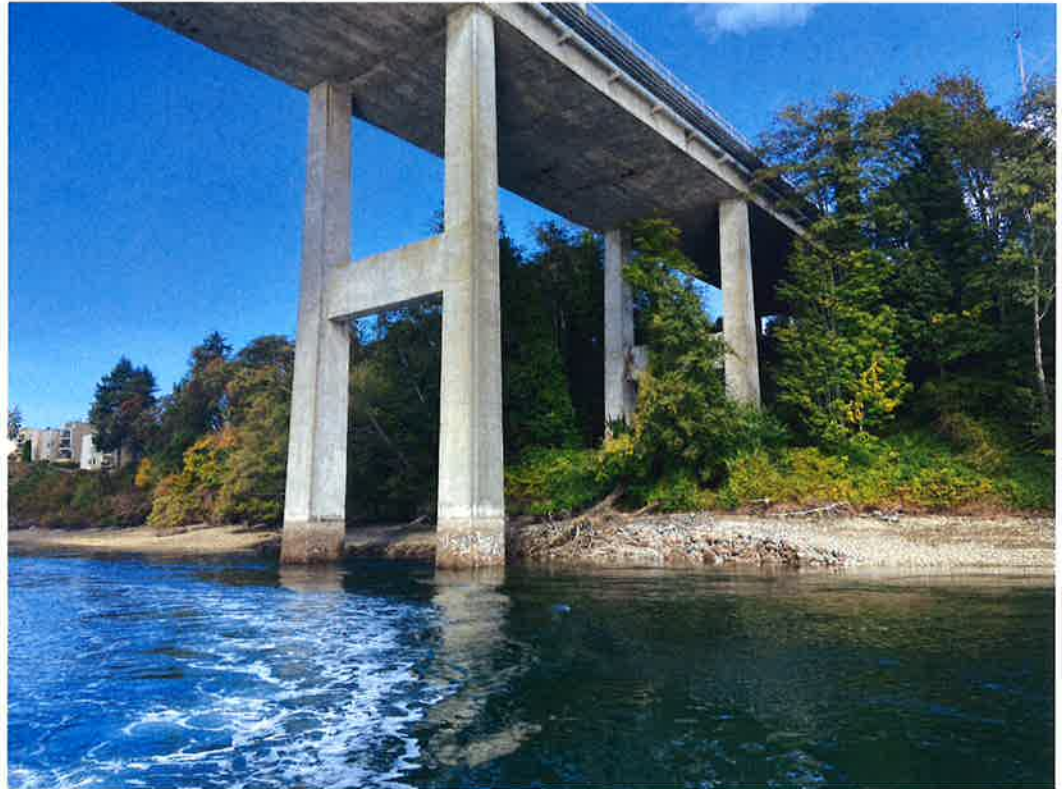
UW-9

Pier 9. Typical in-water pier elevation and configuration. Note north bank riprap.

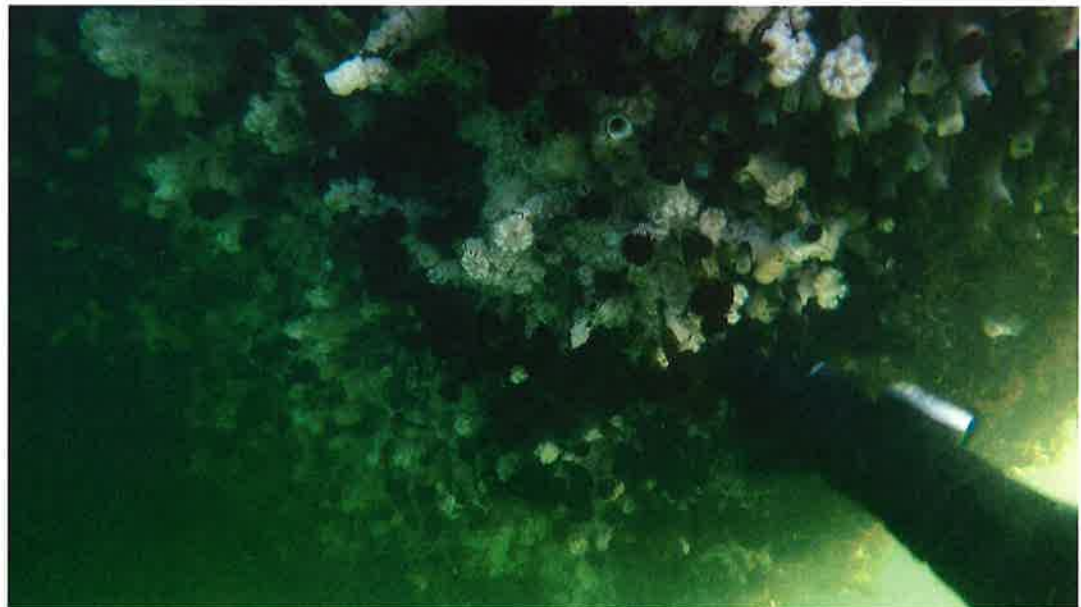
UW-10

Looking down the east column at Pier 8, showing typical heavy marine growth below the ITZ.

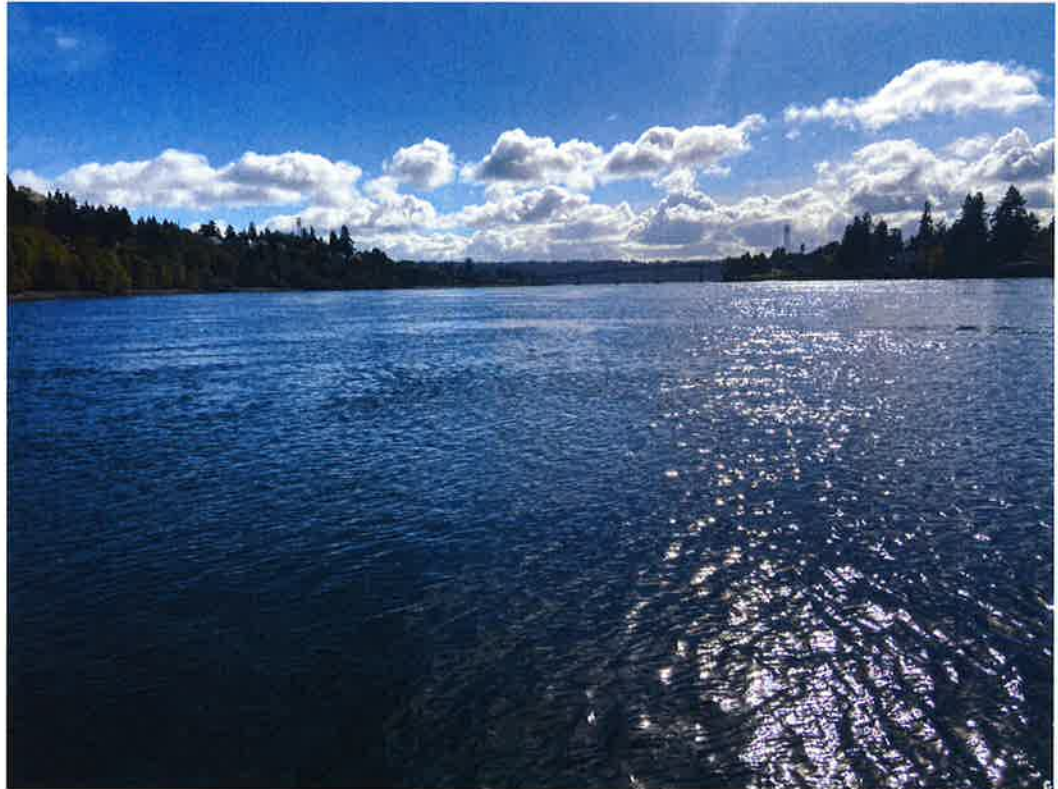
UW-11

Channel view looking east (towards Manette Bridge).

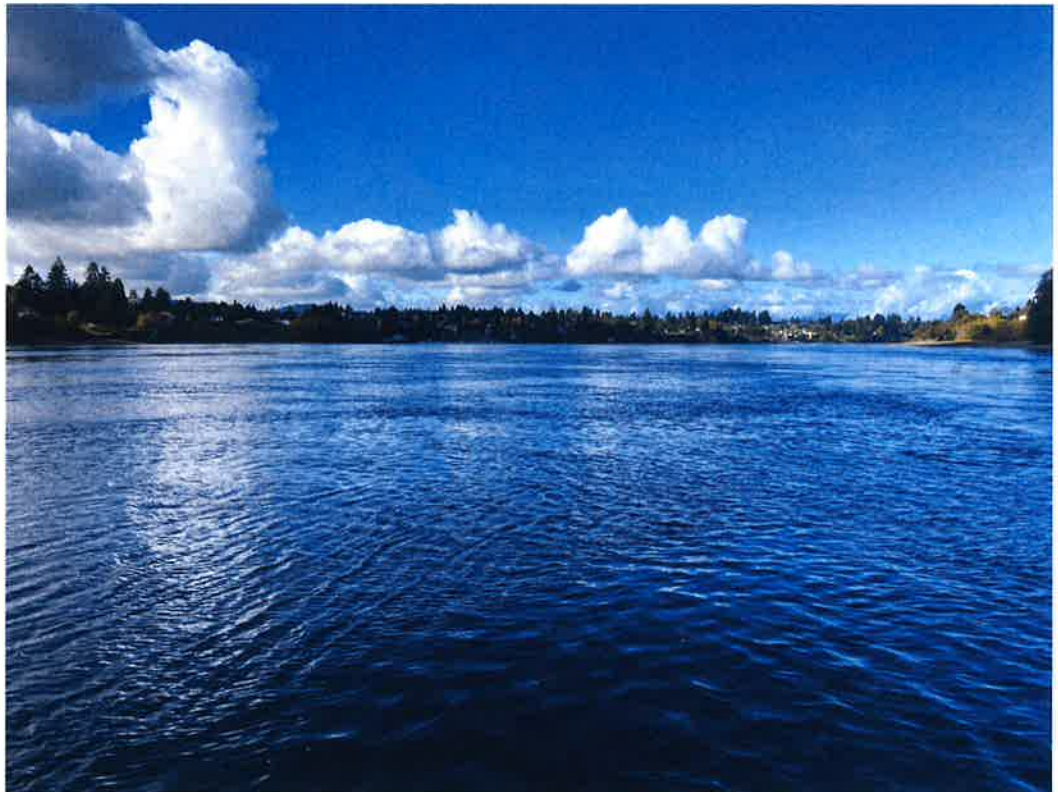
UW-12

Channel view looking west into Dyes Inlet.
