**Washington State  
Department of Transportation  
Bridge Preservation Dive Team**

**UNDERWATER INSPECTION REPORT  
FOR THE  
MANETTE BRIDGE  
BRIDGE NO. 303/4A  
STRUCTURE ID 0017926A**

**Prepared For** WSDOT  
**Inspection Date** May 08, 2017  
**Lead Inspector/Diver** James R. W. Harding  
Cert. # G0911  
**Inspector/Diver** Michael B. Smith  
**Report Status** Released

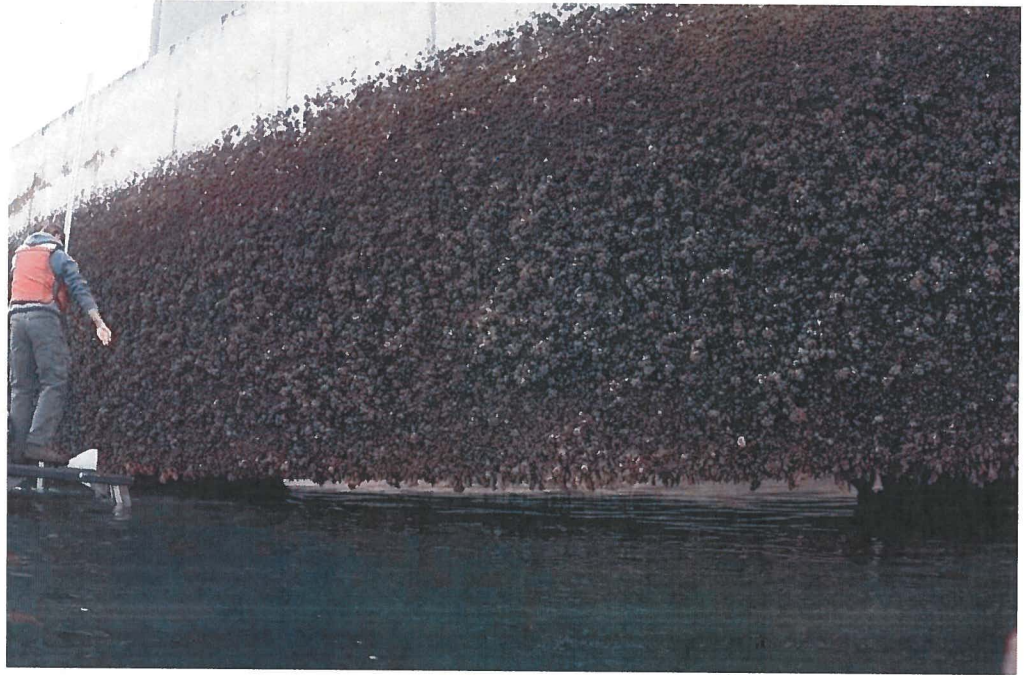
## UW-2

Typical Shaft Cap. Looking at Pier 2.

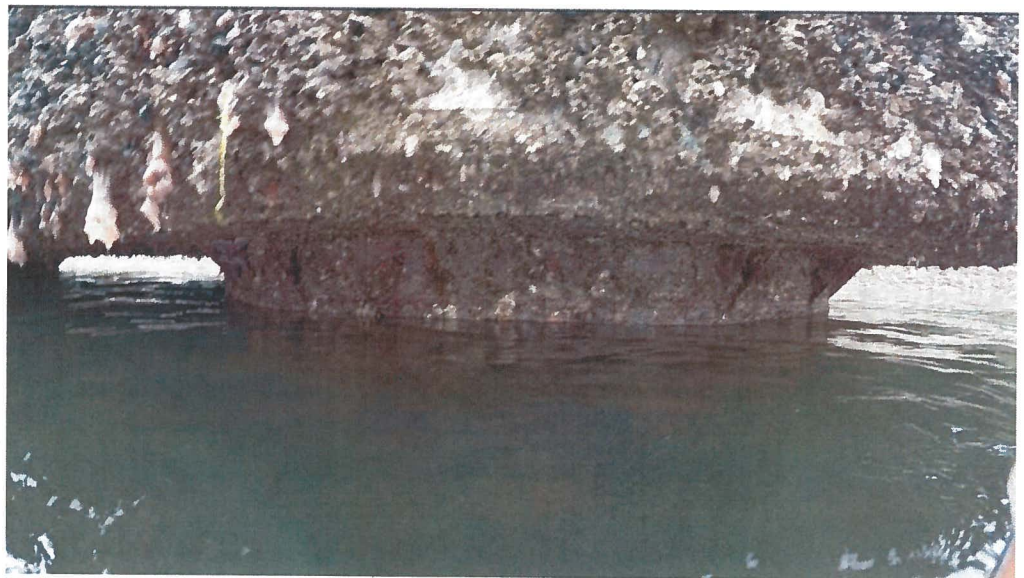
## UW-3

Typical top of shaft to shaft cap. Looking at Shaft 2A.

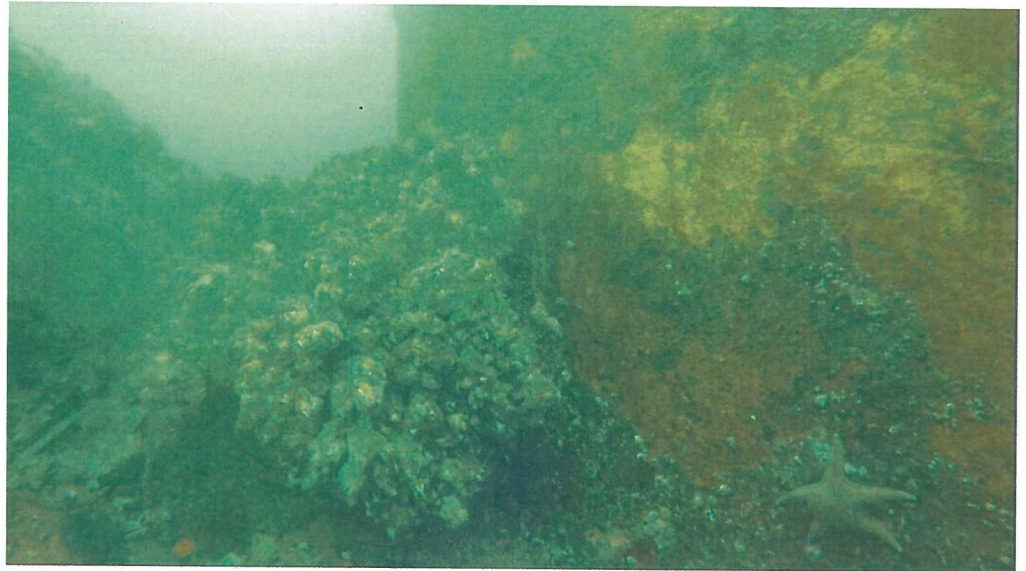
## UW-4

Typical rust nodules. Note the rock that was around the old pier still in place. Looking at Column 5A.

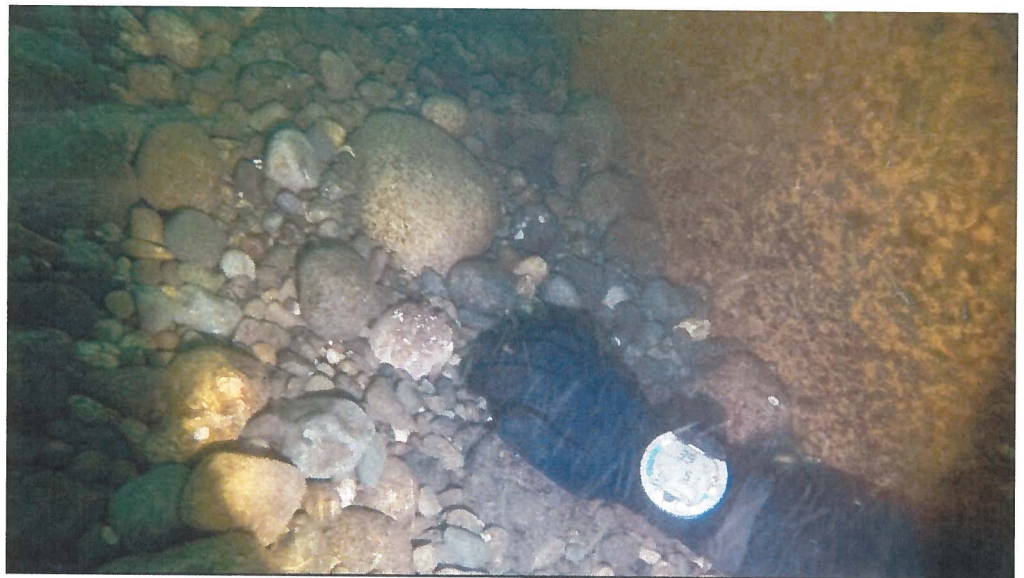
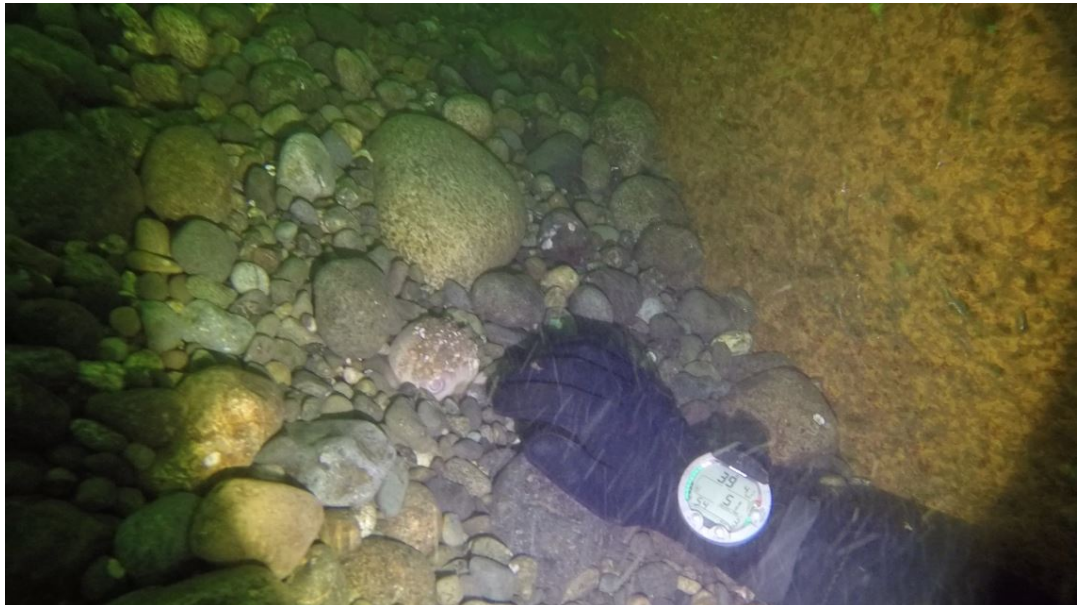
## UW-5

Typical channel bottom is gravel and cobbles. Note the rust nodules on the shaft. Looking at the west side of Column 3B.

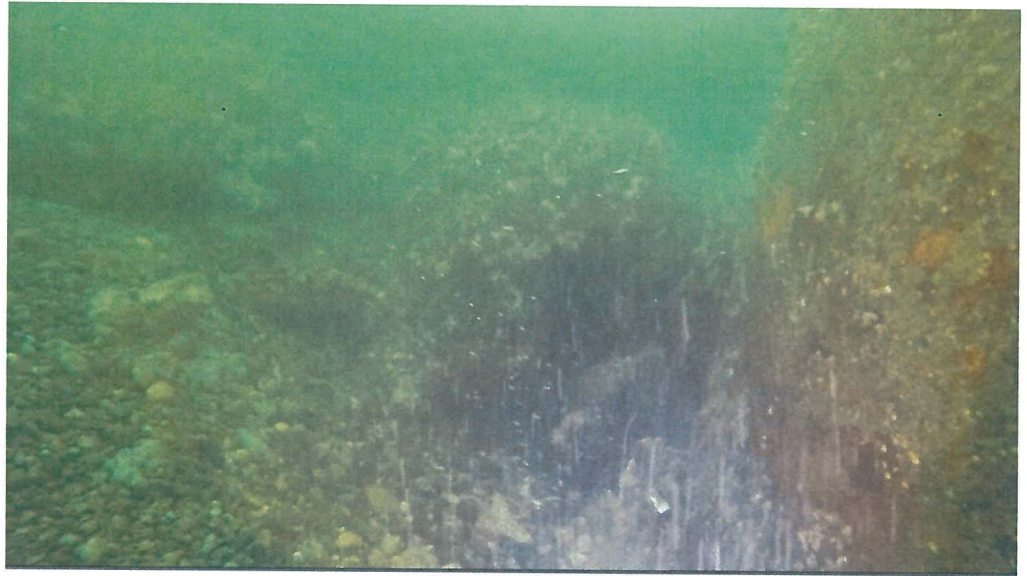
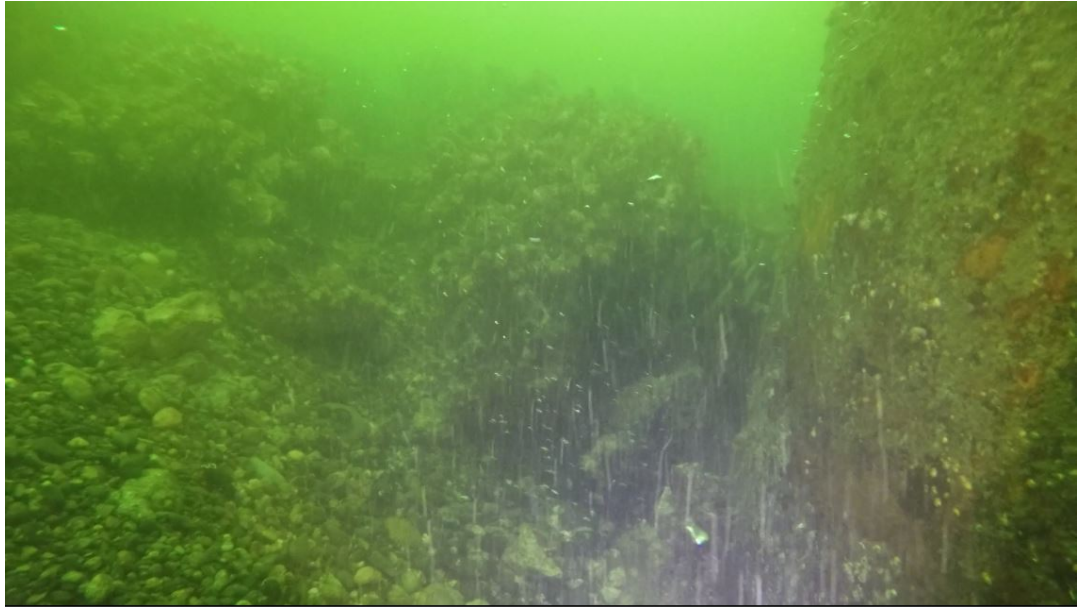
## UW-6

Pile of rock at the south face of Shaft 3A.

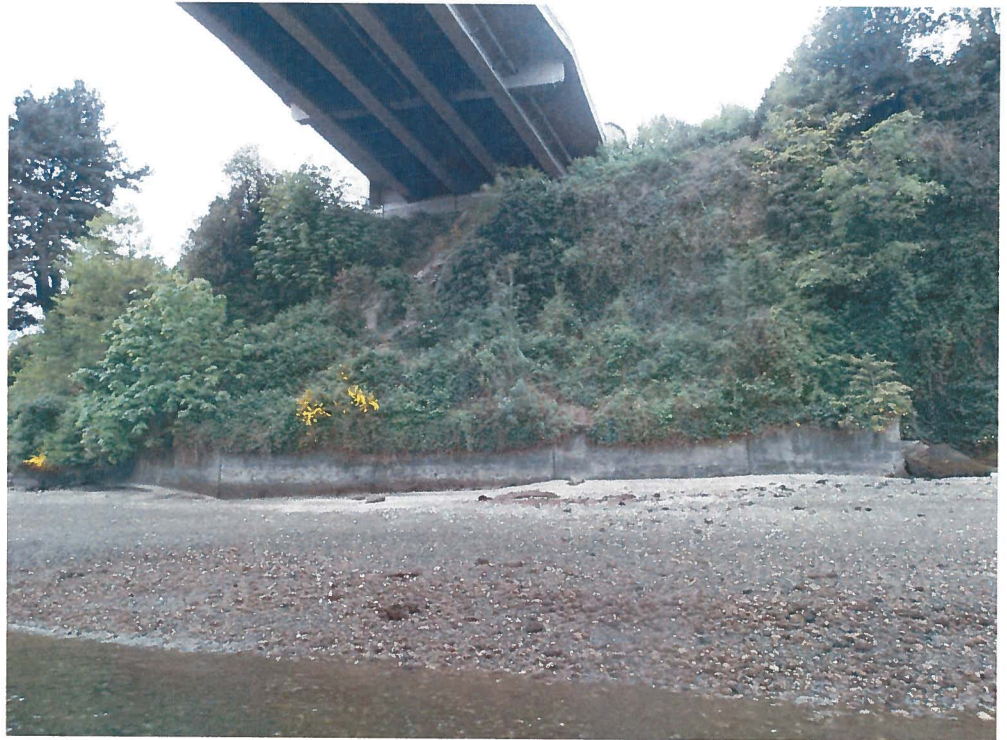
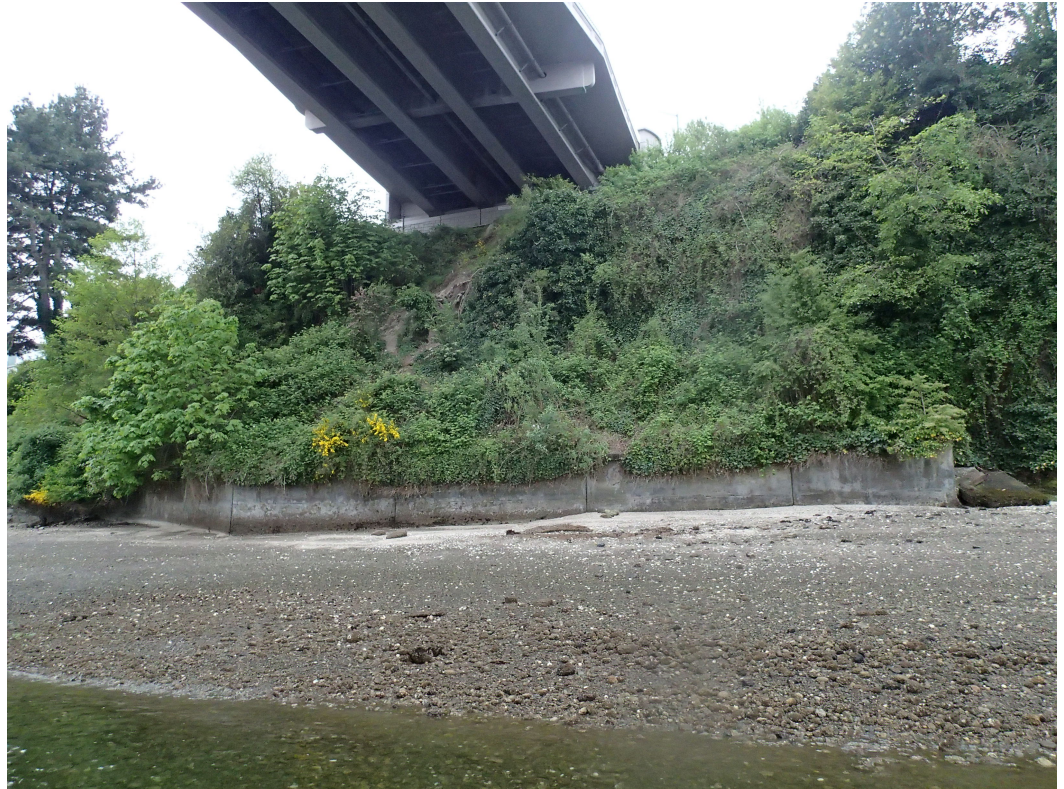
## UW-8

1677	The channel is well established and tidal.  Underwater Inspection Findings: The south bank at the bridge did not show any new sloughing. The concrete wall at the toe of the slope appears stable. See photo UW-8. There was a slope failure west of the bridge. See photo UW-9.
1680	This bridge is founded on drilled shafts.

Concrete wall at the toe of the slope appears stable.

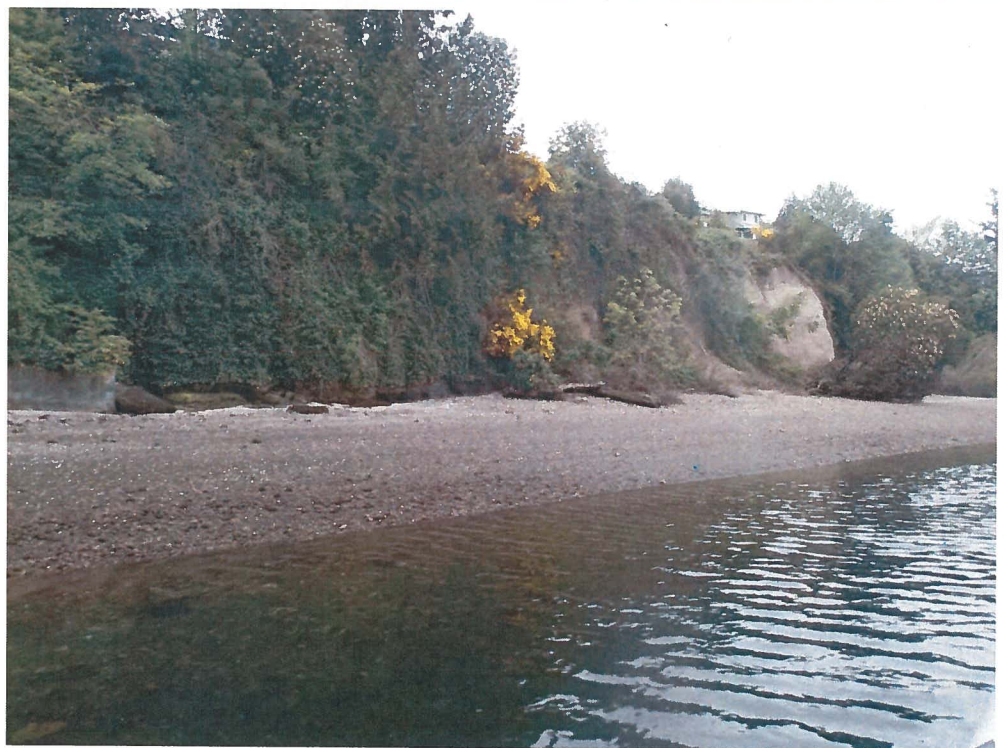
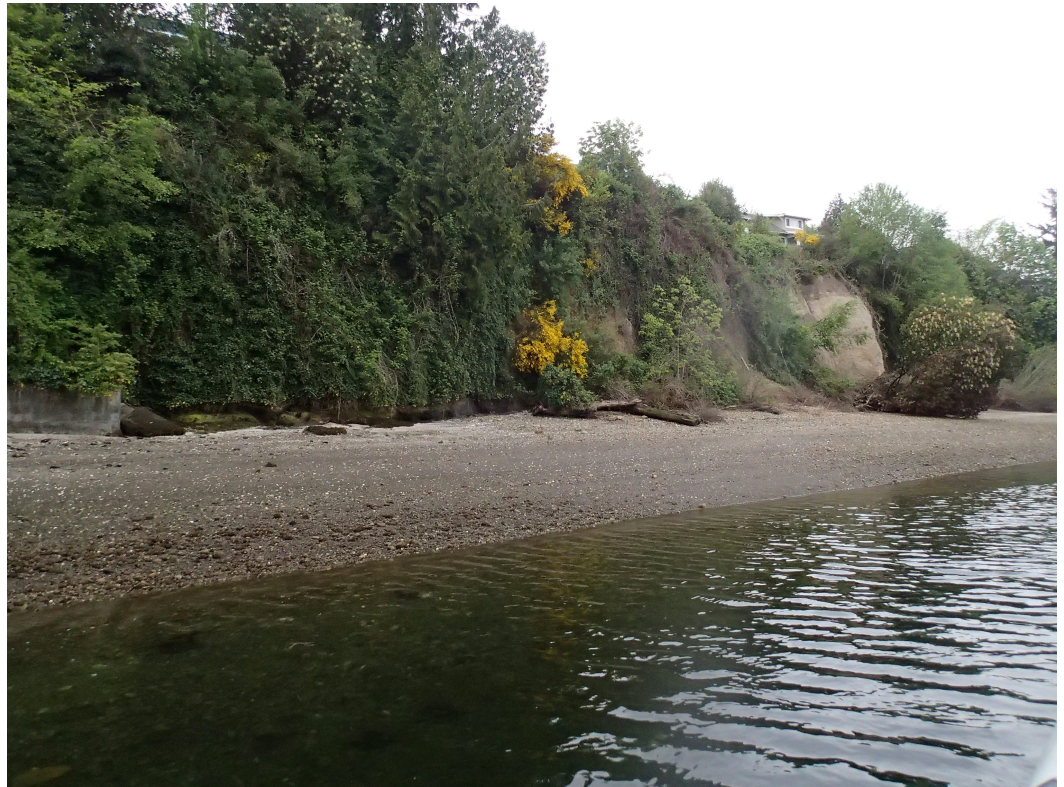
## UW-9

Slope failure west of the bridge on the south bank.
