BRIDGE INSPECTION REPORT

Br. No. 303/4A SID 0017926A Br. Name MANETTE BRIDGE

Br. No. 303/4A **SID** 0017926A **Br. Name** MANETTE BRIDGE
Carrying CITY STREET **Route On** 00303 **Mile Post** 0.26
Intersecting PORT WASH NARROWS **Route Under** **Mile Post**

303/4A MANETTE BRIDGE
WSDOT SID #0017926A
UNDERWATER INSPECTION

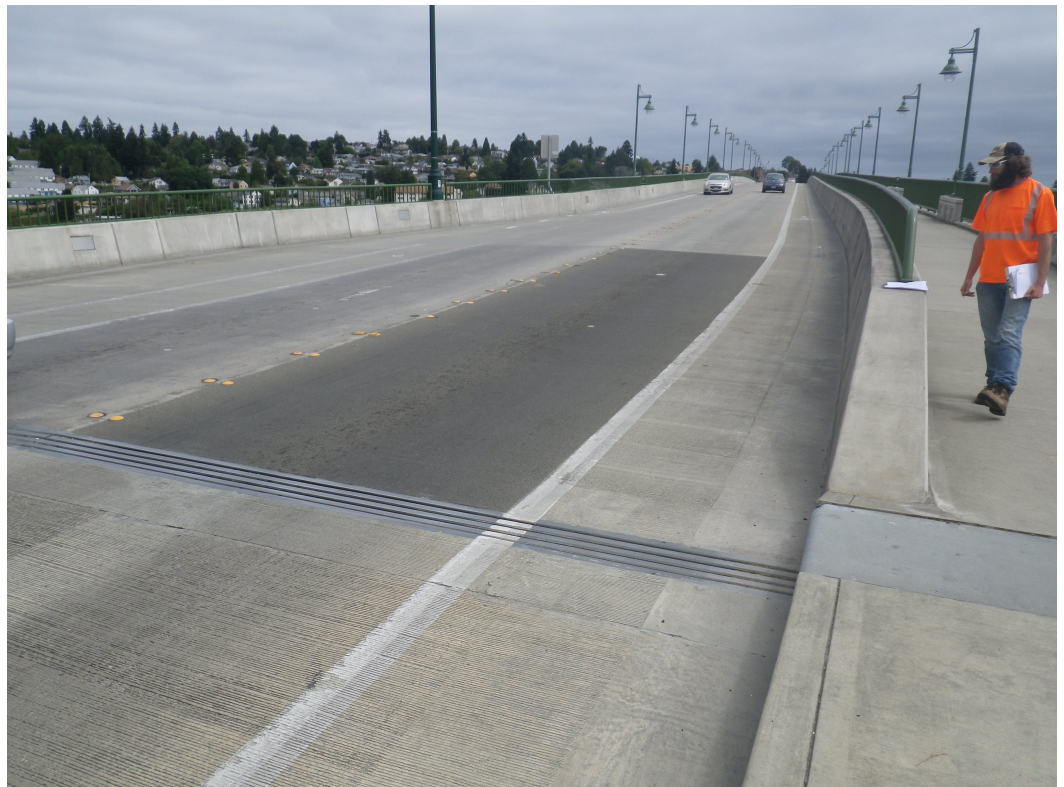
SI-6

26 Deck has transverse cracks throughout, with widely spaced map cracking over the piers.
In the right lane of Span 1 there is an 11 ft. wide x 48 ft. long patch of unknown material. See photo #6

In the right lane of Span 1 there is an 11 ft. wide x 48 ft. long patch of unknown material.

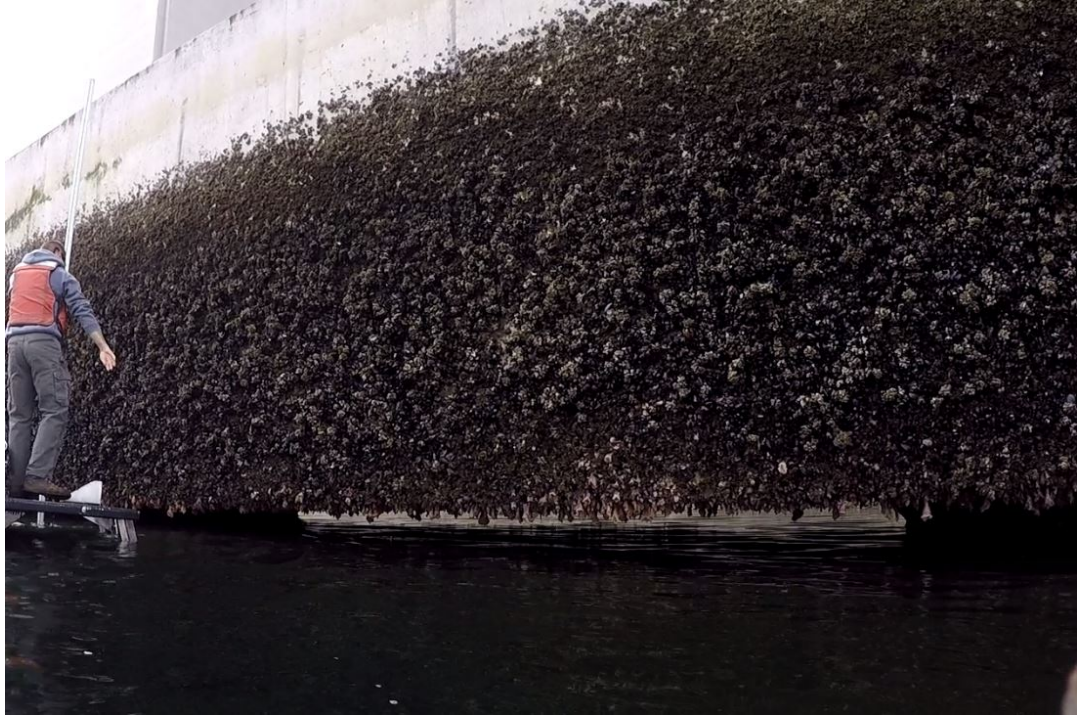
220 Underwater Inspection Findings:
Piers 2 through 7 had exposed foundation elements that are considered submerged. These piers are made up of two 12' diameter drilled shafts capped by a reinforced concrete precast tub with rounded noses. The concrete precast tubs or shaft caps were found to be in excellent condition. See photos UW-2 and UW-3. The steel encased shafts were exposed at Piers 2 through 6.

Typical Shaft Cap. Looking at Pier 2.

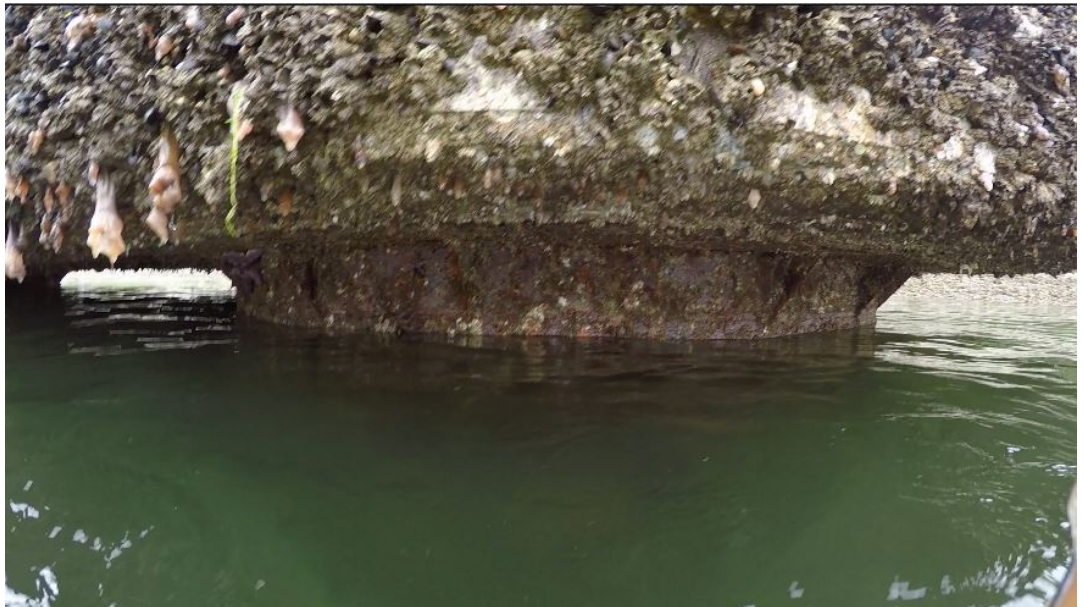
227 Underwater Inspection Findings:
The two 12' diameter drilled shafts are exposed at Piers 2 through 6. The shafts have the full height steel casings still in place. The shafts have rust nodules and marine growth. See photos UW-3 and UW-4.

Typical top of shaft to shaft cap. Looking at Shaft 2A.

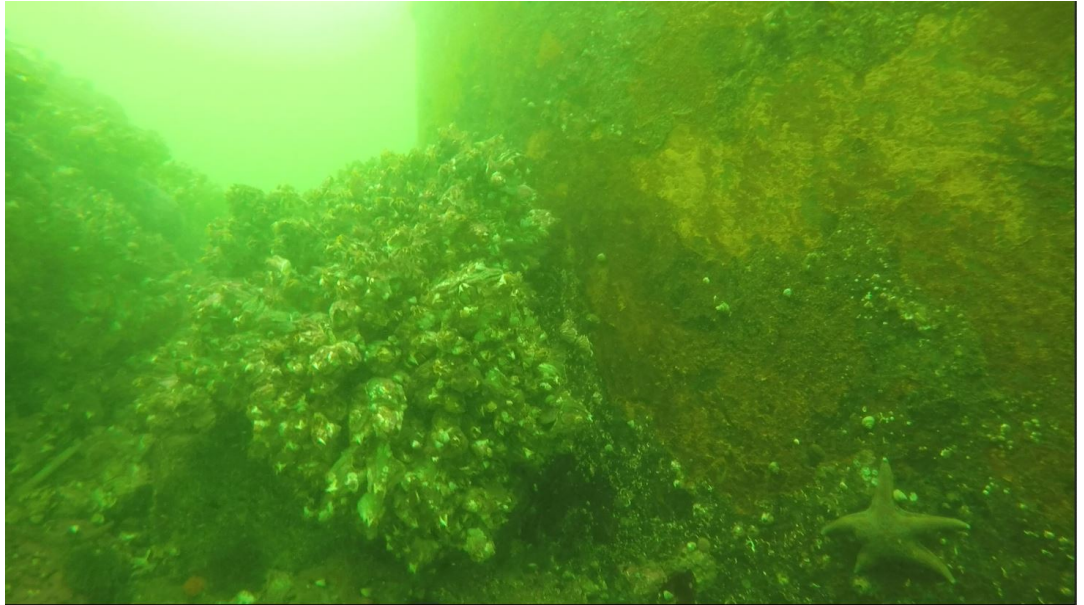
UW-4

Typical rust nodules. Note the rock that was around the old pier still in place. Looking at Column 5A.

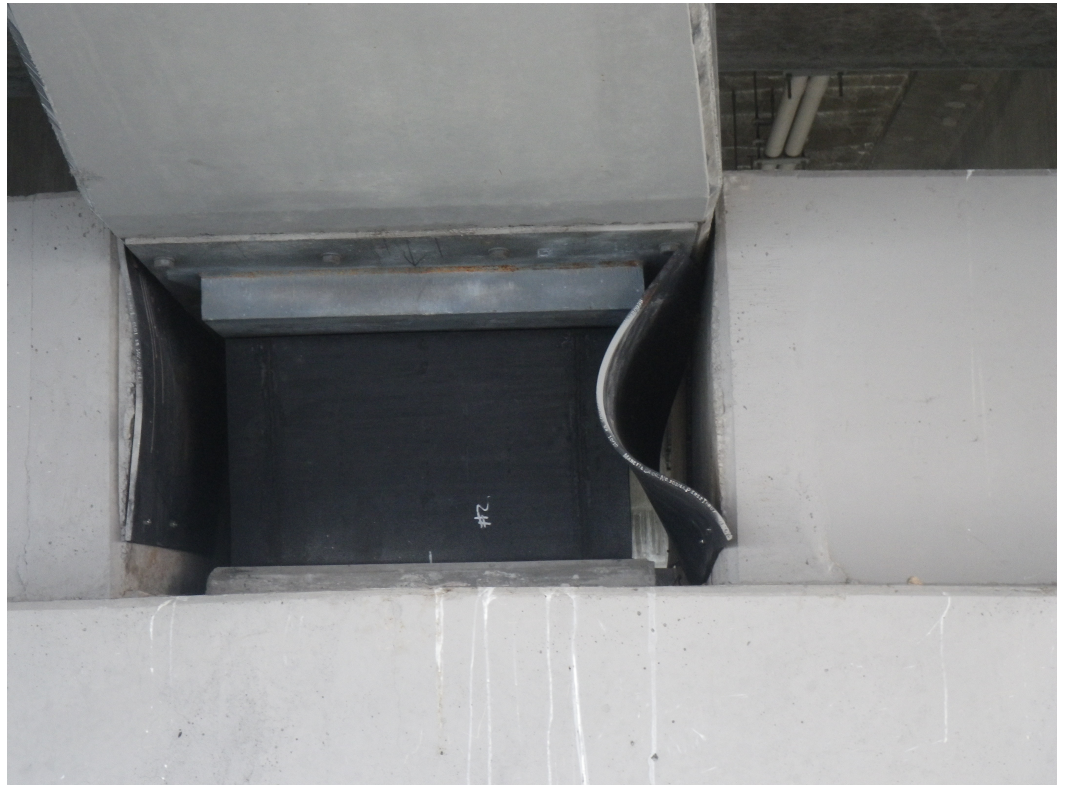
SI-7

310 Bearing 7B girder stop pad has become separated allowing girder to contact the stop. See photo #7.

Bearing 7B girder stop pad separation.

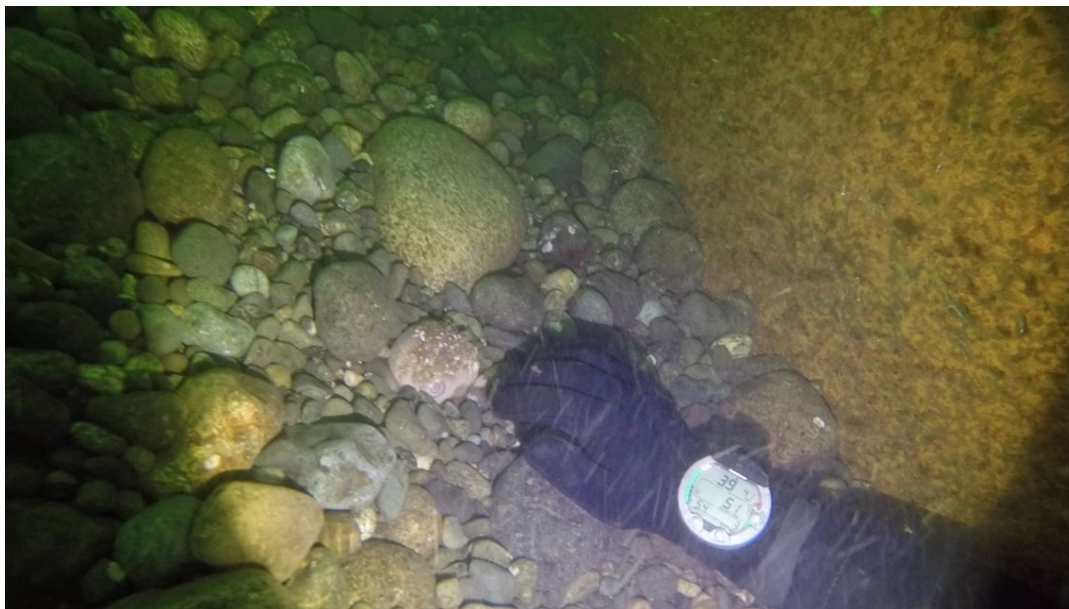
UW-5

The channel bottom is made up of mainly gravel and cobbles with some scattered rock that appears to be from the old bridge piers. See photos UW-4, UW-5, and UW-6. Slight changes in the channel bottom was noticed since the previous underwater inspection. This change was most likely due to the removal of most of the old piers. The old pier that was adjacent to Pier 5 was cutoff at el. -20.3 but still can be seen. See photo UW-7.

Typical channel bottom is gravel and cobbles. Note the rust nodules on the shaft. Looking at the west side of Column 3B.

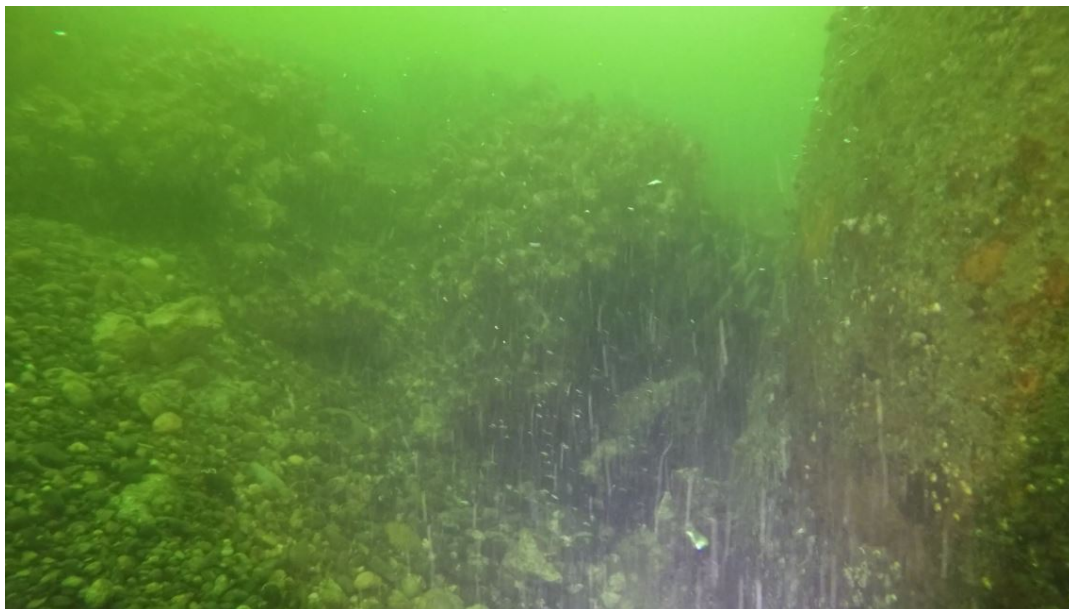
UW-6

Pile of rock at the south face of Shaft 3A.

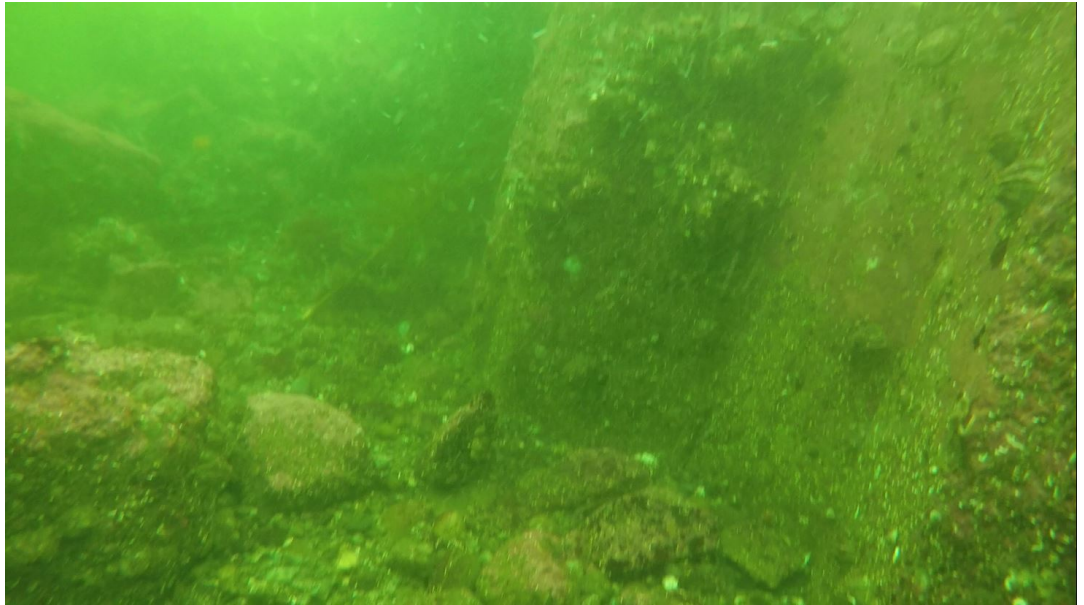
UW-7

Old pier adjacent to Shaft 5A is exposed.

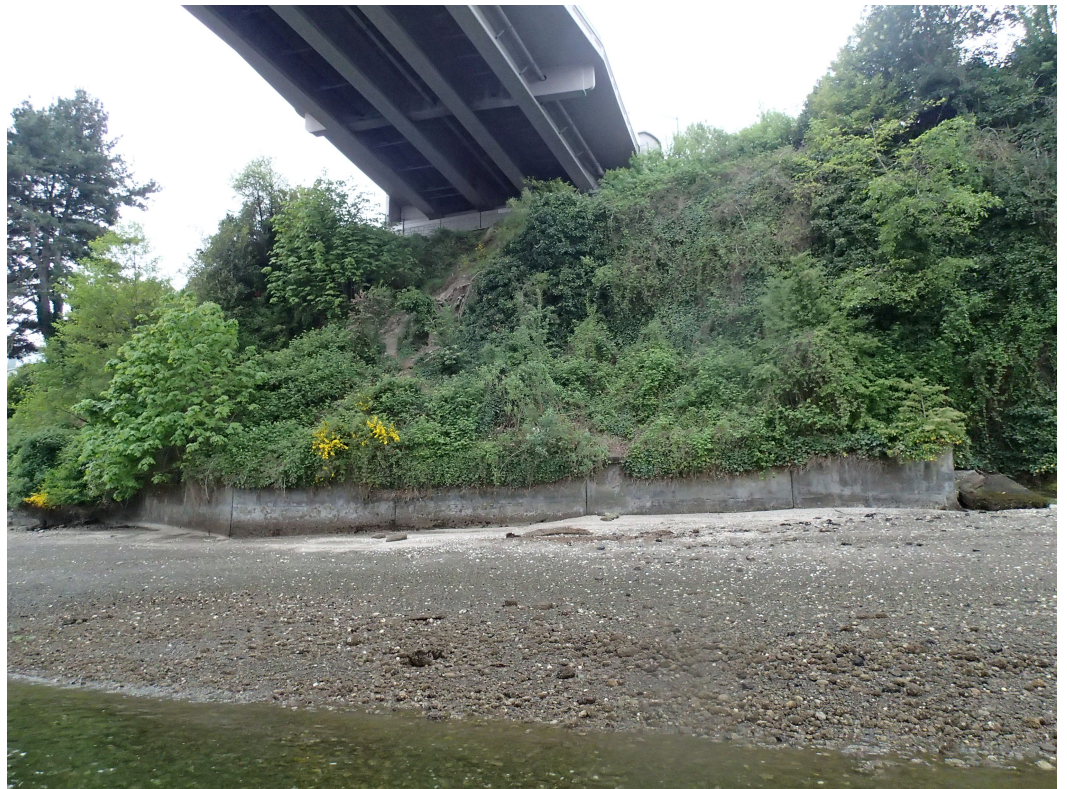
UW-8

The south bank at the bridge did not show any new sloughing. The concrete wall at the toe of the slope appears stable. See photo UW-8. There was a slope failure west of the bridge. See photo UW-9.

Concrete wall at the toe of the slope appears stable.

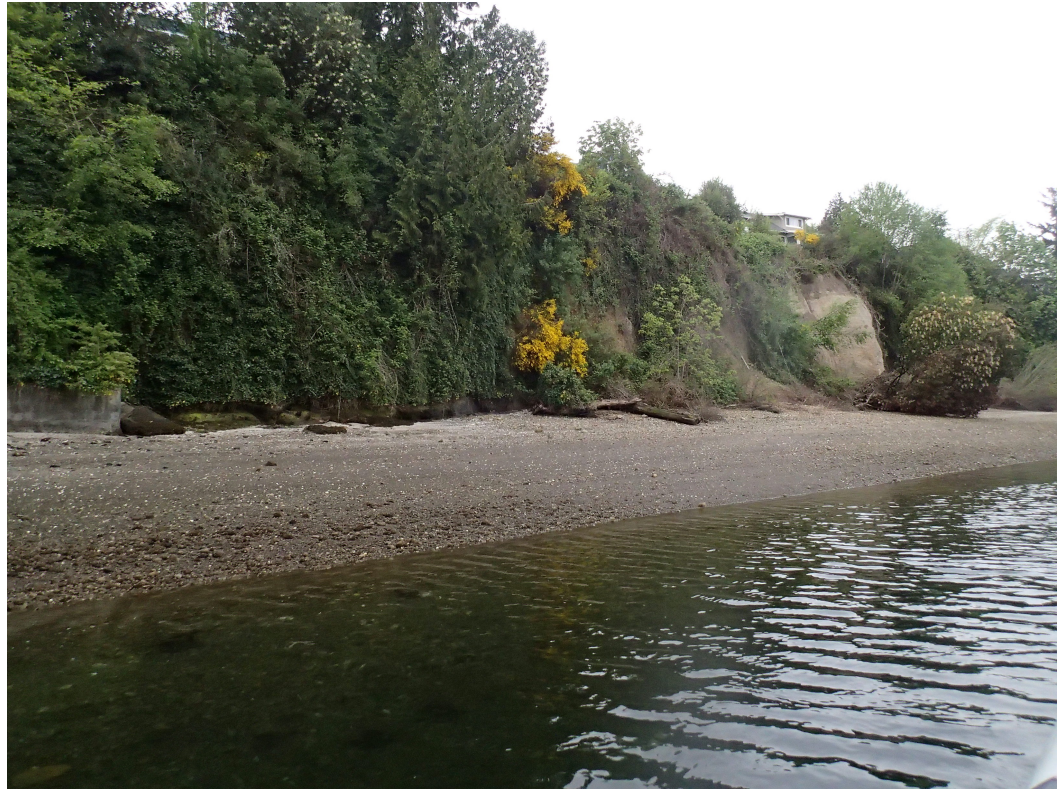
UW-9

Slope failure west of the bridge on the south bank.
