**SR 900 78<sup>th</sup> Vicinity to Newport Way Widening  
Lake Sammamish State Park (LSSP) Wetland Mitigation Site  
WIN #A90098V**

**USACE IP NWS-2007-29-SOD**

**2017 MONITORING REPORT**

**Washington State  
Department of Transportation**

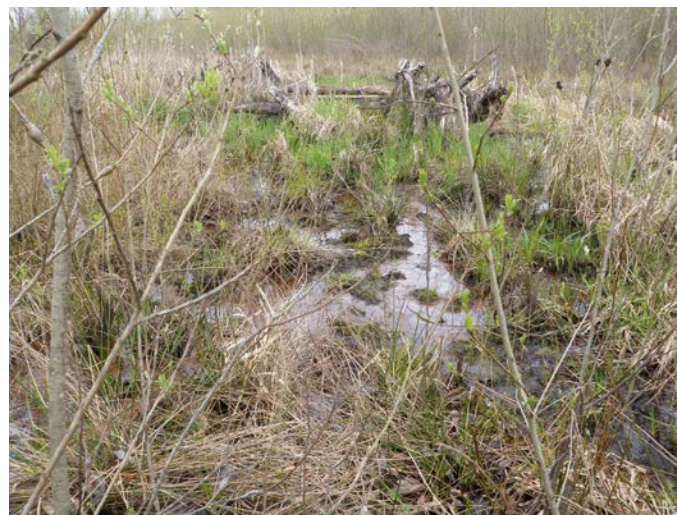
Hydrology monitoring visits were conducted on March 6, March 21, and April 4 in 2017. During these visits inundation or surface saturation was observed in about a quarter to a third of the intended wetland area (Photo 1). There were three shallow groundwater monitoring wells on this site, however, during the first visit in 2017, Well 2 was found broken and has not been replaced. Of the other two wells on-site, one had water within 12 inches below the soil surface during all three visits and the other during only the first two visits. See Appendix 1 for well locations and Appendix 3, Table 1 for a summary of hydrology observations.

**Photo 1**  
**Inundation in the wetland (April 2017)**

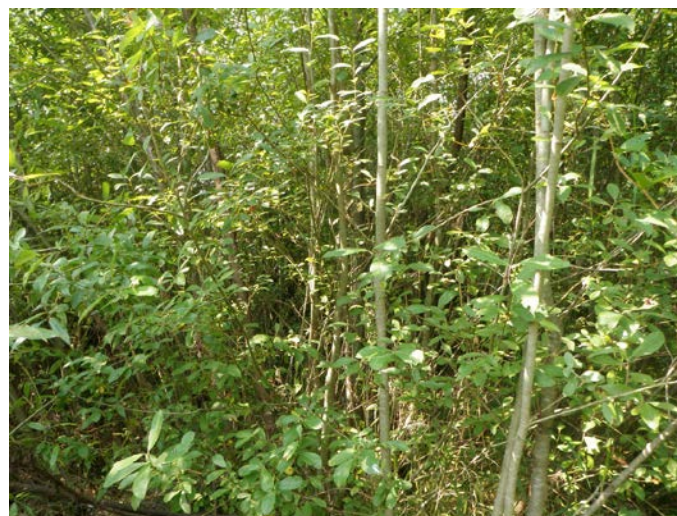
Cover of native facultative or wetter woody species in the scrub-shrub wetland (Photo 2) was visually estimated at 80 percent. This exceeds the final-year performance standard target. Dominant species in these areas were Sitka willow (*Salix sitchensis*) and Pacific willow (*Salix lasiandra*).

**Photo 2**  
**Woody cover in the scrub-shrub wetland (August 2017)**

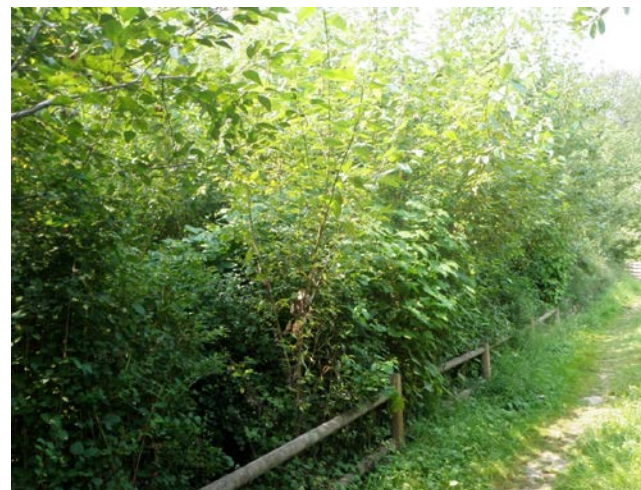
Cover of native woody species in the buffer (Photo 3) was visually estimated at 90 percent. This exceed the final-year performance standard target. Dominant species in these areas were snowberry (*Symphoricarpos albus*), thimbleberry (*Rubus parviflorus*), black cottonwood (*Populus balsamifera*), and western red cedar (*Thuja plicata*).

**Photo 3**  
**Woody cover in the buffer (August 2017)**
