SR 241 MP 1.12 Yakima River Bridge (241/2) Replacement: Hydraulics and Scour Analysis Report

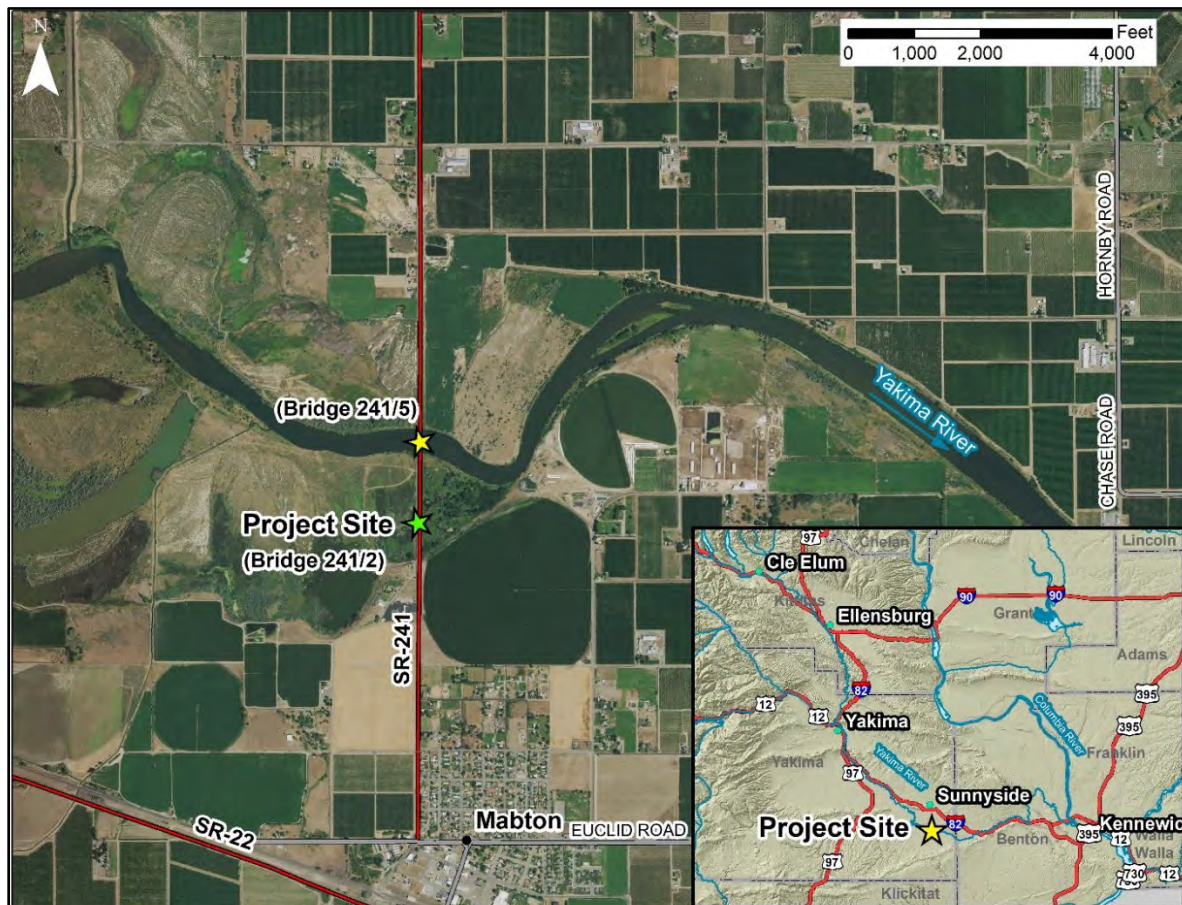
Figure 1.1 Vicinity Map

Bridge 241/2 is located in Yakima County, WA approximately 1 mile north of the city of Mabton (Figure 1.1). At this location, SR 241 runs in the north to south direction, while the Yakima River flows west to east. This project proposes to replace the existing 241/2 bridge with a three-span structure that includes two abutment piers and two in-water piers. The bridge will meet design requirements for hydraulics based on criteria from the United States Federal Highway Administration (FHWA), Washington State Department of Transportation (WSDOT), and the Washington State Department of Fish and Wildlife (WDFW).

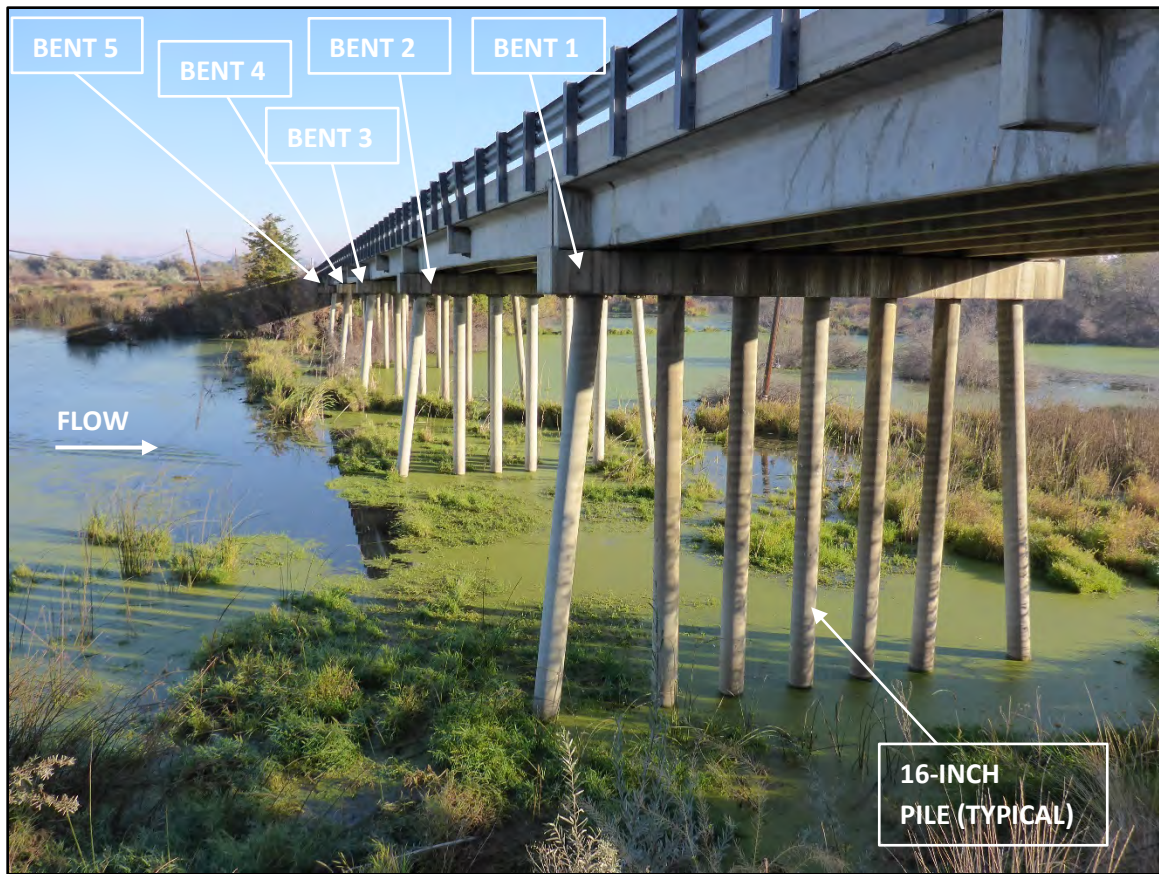
Figure 2.1 SR 241 Yakima River Slough Bridge (241/2) Crossing

During the October 17, 2018 site visit, the slough near the 241/2 crossing was observed to be inundated by water with low flow velocities (see Section 2.2 and Figure 2.1). This nearly stagnant water was interpreted to be present due to the emergence of groundwater throughout the project site. An analysis of existing wells around the project site, taken from the database of the Washington State Department of Ecology (DOE, 2019), revealed that the groundwater horizon is at an elevation of approximately 646 feet. Additional information on groundwater in the Yakima River watershed may be found in ICF (2012).

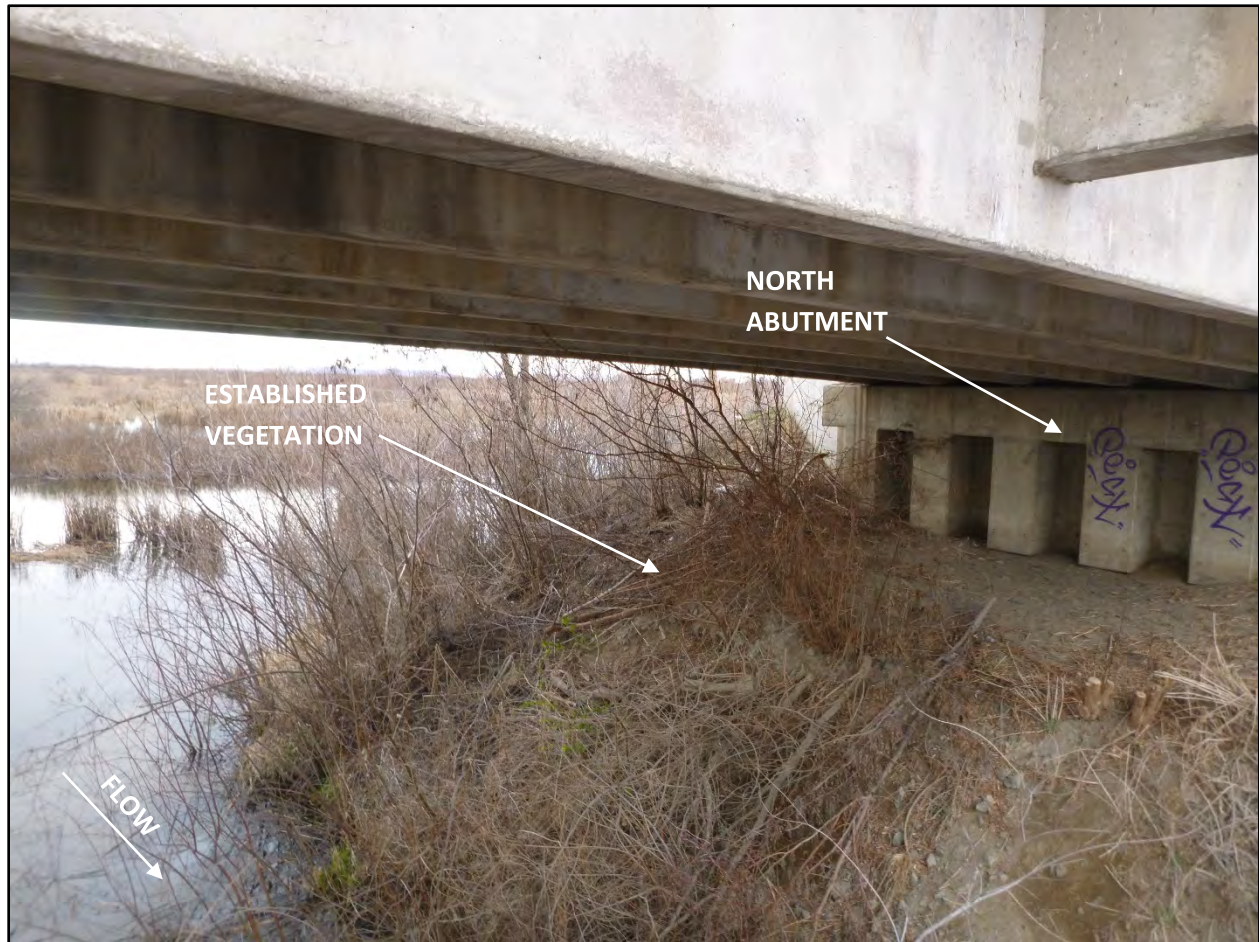
The lack of apparent erosion and the establishment of vegetation around the north abutment, suggests that the flow does not regularly reach the north abutment or the roadway and bridge deck drainage is routed to a different location (Figure 2.3).

Figure 2.3 North Abutment of the SR 241 Yakima River Slough Bridge (241/2)

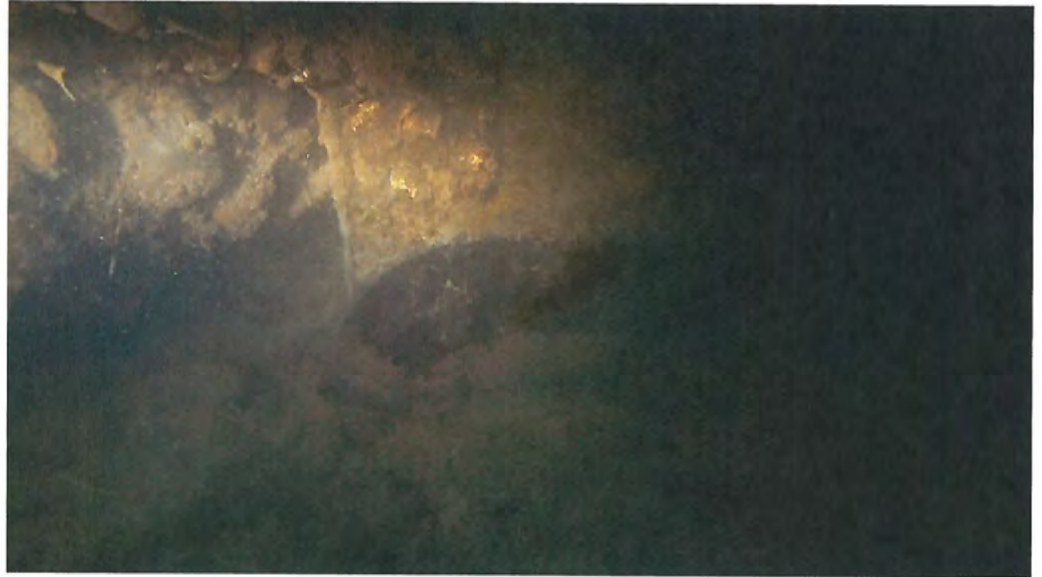
Pier 4 north face east end undermined seal showing exposed H-pile.
