U.S. 101 MP 357.4 Griggs Creek (WDFW ID 997161): Preliminary Hydraulic Design Report

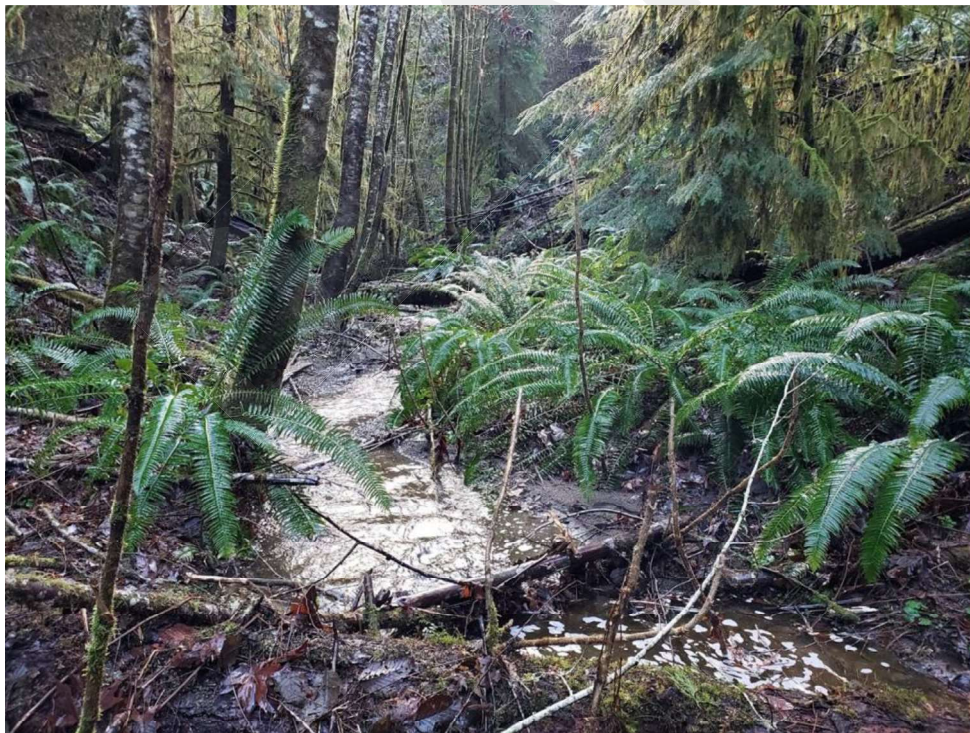
Figure 6: Looking upstream taken from the top of the woody material

The upstream reach habitat is split between a wooded and heavily vegetated area (approximately 500 feet to 250 feet upstream of the crossing), and a slightly vegetated area with highly eroded banks (250 feet upstream to the culvert inlet). Beginning approximately 500 feet upstream of the crossing, Griggs Creek meanders through an area of abundant large woody material (LWM) within the densely vegetated area (see Figure 6). Steep valley walls constrain the channel and incur some occasional undercutting.

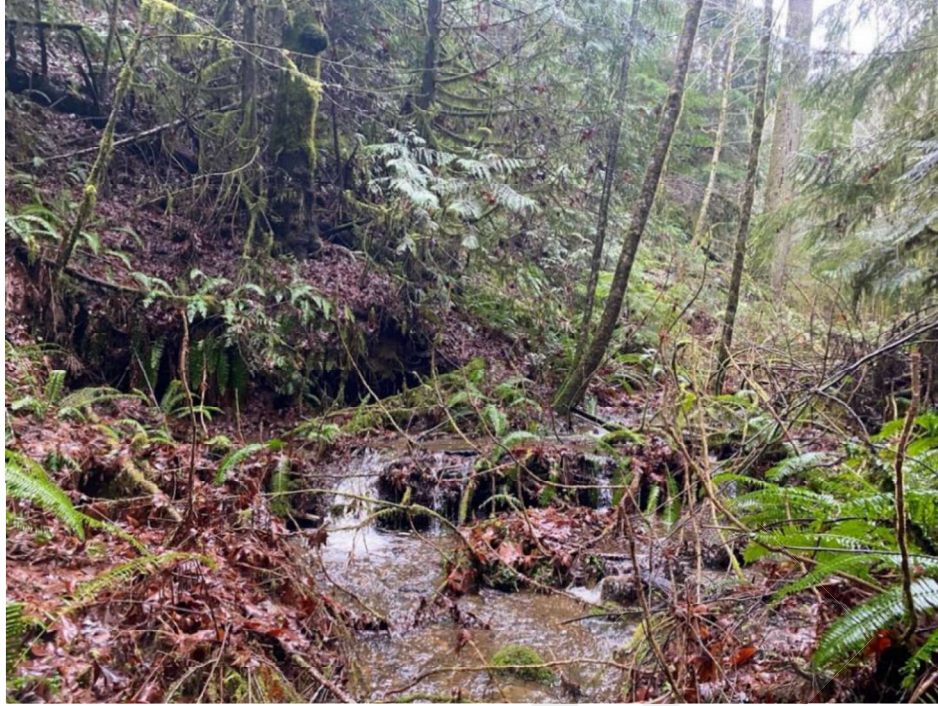
Figure 7: Looking upstream at the woody material jam

Within the stream channel an instance of LWM creates a 1.5- to 2.0-foot hydraulic drop as seen in Figure 7.

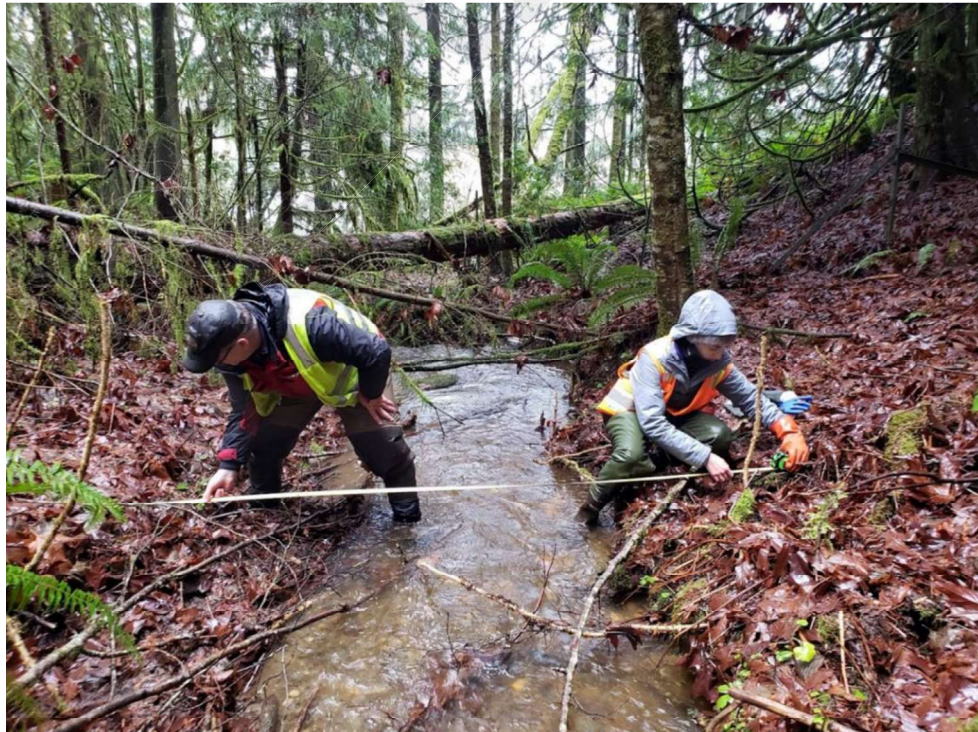
Downstream of the influence of the hydraulic drop, four bankfull width measurements were taken, the average being a 9-foot bankfull width. See Figure 8 for an example bankfull width measurement. Within this reach the material was primarily fine to very coarse gravel with some cobbles and bank heights, approximately 2 feet on the left and right.

Figure 8: Bankfull width measurement being taken

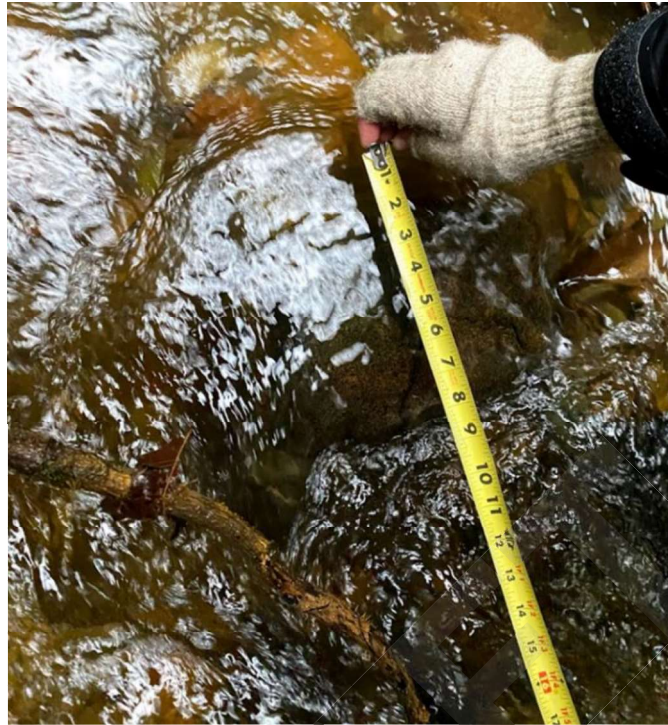
The largest material observed within the reach was a 10-inch cobble; see Figure 9 below.

Figure 9: Largest material observed within stream

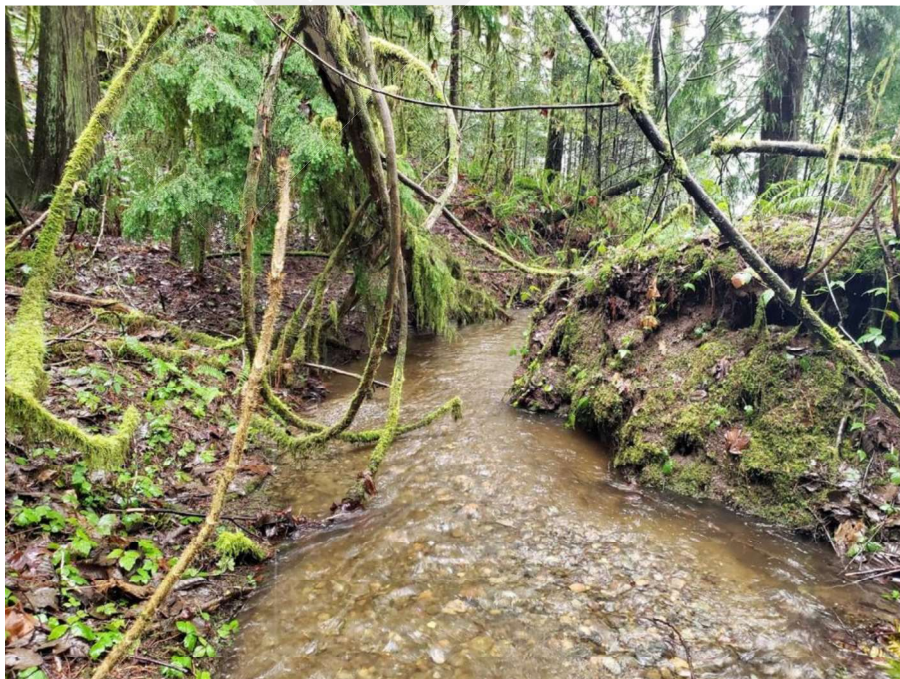
Downstream of the wooded reach, the banks are higher and more eroded, and there is less LWM within the channel (see Figure 10). This reach begins approximately 250 feet upstream of the culvert inlet, ending at the crossing.

Figure 10: Looking downstream at eroded right banks

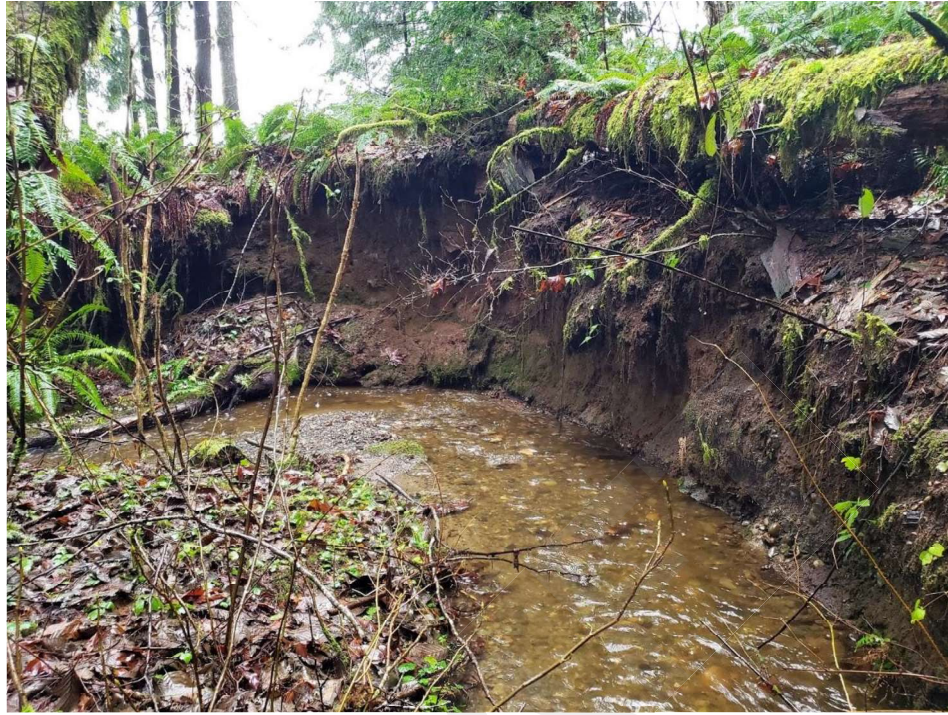
Figure 11: Looking downstream at the gravel bar and eroded right banks

Approximately 100 feet upstream of the culvert inlet, the channel takes a 90-degree left turn, leaving a gravel bar on the left bank and a highly eroded 8-foot bank on the right (see Figure 11). A second bend, nearly 90 degrees, creates an S-curve (see Figure 12 below).

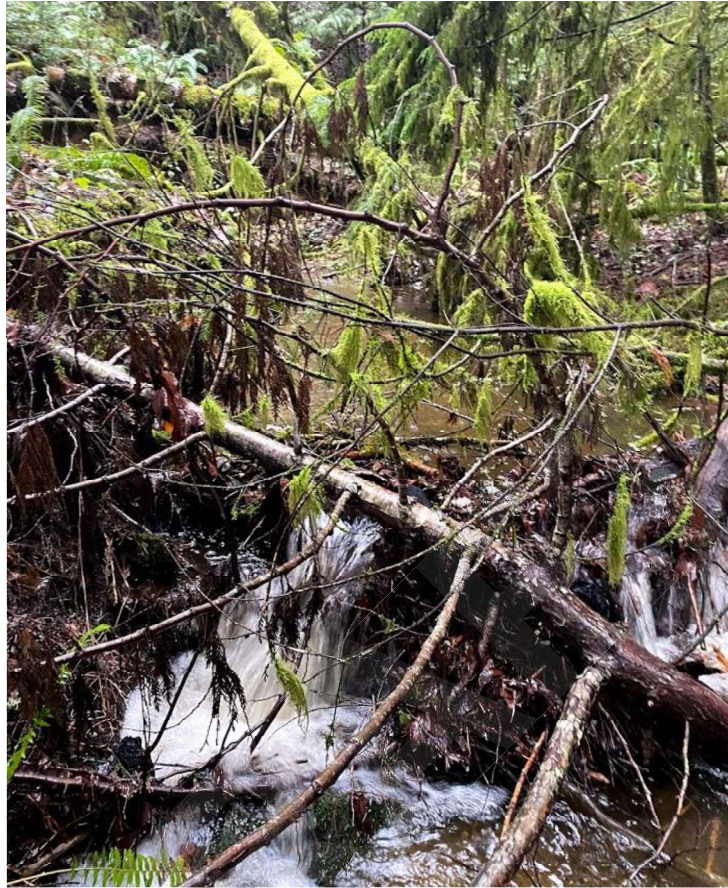
Downstream of the S-curve, deadfall trees within the stream have created some flow path deflection and a slight channel meander. Sediment and material have accumulated to surround the LWM. Because of the LWM and sediment buildup, the channel has a 1-foot hydraulic drop (see Figure 13).

Figure 13: Looking upstream at the hydraulic drop

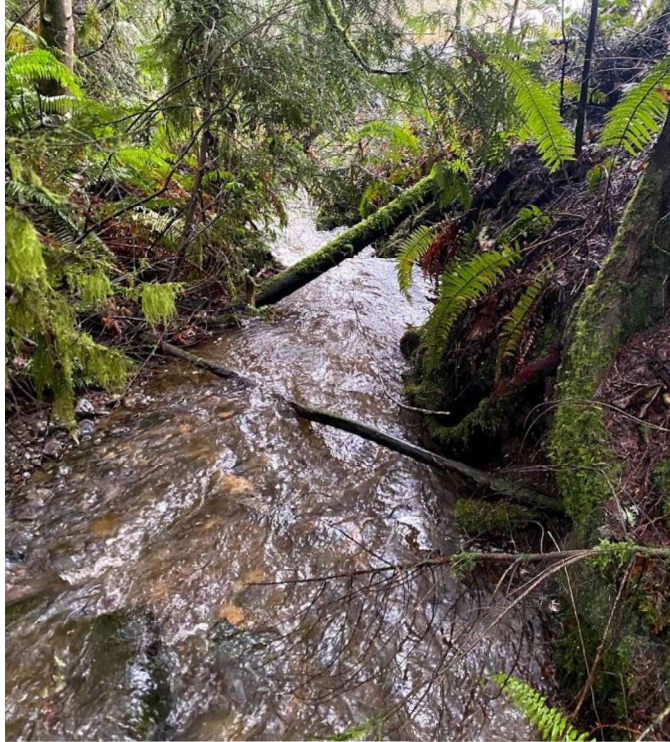
Immediately downstream of the hydraulic drop, the channel is incised with 2- to 3-foot-high vegetated banks (see Figure 14). This incised channel is straight and had quarry spalls within it as it approaches the culvert inlet. A roadside ditch flows into Griggs Creek immediately upstream of the culvert on the right bank (see Figure 15).

Figure 14: Looking downstream at incised banks

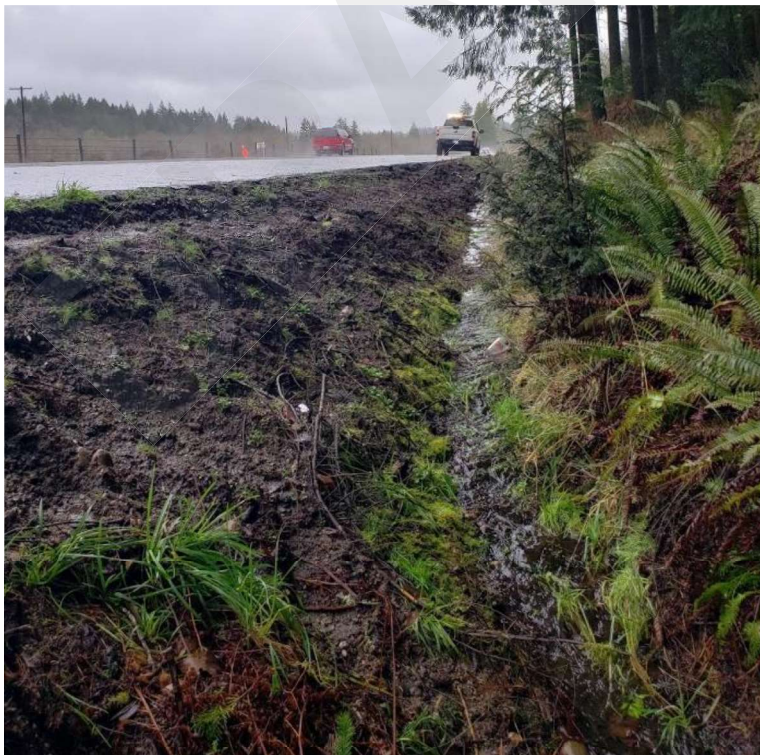
Figure 15: Roadside ditch entering on the right bank upstream of the culvert inlet

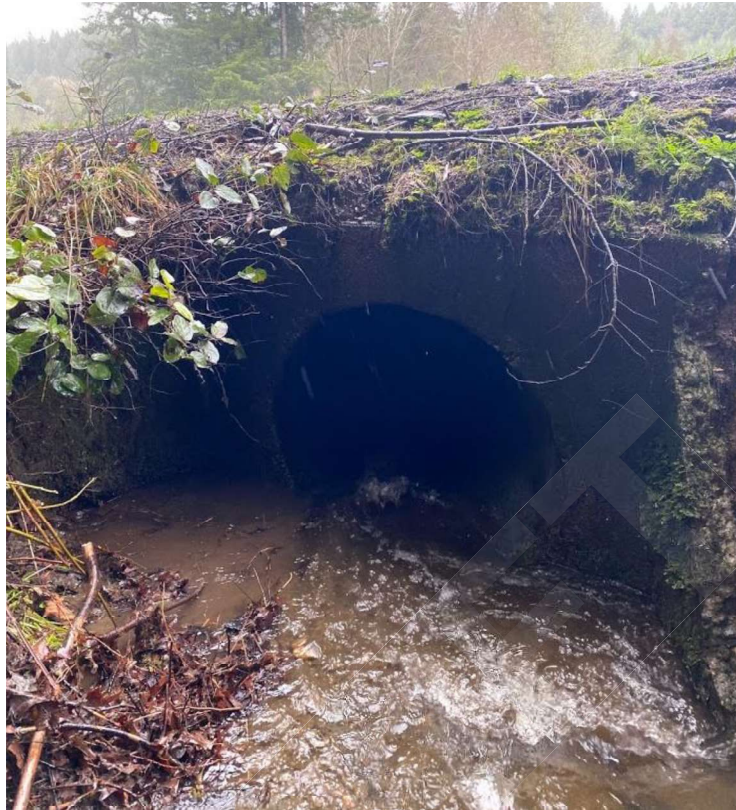
The 36-inch concrete culvert invert is clear of sediment and has concrete headwalls that come out at roughly a 45-degree angle. The right headwall is broken. See Figure 16 below.

Figure 16: Culvert inlet

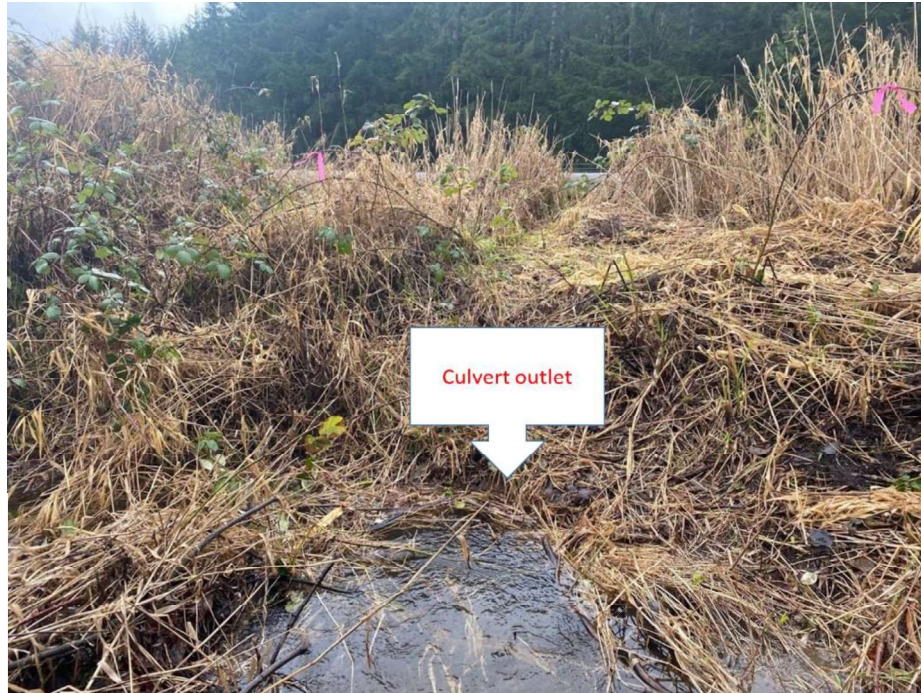
On the day of the first site visit the culvert outlet was completely inundated and not visible (see Figure 17). The culvert outfalls into a vegetated wetland area that is divided by a raised vegetated island (see Figure 18 below). A roadside ditch comes in from the left bank (see Figure 19). A wire fence appears to have caught debris and caused several feet of deposition upstream of it that extends to the culvert outlet. There was an approximate 2-foot hydraulic drop across the fence.

Figure 17: Submerged culvert outlet

The existing 3-foot-diameter, 193-foot-long concrete culvert has a 2.9 percent slope according to the March 2020 survey. The structure is slightly skewed beneath U.S. 101. The culvert outlet is completely submerged, and the top of the culvert is not visible beneath the elevated water surface and debris. The outlet is filled with approximately 2 feet of sediment. The culvert inlet was not observed to have sediment or any obstructions.

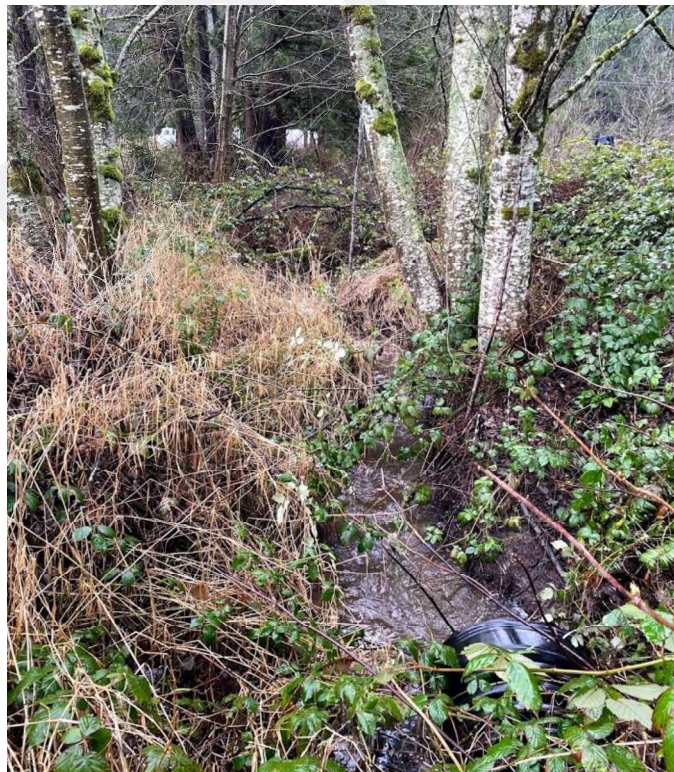
Figure 20: Access road culvert inlet

After the drop, the channel continues to meander through vegetated banks, taking a hard left turn, and reaches a 2-foot-diameter high-density polyethylene (HDPE) culvert that goes underneath an access road (see Figure 20 below). There is a scour pool at the culvert outlet before the channel continues to the left (see Figure 21).

Downstream of the culvert outlet, a large sediment buildup has caused the culvert to be submerged. Flow travels around the buildup, creating an island (see Figure 18 above). A small tributary coming in from the left bank is assumed to be from roadside drainage. The tributary joins Griggs Creek upstream of the fence that has accumulated debris and sediment. Approximately 200 feet downstream of the culvert outlet, there is a small privately owned access road with a 2.5-foot-diameter, 32-foot-long HDPE culvert that Griggs Creek flows through.

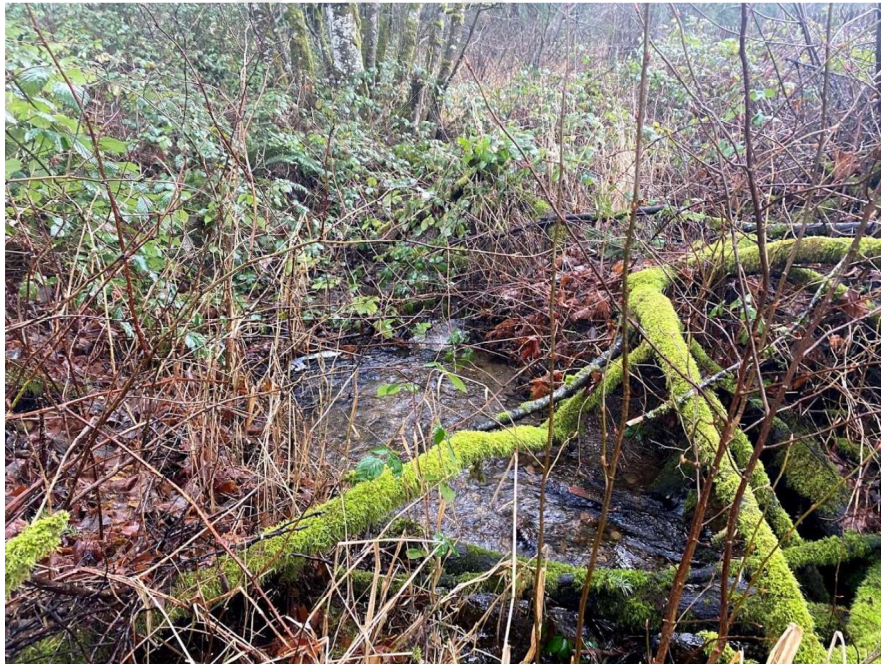
Figure 22: Looking downstream of smaller woody material in the stream

There is some small wood within the channel, mostly branches fallen from larger trees (see Figure 22). The banks range from 1 to 3 feet high, are well vegetated, and consist of a clayey sand material. The channel substrate is consistent gravel throughout the reach. Downstream of the influence of the auxiliary culvert, three bankfull widths were taken resulting in an average 8.6-foot bankfull width.

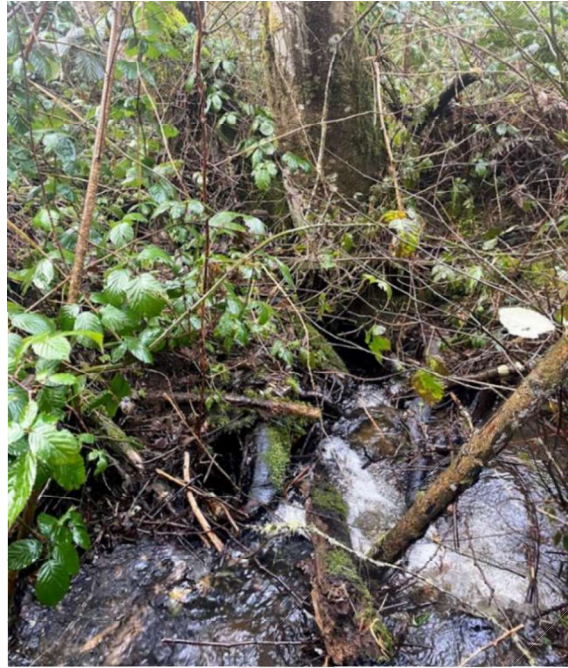
Figure 23: Looking downstream at woody material within the stream and hydraulic drop

Approximately 150 feet downstream of the access road culvert, the channel steepens and becomes more incised with 3-foot-high vegetated banks. Two trees and LWM within the stream create a 2-foot hydraulic drop, shown in Figure 23 and Figure 24 below.

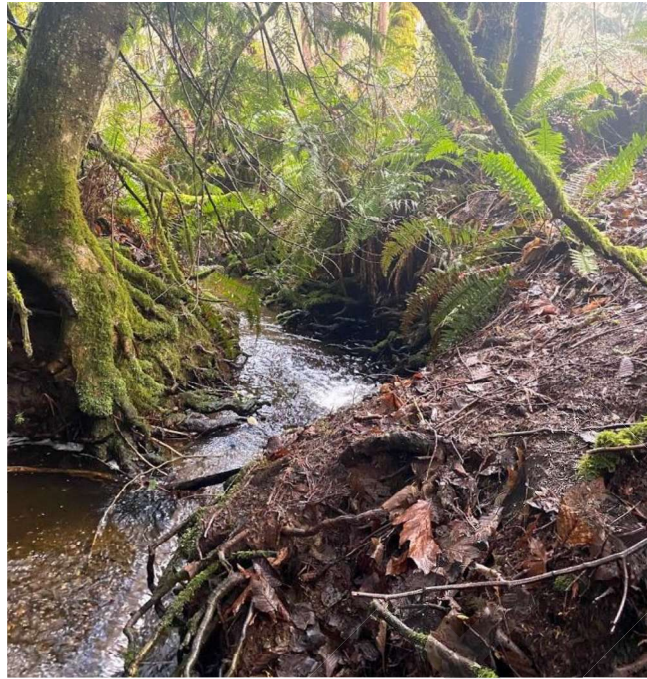
Figure 25: Roots within meandering stream and undercut banks

Downstream of the drop, the channel meanders, taking left and right turns and creating eroded and undercut banks. Many roots are lying in the channel, shown in Figure 25.

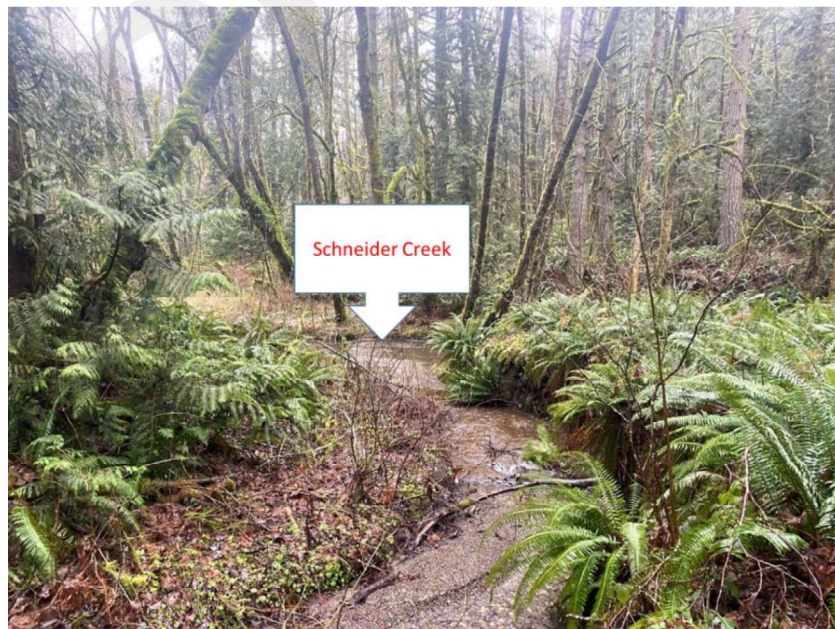
Figure 26: Looking downstream at the Schneider Creek confluence

The channel meanders for another 300 feet until reaching the confluence with Schneider Creek, roughly 700 feet downstream of the U.S. 101 crossing. Directly upstream of the confluence, the right bank is slightly eroded as the channel takes a left turn to meet the much larger Schneider Creek (see Figure 26 and Figure 27 below).

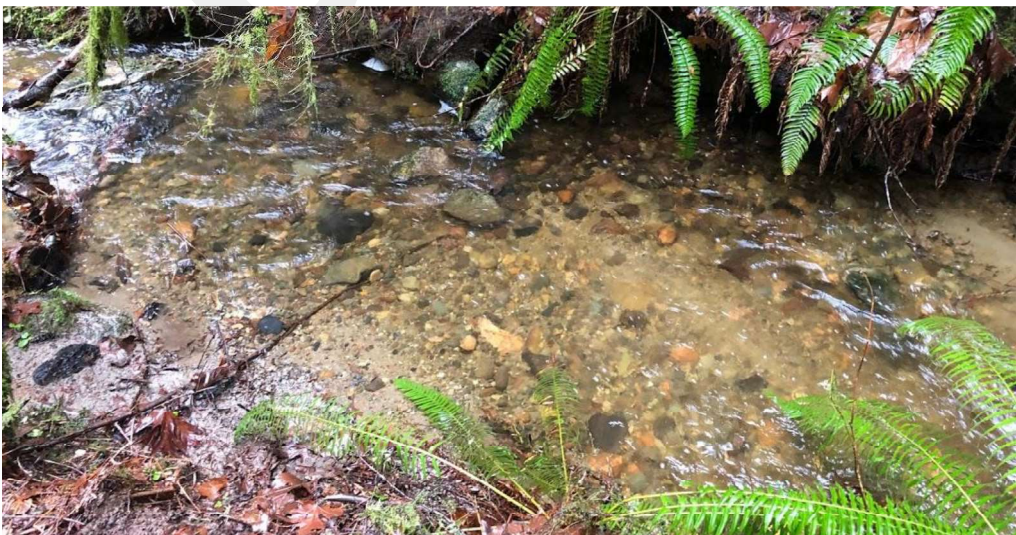
Figure 32: Sediment within reference reach

Two Wolman pebble counts were conducted on January 21, 2020, at the upstream reference reach, between bankfull widths 2 and 4, with the D_{50} being 0.6 inch; see Figure 29 above for pebble count location. It was obvious after two pebble counts the channel material would be categorized as streambed sediment so a third pebble count would not be needed. The pebble count was located in an area that was beyond the influence of the culvert. The results of the pebble count indicated that the substrate was composed primarily of fine to very coarse gravel with some cobbles. The bed material is a mixture of very fine to coarse gravel, generally smaller than streambed sediment. The largest sediment size in the reference reach observed was a 10-inch-diameter cobble (see Figure 9). Within the watershed the sediment supply is healthy, there was evidence of material moving within the system as sediment deposits were observed downstream of the culvert outlet and upstream of log jams. Table 3 provides a summary of pebble count data. Figure 31 shows sediment size distribution and Figure 32 shows sediment within the reference reach.

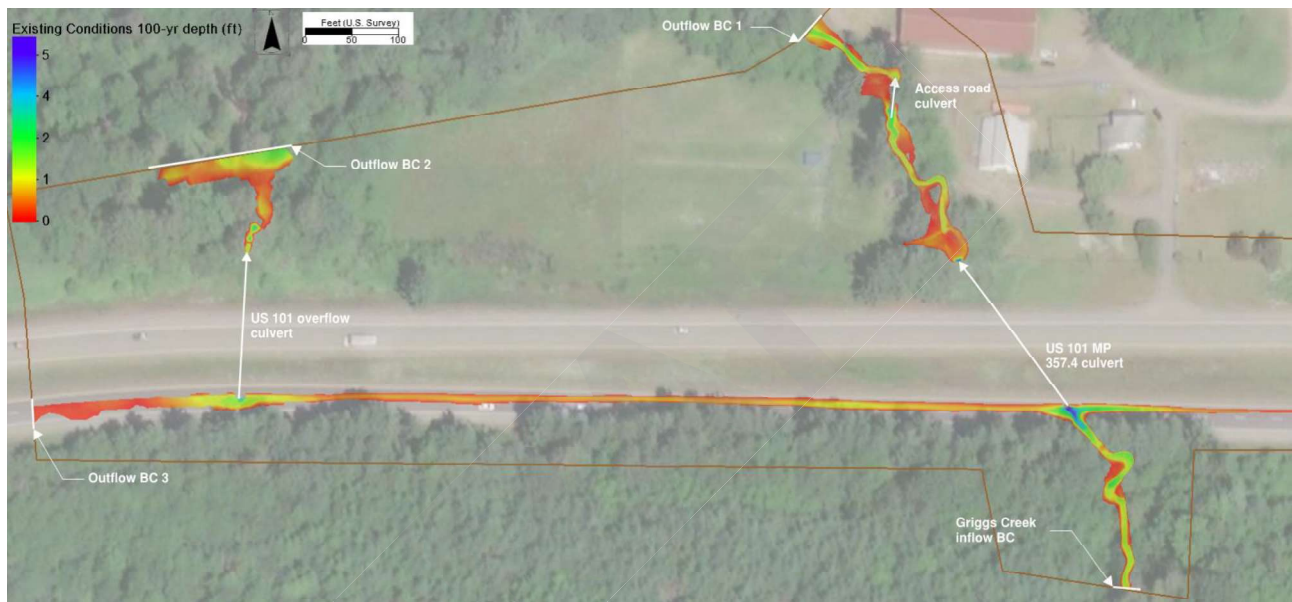
As shown in Figure 38, there are three outflow boundary conditions. The outflow BC 1 at the downstream boundary is used in both the existing and proposed conditions as a normal depth rating

Figure 38: Boundary condition locations
