## BRIDGE INSPECTION REPORT

Br. No. 303/12

Br. Name PORT WASHINGTON CS1840

Intersecting PORT WASHINGTON NARROWS

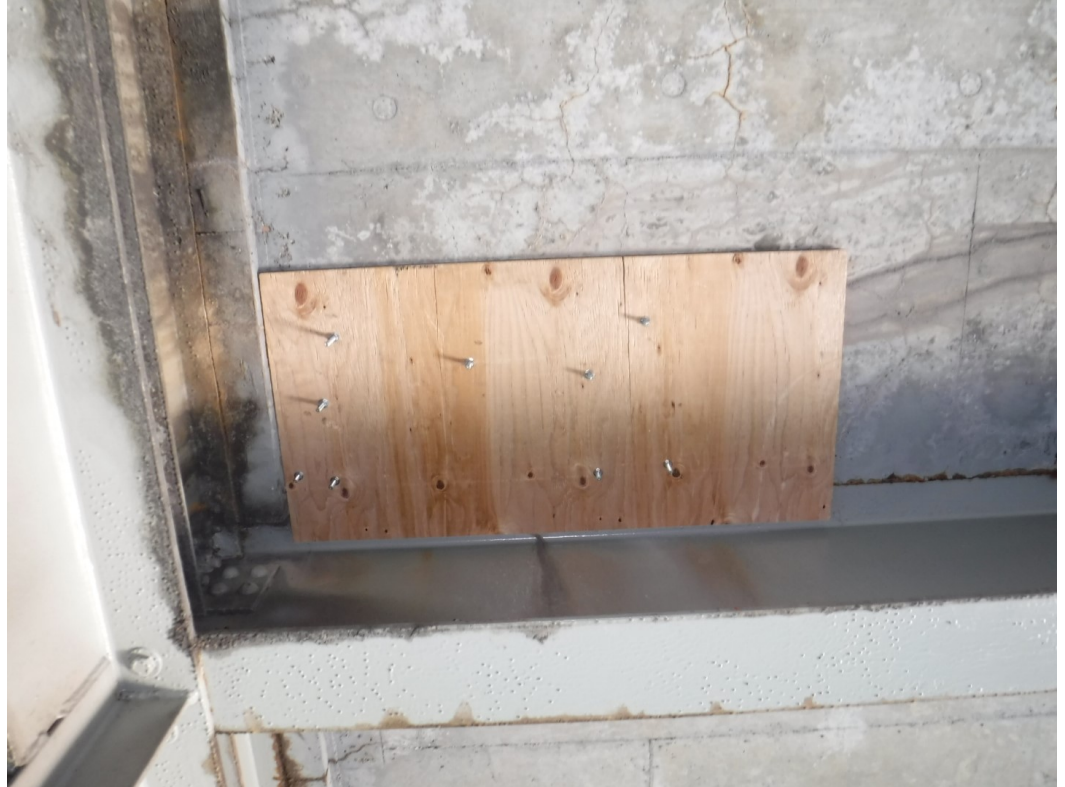
## SI-87

35 Concrete Deck Soffit  
Photo Type: C - Completed  
Orientation: UP  
Date: 11/7/2018  
Repairs:  
Soffit patch in Span 6 Panel 1 SB.

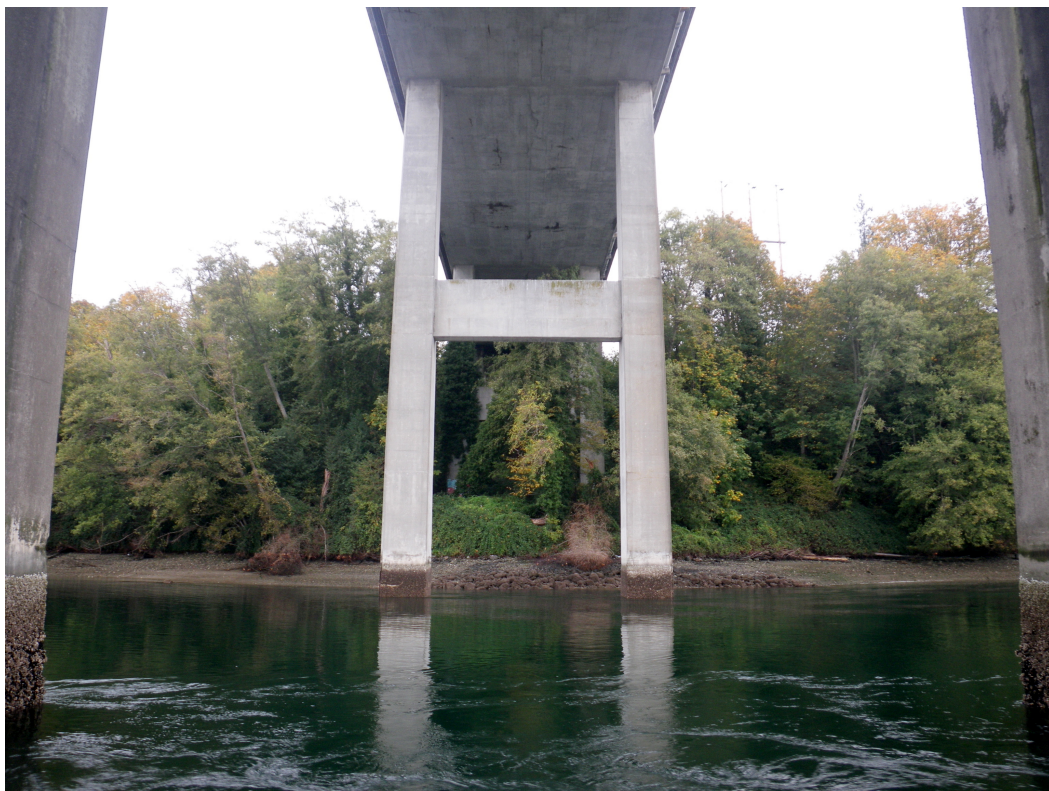
Pier 9. Typical in-water pier elevation and configuration. Note north bank riprap.

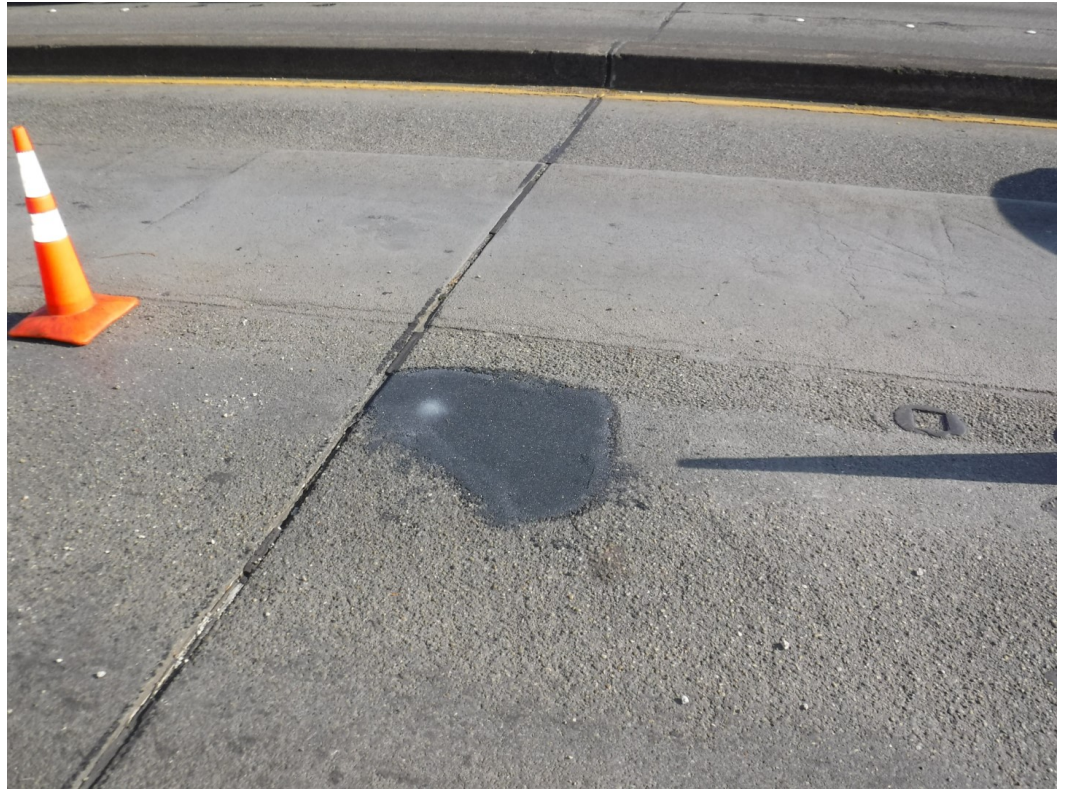
## SI-88

804 Polyester Concrete Overlay  
Photo Type: G - General  
Orientation: E  
Date: 11/13/2018  
Repairs:  
Span 6 Panel 1 SB patch in overlay.

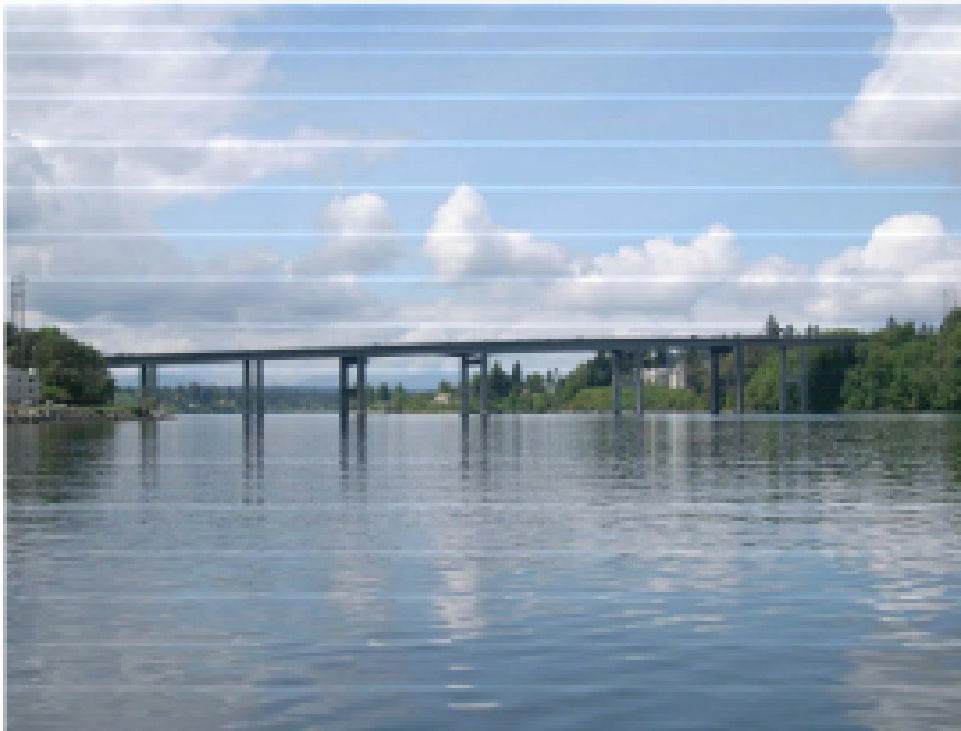
Photograph 1 : Elevation looking West. Pier 3 is at the left of the photo and Pier 9 is at the right.
