**Washington State
Department of Transportation
Bridge Preservation Dive Team**

UNDERWATER INSPECTION REPORT FOR

PORT WASHINGTON CS1840

BRIDGE NO. 303/12

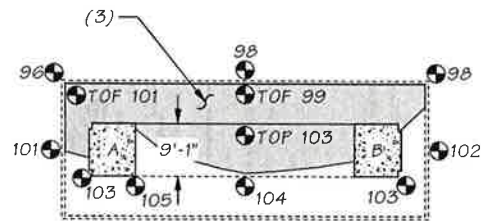
PIER 3 - PLAN

All submerged piers have exposed footings to varying extents. The footing exposures are similar to previous underwater inspections. The maximum vertical footing exposure was found at Pier 3 on the northwest corner where there is an estimated remaining embedded depth of 10-feet. No evidence of significant local scour was found at the piers since the last underwater inspection. Riprap protection is in place at Piers 4 through 8. Riprap extents should continue to be monitored during each underwater inspection, since the piers were designed for riprap protection. REPAIR #14242 calls for the riprap to be restored to the originally designed conditions.
